HMVS CERBERUS – Documentation in support of an application for a Heritage Permit to undertake structural reinforcement works

1. Introduction

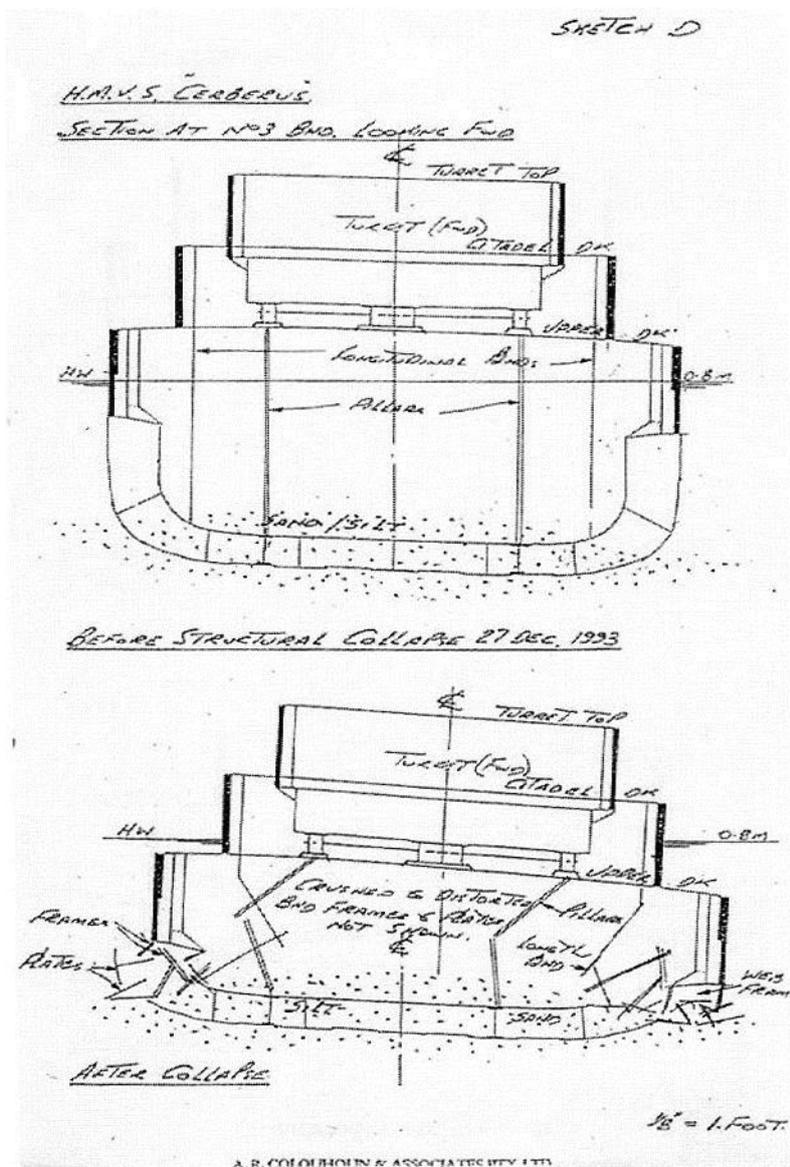
Figure 1 A section at number three bulkhead before and after the 1993 collapse (source: sketch by A.B. Colquhoun reproduced in Anderson 2002)

In 1993 and 1994, wave energy during intense storm activity caused catastrophic collapses of the corroded buoyant hull structure under the influence of the great weight of the armoured hull, breastwork, decks and turrets (**Figure 1**). Although the upper deck is now awash at high water, the essential shape and profile of the vessel at present remains intact. However, as is stressed by Anderson, the next catastrophic collapse of *Cerberus* is predicted to entail the breaking up of the deck as the unsupported weight of the armour hinges the remaining structure out of alignment. GHD's structural analysis, based upon the corrosion rates developed by MacLeod in 1994, indicated that stress levels in the deck beams are approaching four times the safe working capacity (GHD 2003:i). Splitting of the sternpost, observed during an MHU inspection in 1999, was regarded as a forewarning of this final stage. A recent diving inspection undertaken by Malcolm Venturoni of Professional Diving Services has reported that a 20 metres length of the bow structure is now entirely devoid of structural support (M.Venturoni pers. comm. 17th October 2017). As the armour is segmental and bolted to relatively lightweight substructures, collapse is likely to result ultimately in loss of integrity and the vessel's present visual coherence. An engineering assessment places the likelihood of hull failure and collapse in the near future in the

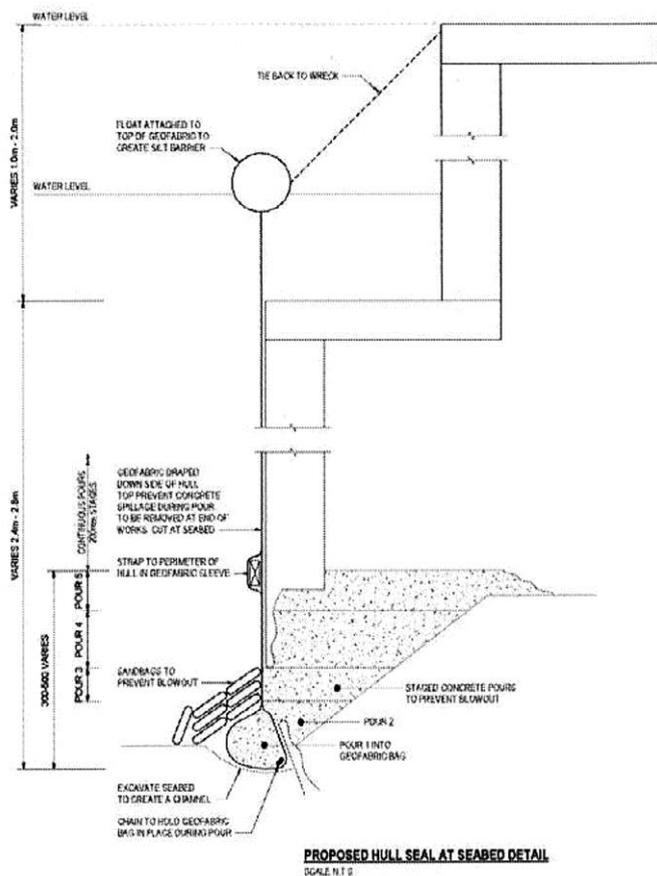
Figure 2 A part section of hull (not to scale) showing method of dealing with gaps at base of armour belt (source: Venturoni 2017)

Deep penetrations on the main and upper decks will be blanked off with timber shuttering and progressively removed according to infill level. This will ensure that the hull will be filled to the level of all penetrations and limit spillage from within the hull during placement. The open spaces at seabed level on the port side, at the bow and stern, together with some 20 metres length of gap below the armour belt on the starboard bow, will be blanked off and a geofabric skirt will be secured against the hull with sandbagged walls during infilling (**Figure 2**). Debris from the wreck surrounding the hull that may be hazardous to divers working adjacent to the vessel will be relocated nearby for site safety.
