METALWORK

INTRODUCTION

This information sheet deals with the care and conservation of metals used in building, including cast and wrought iron as fencing and decorative panels, steel-framed windows and roof plumbing. For more information refer to the section *Further Reading*, and to the separate information sheets on *Corrugated Roofing* and *Slating, Tiling and Roof Plumbing*.

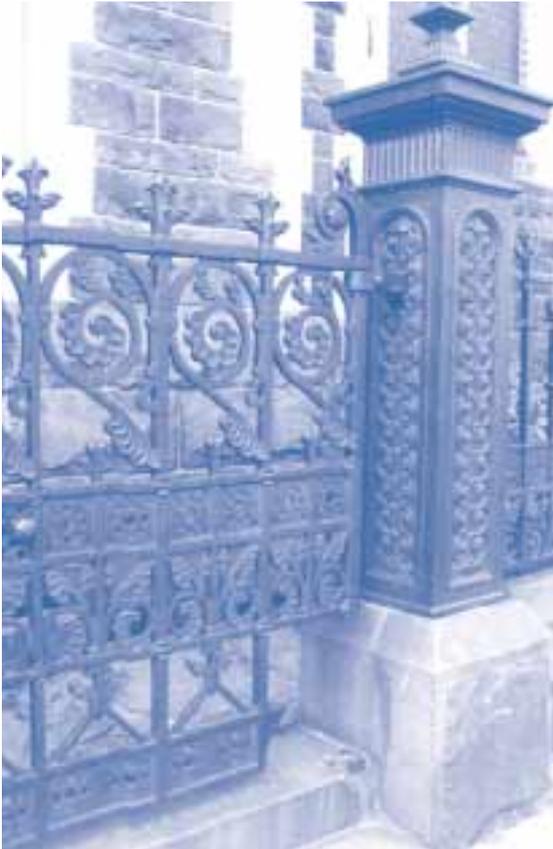
This cast-iron fence was produced in Glasgow at Macfarlane's 'Saracen' Foundry. Such imports were not rare in the nineteenth century but they are now becoming increasingly harder to find. The broken segment will be virtually impossible to repair.

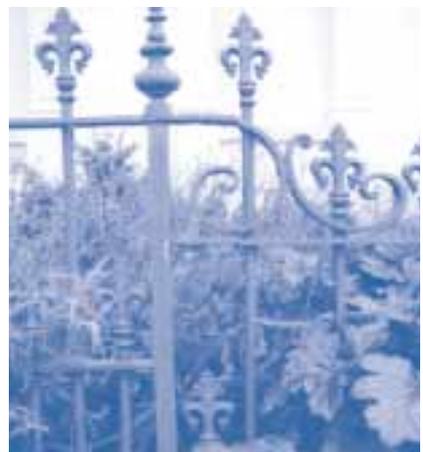
This residential scale palisade style fence is made of wrought iron and cast iron components.

Palisade fences typically have a low stone or rendered brick plinth surmounted by a palisade of wrought iron or mild steel shafts. The shafts penetrate flat wrought iron or mild steel rails and carry ornamental spearheads or tops of cast iron. The iron palisade is supported along its length by posts of cast or wrought iron or masonry.

A common conservation measure needed for palisade fences is to replace stays that may have been misguidedly removed to allow easier access for lawnmowers and the like. The stays are needed to brace the fence and ensure its lateral stability.

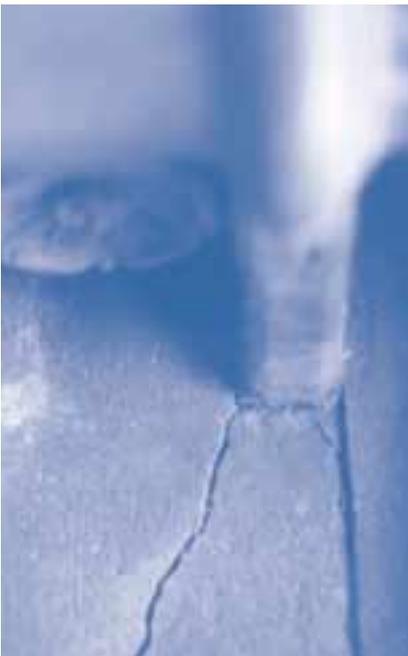
As a result of the wrought iron metal corroding, the stone fence pillar is splitting apart to the point where it is cracking and becoming virtually irreparable. Immediate action is required to remove the metal, treat it and install a new soft lead plug to accommodate expansion and any future slow corrosion.

The problem with such fixings is that repeated thermal cycling creates a very small gap between the iron and the lead, allowing water entry and consequent crevice corrosion. Severe corrosion of the iron can result in rupturing of the masonry base as the rusted metal expands.

In order of increasing intervention, conservation approaches to corroded palisade shafts include:

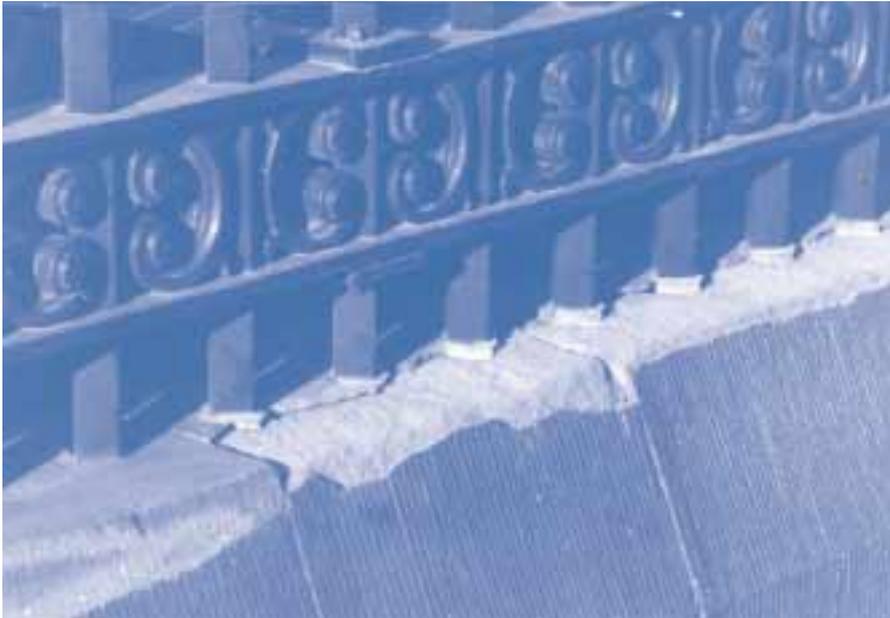
This palisade fencing has encouraged the delamination of the bluestone base. The pikes of the fence rest in lead sleeves which absorb the movements of the metal. The stone delamination shows where the lead sleeves are not effective.
