Timber

Timber repairs

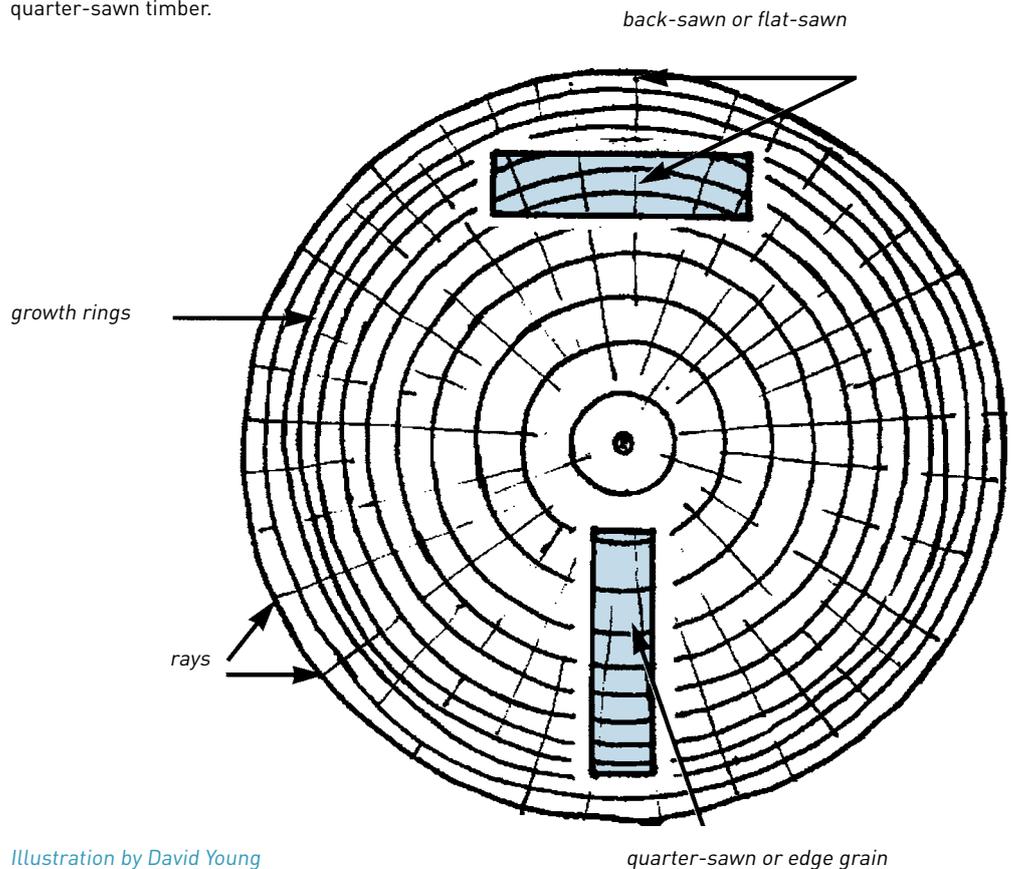
Back-sawn and quarter-sawn timber

Back-sawn timber (tangentially cut) will swell and shrink in response to changes in moisture levels to a much greater degree than the radially cut, quarter-sawn timber.

Most swell or shrinkage occurs tangentially (around the circumference of the log), where it can be up to 12% of the original size, compared to up to 6% radially. The amount of swell or shrinkage also varies between species and with different growth conditions. Boards cut tangentially (back-sawn or flat-sawn) will swell in width up to twice as much as boards cut radially (quarter-sawn) and are less suitable for use in exposed locations such as weatherboards. Fortunately, wood swells very little longitudinally (0.1%-0.2%), or it would have to be specially treated to be used for building or furniture.

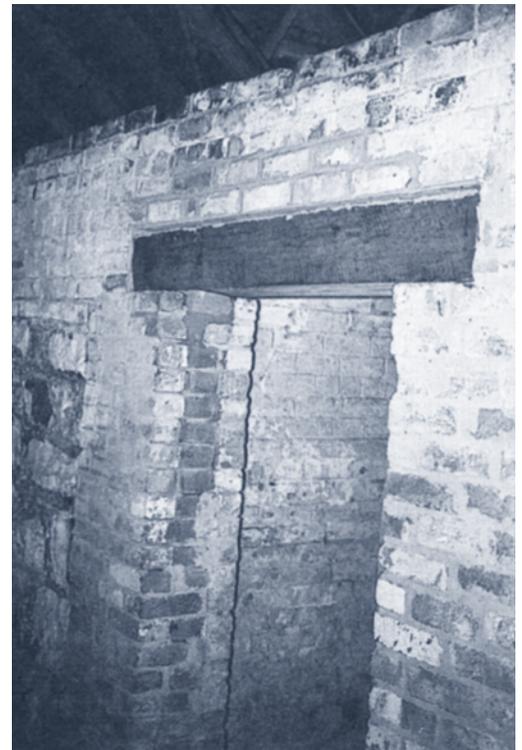
This replacement lintel was green (unseasoned) when installed as part of repair works. It has now dried and shrunk, leaving a 20mm gap and unsupported brickwork above.

In normal use, seasoned wood swells or shrinks by 1%-2%. Greater movement than this leads to weakening of joints, and allows weather penetration through cracks, which promotes further deterioration.

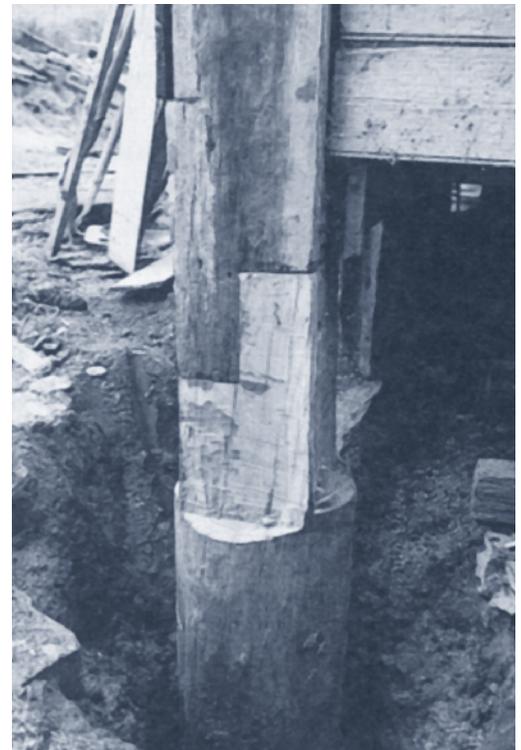
Replacing the rotten base of a post while retaining as much of the original as possible. Note the light outer sapwood and the darker heartwood of the new post base. The use of fungicidal rods and external 'bandages' should be considered when undertaking work such as this, particularly as the sapwood has no inherent durability. Posts not carrying a heavy structural load should not be set in concrete, but in free-draining gravel and earth.

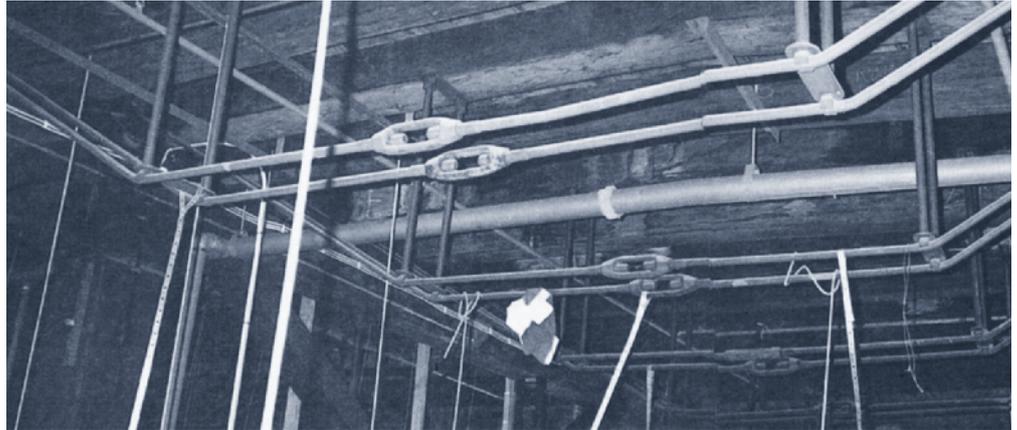
Trussed girders used to strengthen beams at Walsh Bay wharves, Sydney.
Photograph by Peter Phillips

Steel reinforcement can also be used with timber members. It may consist simply of steel plates either side of a member (or top and bottom), bolted through the timber. A method sometimes used for overstressed beams is to convert them to trussed girders by adding steel struts and tension rods underneath. Where space is not available for this, a variation using side rods is possible.

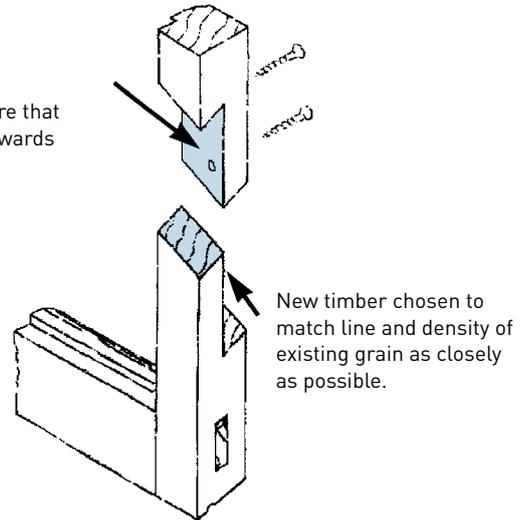
(i) Patching the bottom rail

Splayed splice joint with undercut and step to give optimum surface area for gluing/fixing and to ensure that moisture is directed away from vulnerable areas towards the outer face of the window.

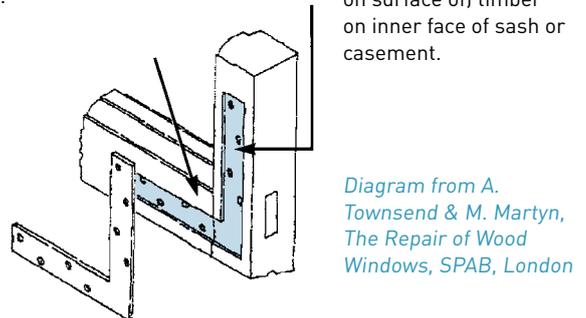
(ii) Reinforcing a loose corner with a brass angle

Brass angle bracket fixed with brass screws.

and reglueing. On window sashes, minor decay combined with loose joints can often be repaired by removing the decay and repairing with epoxy, and using brass angle brackets let into the surface on the inner face.
