AIRLIE

452 St Kilda Road, South Melbourne

Conservation Management Plan

December 2005 (Revised 21 December 2005)

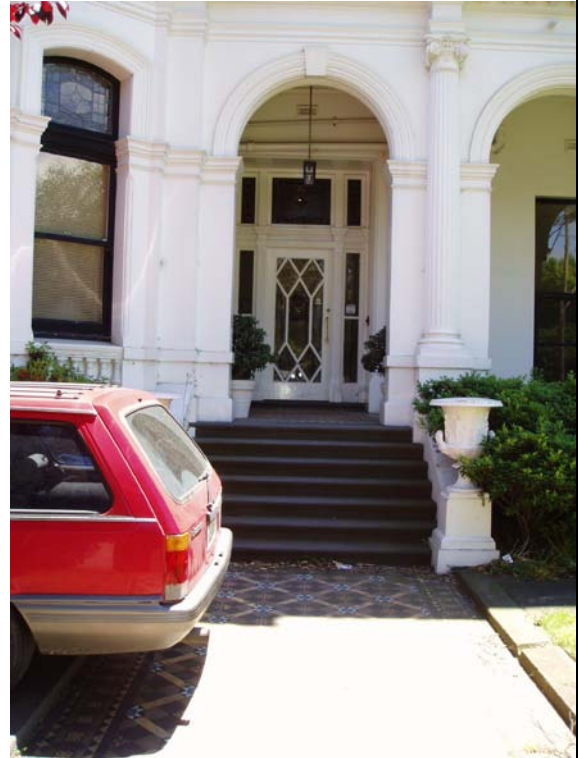
Figure 15 South elevation, entrance.

The main entrance is located between the canted bay to the west and a fluted engaged Corinthian column to the east, mounted on a pedestal at ground and first floor level at the end of the arcade, and forming a porch. The porch is further denoted by a keystone in the arch which distinguishes it from the arches in the

loggia. Low rendered balustrades, with cast iron urns set on the pedestals, project from the base of the porch on either side of bluestone steps. An open rendered balustrade extends between the pilasters of the loggia. Beneath the balustrade is a moulded and modillioned cornice which is repeated above beneath the balustraded parapet comprising open balusters between pedestals, which presumably were surmounted by urns (now lacking).

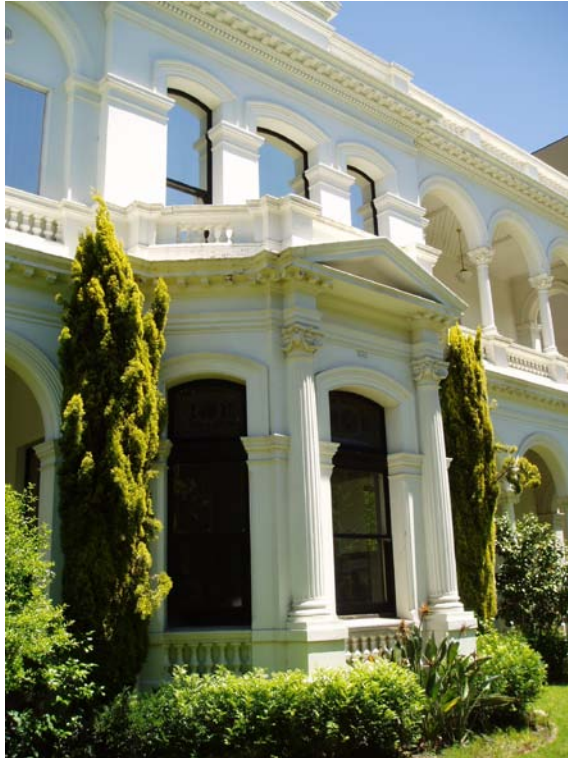
Figure 17 East elevation, the canted and breakfront central bay.

The central bay is canted at the ground floor level and breakfront above. Corinthian pilasters frame the central window of the canted bay and support pedimented entablature with a solid rendered balustrade between pedestals above.

The central bay has three stilted-arched window openings at ground floor level with balustraded spandrels below and three similar window openings at first floor level. A solid parapet articulated by pedestals and surmounted by a pediment extends across the central bay.

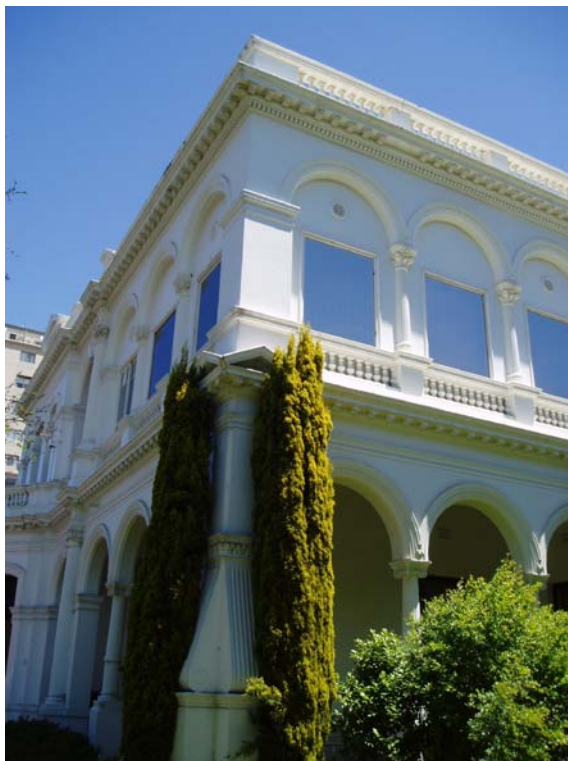
Figure 19 The enclosed south-eastern loggia.

Like the south elevation, the first floor of the southern loggia was enclosed by fixed windows and render within the arches in 1985. The most northerly ground floor window was also replaced with a glazed door and highlight some time in the late twentieth century.

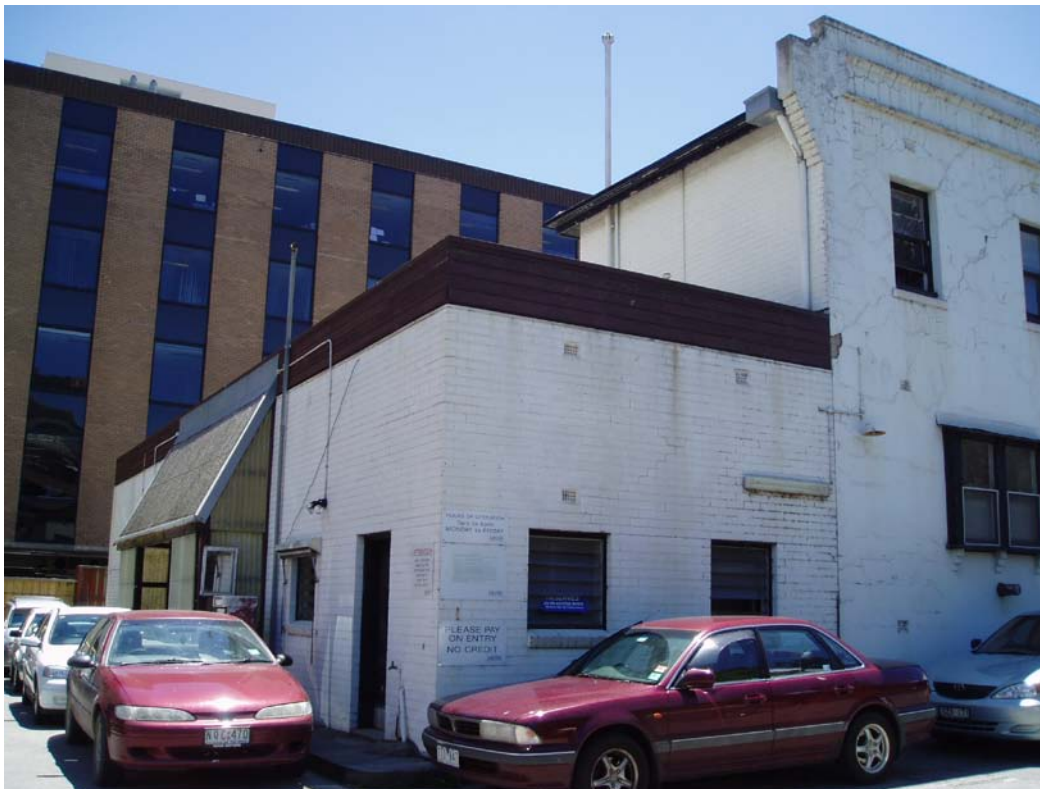
Figure 24 The west and south elevations of the 1954 additions.

The single-storey c.1954 additions are painted face brick with a flat roof. The windows throughout are formed by glazed louvres. The flat roof is generally concealed by a parapet formed of vertical timber boards. There is a large opening in the centre of the west elevation, providing access to an under-cover parking area, which is partially covered by a corrugated fibreglass awning.

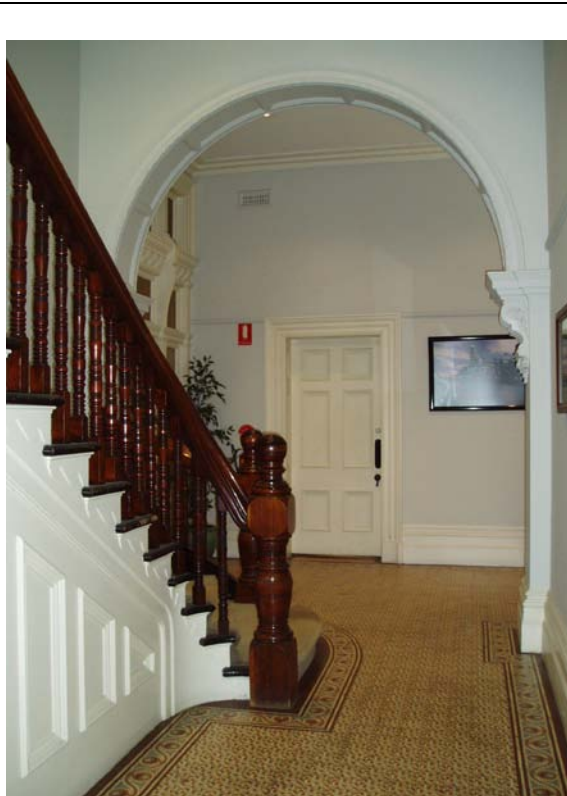
Figure 25 The main hall, ground floor.

The entrance lobby (Room G1) is a small rectangular space leading to the L-shaped main hall (Room G2). A large arch divides the eastern and western ends of the hall and frames the main staircase, which is the focus of this space. At the northern end of the main hall, an elaborate timber doorcase forms a decorative screen across the space and opposite the main entrance and separates the northern rooms. The western end of the main hall provides access to the rear of the house through a doorway under the main stair.

The ceiling and floor of the entrance lobby and main hall are continuous. The timber floor is covered with faux mosaic tiles with borders. The ceiling is plasterboard ceiling with a decorative cornice typical of the 1930s. The large arch features panelled reveals and decorative corbels.

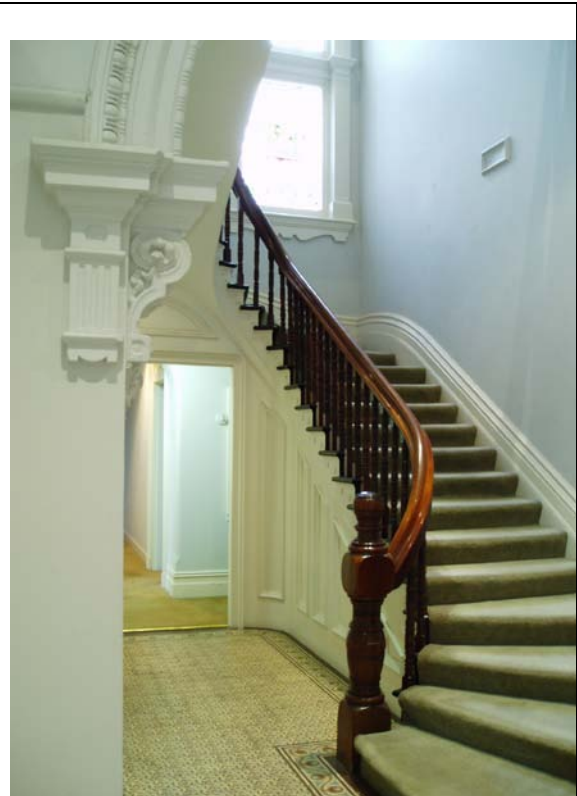
Figure 26 The main stair.

The main timber stair doglegs around the main hall. It features two heavy turned newel posts, moulded handrails and turned balusters of varnished timber, with moulded stringers and panelling to the underside of the stair. In the western wall of the main hall, and lighting the main stair, were originally four elaborate stained and painted glass windows. As part of the 1930 alterations, the lower southern stained glass window was removed to create a doorway to the new first floor rooms. The construction of the 1930 wing also obstructs the light to the retained stained glass window above, diminishing its presentation. The rectangular windows feature painted pastoral scenes and the lower window is framed by reeded timber pilasters and under-sill decoration.

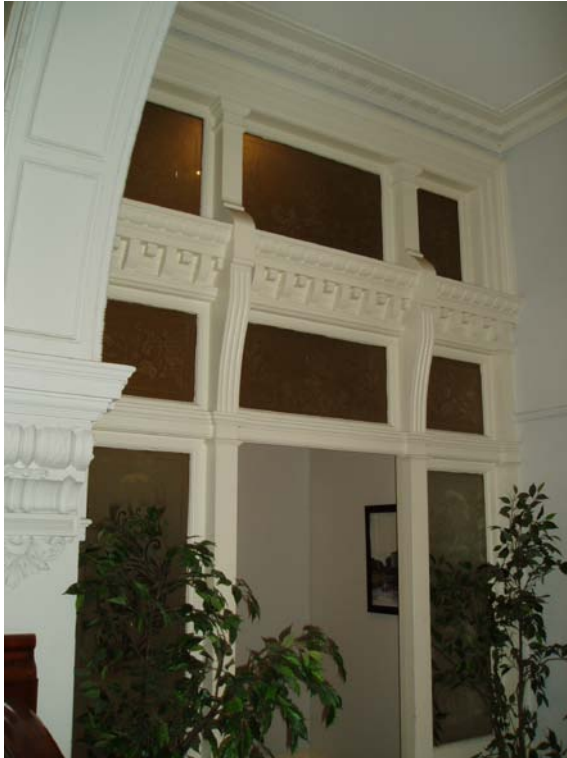
Figure 27 The glazed timber screen at the northern end of the main hall, ground floor.

The elaborate doorcase comprises two etched glass sidelights on either side of a central doorway (now lacking a door) and two transoms, between which are two rows of three etched glass highlights. The mullions are partially reeded and terminate in miniature Doric pilasters. The deep upper transom is embellished with stylised dentils above a row of stylised modillions. The joinery was presumably originally varnished and has since been over-painted.

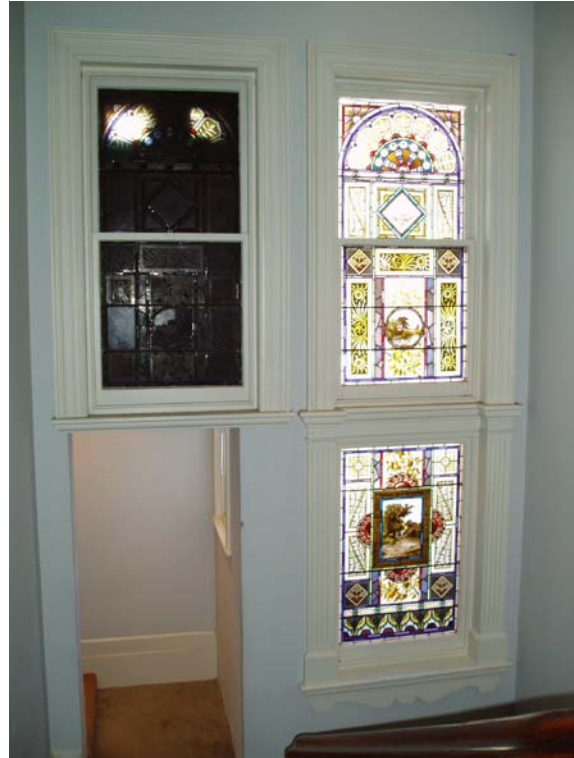
Figure 28 Stained and painted glass windows to the main stair.

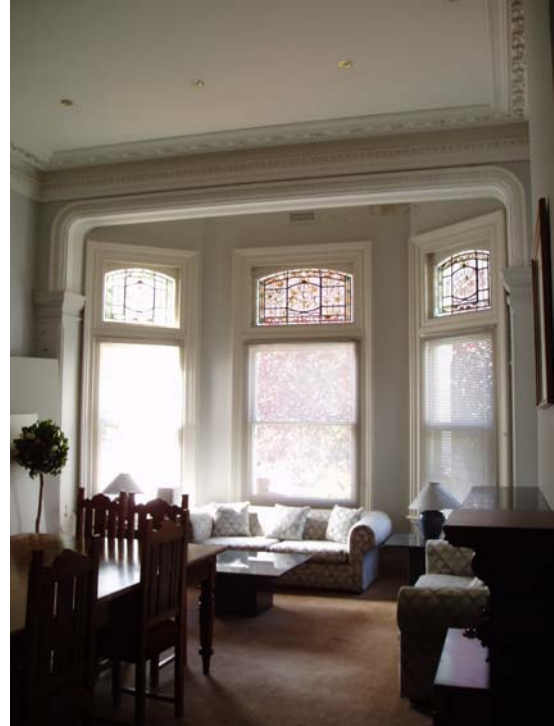
Figure 30 Canted bay of Room G19.

Rooms G4 and G19 have been further decorated by square archways with staff beads and decorative plaster mouldings framing the canted bays. Each of the three windows within these bays features stained glass highlights.

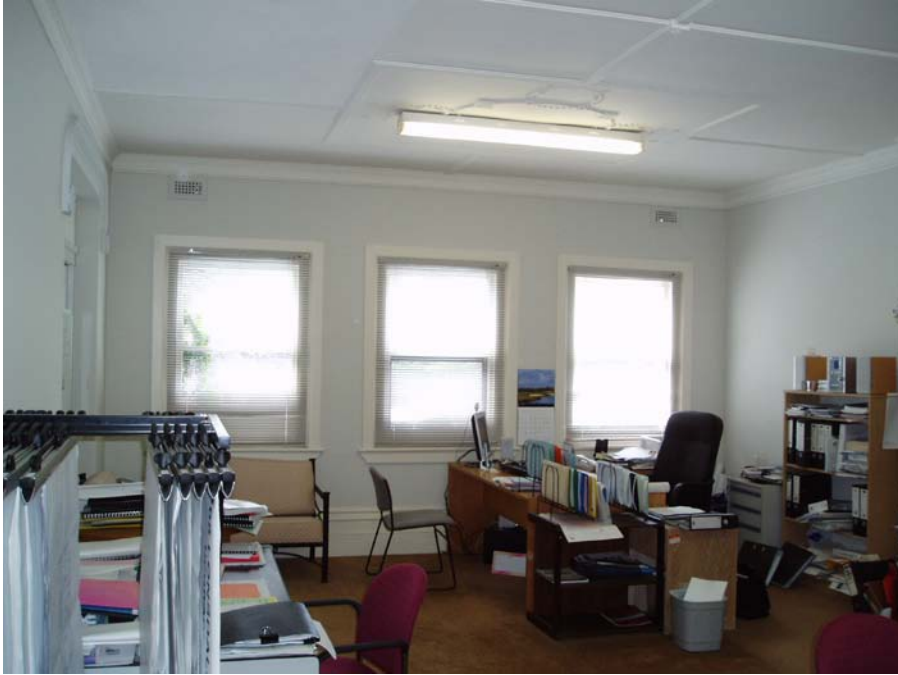
As described in Section 3.4.2, Room G20 dates from the 1891 phase of construction but was substantially altered and extended southwards in 1930. The original chimneybreast has been retained, as described above, and the room features high, moulded Victorian skirtings and a four-panel door with moulded architraves; however, the ceiling has been lowered and the three timber-framed, double-hung sash windows are typical of the 1930 additions. Two new openings have also been

Figure 31 Room G20, originally part of the 1891 residence but substantially modified in 1930.

formed in the eastern wall and fitted with bi-fold panelled doors connecting with Room G19.

If room G20 is demolished as is currently proposed, the mantel and hearth tiles from this room should be carefully removed for reinstatement in room G4. Similarly, any original doors and joinery located within areas of contributory significance which are to be redeveloped, should be carefully removed and utilised to replace missing or altered elements within the retained 1891 mansion.

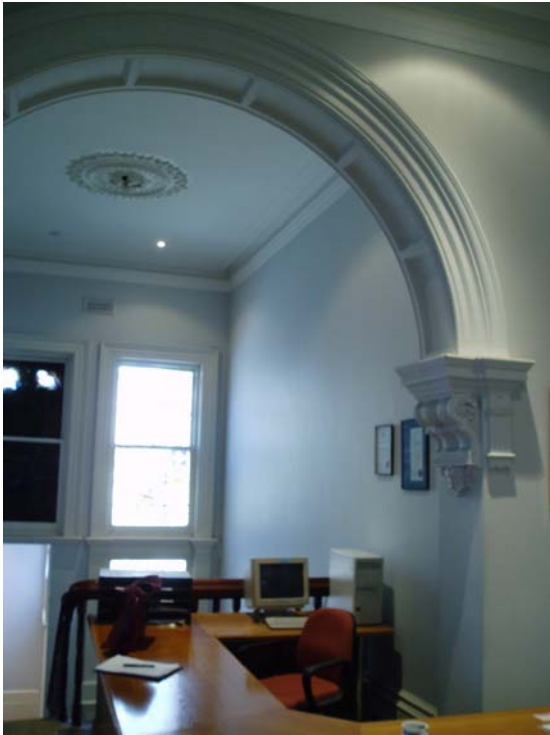
A large arch with panelled reveals and decorative corbels, which appears identical to the arch directly below in the ground floor main hall (G2), frames the division between the main stair and the first floor hall (F1). Smaller versions of this arch are repeated at the northern and southern ends of the hall at the entrance to the lobbies. All the other extant features in the hall are typical of the original rooms at this level; they comprise lath and plaster ceilings with elaborate ceiling roses and moulded cornices, hard-plastered walls, timber floors covered with carpet and high moulded skirtings. A textured finish to the ceilings of F9 and F14 indicates that modifications or repairs have been made to these ceilings, including the installation of halogen downlights. In addition, the original ceiling in room F3 has been

Figure 32 The arch between the main stair and first floor hall.

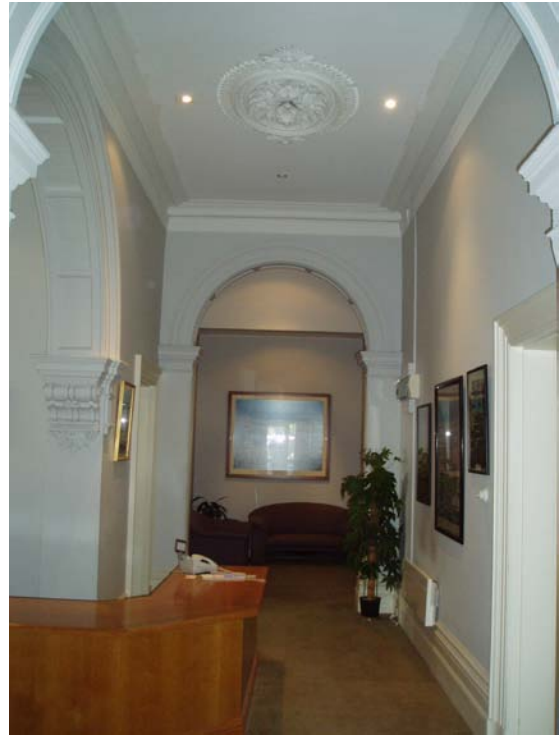
Figure 33 The arches between the hall and lobbies, first floor.

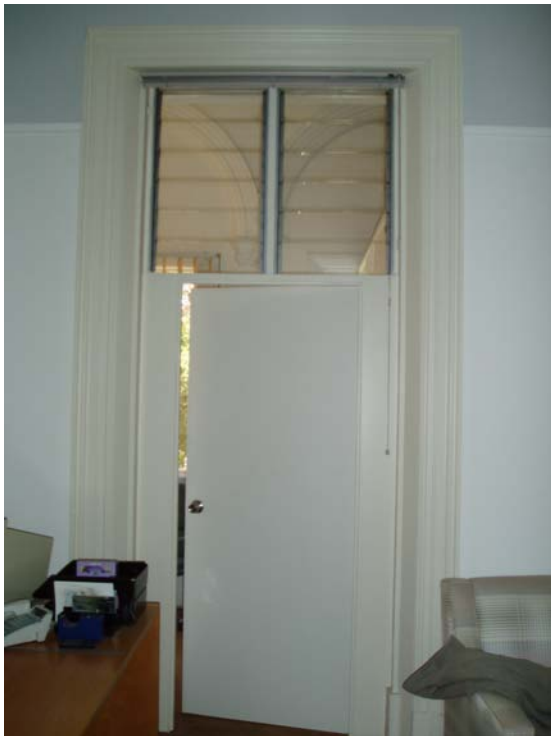
The modifications to the south-eastern loggia (F10) have included the replacement of two full height, timber-framed, double-hung sash windows with doors to provide easier access. One window is at the northern end of the loggia (providing access to F9) and the other is in the southern wall of F12. Both windows have been replaced with a modern flush timber door and glazed louvred highlight above. The outer face of the loggia has been enclosed with a combination of fixed windows, building sheet and render. The original timber floor has been covered with carpet while the original ceiling of diagonal timber boards has not been altered.

Figure 35 Modified opening between room F12 and the enclosed loggia.

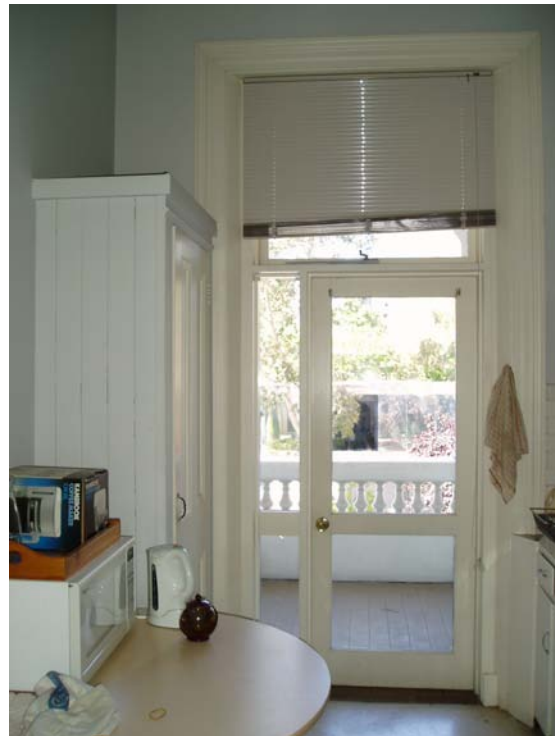
Figure 36 Modified opening to the kitchenette, F13.

The original window opening in the kitchenette (F13) has been in-filled with a modern glazed door, side light and highlight. The room has a vinyl floor laid over timber, an original ceiling rose and cornice and an early built-in cupboard in the south-eastern corner. The bathroom (F4) has a lowered plasterboard ceiling, ceramic-tiled floor and partially tiled walls.

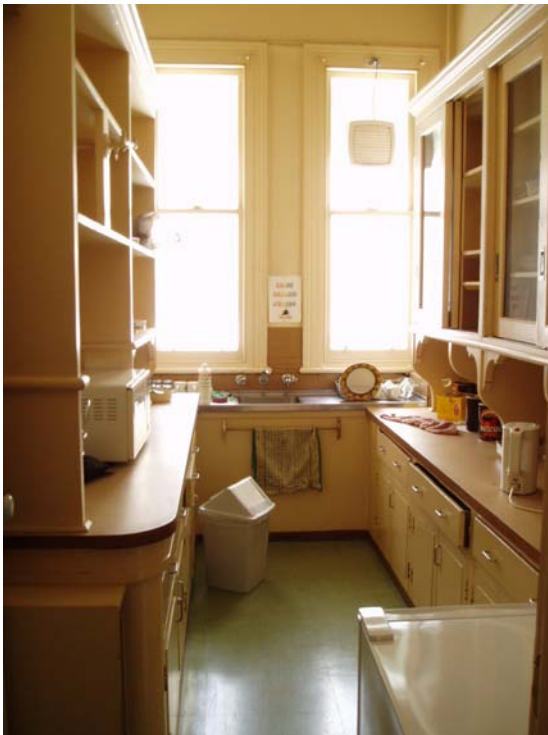
The frames of the original Victorian built-in cupboards to the pantry and larder have been retained, but include later modifications dating from c.1930. An original gas lamp bracket remains attached to this joinery in the pantry, and a similar gas lamp bracket is located within the alcove under the main stair leading to the cellar.

Figure 37 The pantry, room G9.

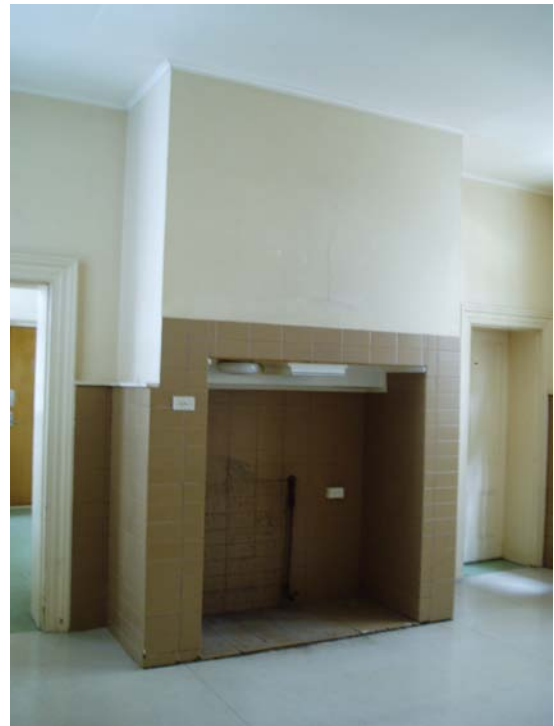
Figure 38 The chimneybreast to the kitchen range, room G10.

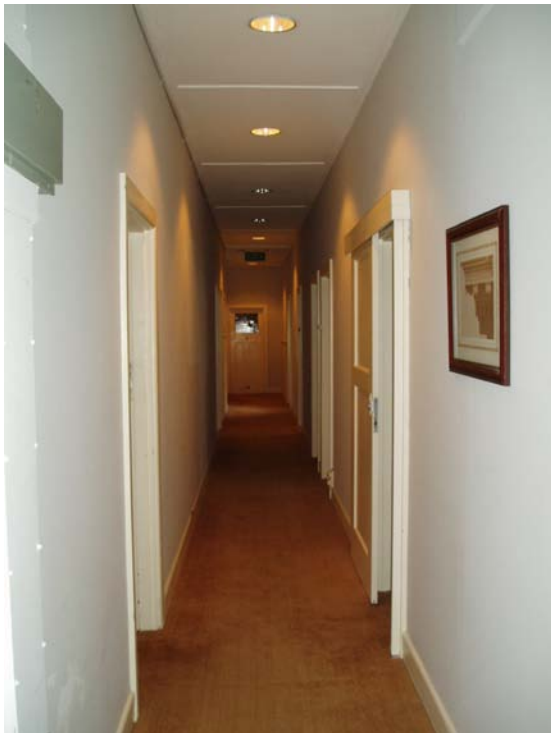
The 1930 rooms and corridors typically have plasterboard ceilings with battens and simple plaster cornices, timber floors covered with carpet and hard-plastered walls. Skirting boards and architraves are typically bull-nosed with no mouldings. Doors appear to have been variously altered or replaced over the years and include flush timber doors, half-glazed doors, three-panel doors and sliding two-panel doors.

Figure 39 The ground floor double-loaded corridor in the 1930 wing.

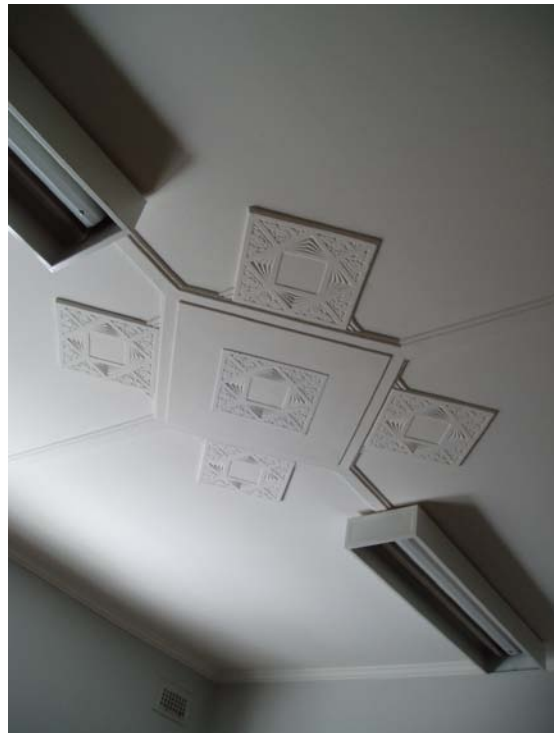
The ceilings in rooms G30, G31, F22 and F23 feature decorative plaster centrepieces in the Art Deco style. The corner fireplaces in these rooms have been concealed with plasterboard sheets. The walls to some rooms have been lined with imitation pine laminate sheeting.

Figure 40 Typical decorative ceiling to a sitting room in the 1930 wing.

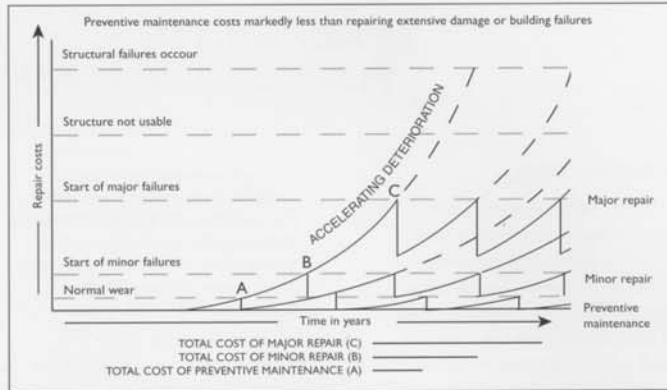
Preventive maintenance costs markedly less than repairing extensive damage or building failures. Diagram from *Preventive Maintenance of Buildings*, Van Nostrand Reinhold, New York, 1991.
