Heritage Impact Statement

Proposed Works at Former Rechabite Hall (VHR H0575) 10 Little Chapel Street, Prahran

AuthorTrethowan ArchitectureDate31 March 2025

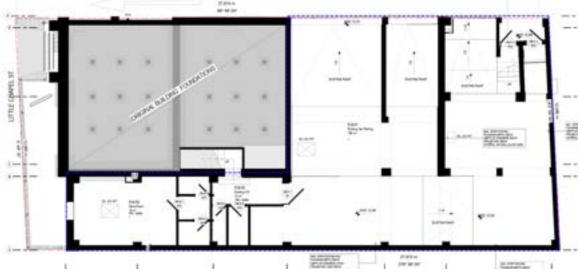
Figure 17: A1-100 Existing basement floor plan. Source: Trethowan Architecture, 2025.

At the Victorian building, the basement is accessed via the carpark entrance at the north elevation. It leads to Existing Car Parking R.B-01, which connects to the 1980s section. The carpark entrance and R.B-01 are in fair condition but covered in graffiti.

At the 1980s section, the basement consists of Store Room R.B-03, Existing WC R.B-02 which are located towards the western part, and carparking towards the eastern part. R.B-02 connects to the ground floor via stairs. These rooms are generally in fair condition.

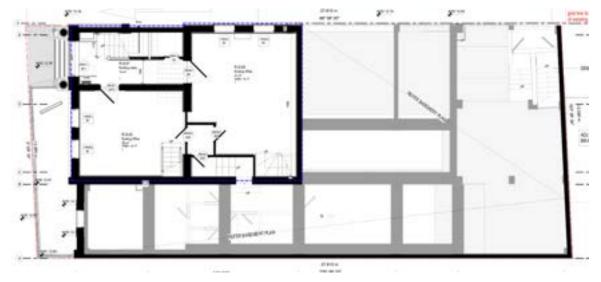
Figure 20: A1-101 Existing ground floor plan. Source: Trethowan Architecture, 2025.

At the Victorian building, the front entrance leads to Existing Lobby R.G-01, which connects to Existing Office R.G-02 to the south and Existing Office R.G-03 to the east. R.G-01 has an oval ceiling rose and simple cornices. Along the north boundary is a set of original stairs and unpainted blackwood timber balustrading. Door architraves, doors, and skirting boards are elaborately detailed and painted in a non-original pink and light blue colour scheme. Original tessellated floor tiles are installed throughout. R.G-01 is in fair but declining condition due to high use.

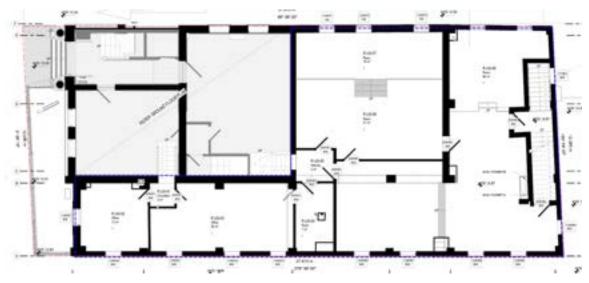
Figure 29: A1-102 Existing upper ground floor plan. Source: Trethowan Architecture, 2025.

At the Victorian building, the non-original southeastern stair in R.G-03 links with Hallway R.UG-05, which connects to Rooms R.UG-06 and R.UG-07 to its north which are of a stepped arrangement. These three rooms are all later modifications made to the building as part of the 1980s addition. They are in good condition.

R.UG-05 connects to the 1980s section via southern and eastern doors. The southern door leads to Room R.UG-04, which is connected to Offices R.UG-02 and R.UG-03 to its west. The two offices are separated by Circulation R.UG-01 which adjoins R.G-02 on ground floor. The eastern door connects to an L-shaped space Room R.UG-08 containing a raised platform to the north and a fire stair to the east. They are in good condition.

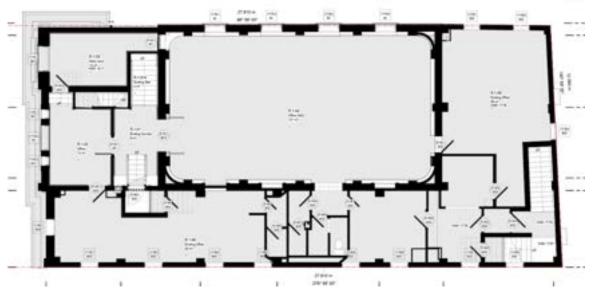
Figure 32: A1-103 Existing first floor plan. Source: Trethowan Architecture, 2025.

At the Victorian building, upon ascending Existing Stair R.1-01A is the Existing Corridor R.1-01. It has a narrow, arched door on the north wall that leads to the Tower, a western door to Office R.1-02, an eastern door to Office (Hall) R.1-04, and a southern stair and door with plinths to the 1980s section. R.1-01 has a similar decorative scheme as the ground floor R.G-01, with cornices, an oval ceiling rose, and skirting boards with a later paint scheme. R.1-01A and R.1-01 are in fair but declining condition due to high use.

R.1-04 is the original Main Hall of the Victorian building. It is accessed via a set of original doubleswing doors. Upon entry, a painted coffered ceiling with elaborate decorative features such as a ceiling rose, cornices, and decorative vent covers can be observed. Coloured LED lighting is concealed within the top of the cornices, and additional downlighting is installed in the ceiling. To the north wall are four arched windows with timber double-hung sash windows. On the south wall are the former (refer to Figure 44) arched window openings turned into alcove shelving. One opening is modified into a doorway connecting to the 1980s section. A stone memorial plaque is affixed to the west wall next to the entrance door. It appears to have been installed to commemorate Reverend George Mackie (d.1871), who was a member of IOR. Next to the plaque to the northwestern corner of the Hall is an infilled and overpainted doorway with two steps. The east wall has a later door opening connecting to the 1980s section. The decoration of the ceiling appears to be a reproduction, with some areas of repair noted in the northeast corner. The main hall appears to be in good condition, with minor bubbling paint observed in the ceiling.

At the 1980s section is a series of rooms. Broadly, existing Office R.1-06 at the western end is connected to R.1-02. Existing Office R.1-05 at the northeastern corner is connected to R.1-04 and a series of smaller rooms and a fire stair in between. These rooms are in good condition.

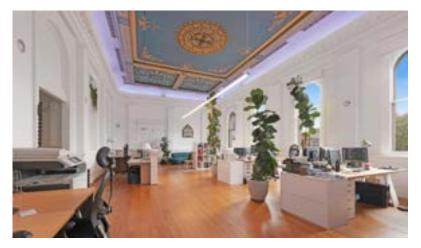
Figure 42: West-facing view of Office (Hall) R.1-04. Note that the south wall's original window openings have either been infilled or altered into a doorway that connects to the 1980s section. Source: realcommercial.com.au, 2023.

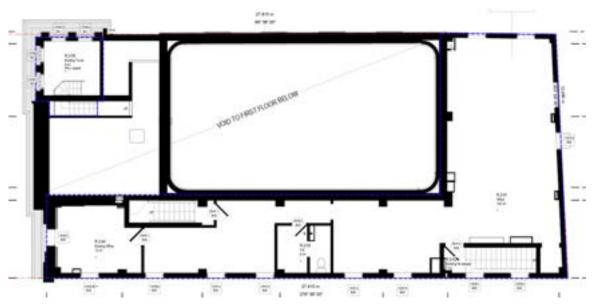
Figure 45: A1-104 Existing second floor plan. Source: Trethowan Architecture, 2025.

The Existing Tower R.2-05 is the only second floor space in the Victorian building. It has timber plank ceilings, blue-painted walls, white-painted timber double-hung sash windows, and timber floorboards. Stair balustrading is simple and unadorned. To its east, the Victorian building's ceiling crawl space can be entered via an access hatch opening. Timber roof rafters and miscellaneous timber items can be observed. The tower is in fair condition despite wear-and-tear.

At the 1980s section is an L-shaped, largely open-plan Office R.2-01, which comprises of a westfacing Existing Office R.2-04, a central WC R.2-03, and an Existing fire escape R2.02 to the southeastern corner. The space is plainly decorated but in good condition.

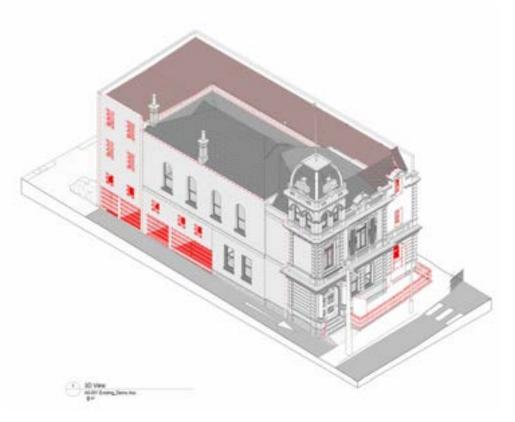
At north elevation, gutters, downpipes, signage, and graffiti at the western portion of the Victorian building's ground level façade is to be removed. The eastern portion of its façade is to be demolished, including non-original walls, windows, and carpark gates. Additionally, the entire 1980s section's façade is to be demolished; its structure is to be retained.

At south elevation, all 1980s window units are to be removed.

Figure 52: A0-001 Axonometric view of proposed demolition to the building's exterior. Source: Trethowan Architecture, 2025.

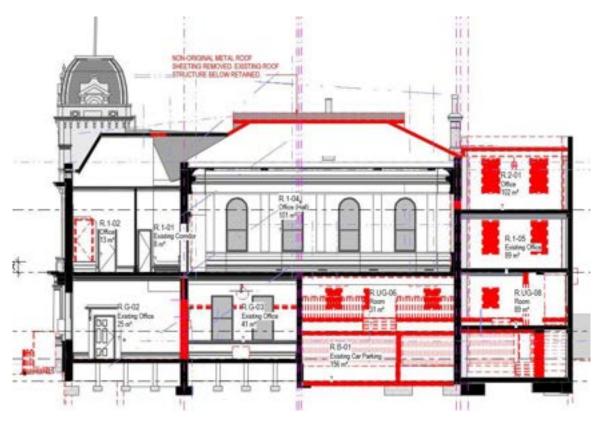
At first floor of the Victorian building, later light fittings are generally removed. The door and floor coverings in Store Room R.1-03 are to be demolished. In Existing Corridor R.1-01, the north door that leads to the Tower, the non-original south stairs, plinth, and a small section of the original wall that connect to the 1980s section are to be demolished. A rectangular section of the ceiling is also to be cut for a future skylight. In the Office (Hall) R.1-04, non-original build-outs to pilasters are to be removed to enable future restoration works. Sections of west and east walls are to be removed at high levels to allow for future HVAC works. Generally, at the 1980s section, walls, doors, bathroom fittings, stairs, and sections of floor slabs and beams are to be demolished.

At second floor of the 1980s section, roof structures, ceilings, light fittings, walls, wall claddings, doors, bathroom fittings, joinery, fire services, stairs, and sections of floor slabs and beams are to be demolished.

Figure 53: A2-251 Demolition section across the original building and 1980s section. Source: Trethowan Architecture, 2025.

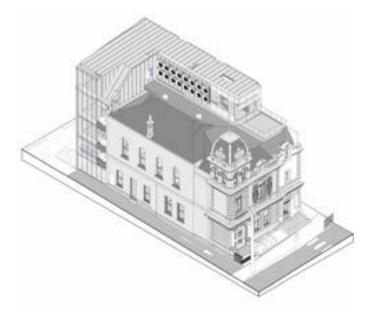
All existing window openings are to be fitted with new double-hung sash windows. Similar to the east elevation, a new third floor addition is to be constructed on top of the existing structure, with a shadow gap to delineate old and new fabric. The new façade is clad in standing seam metal in shale grey. Matte dark grey powdercoated cladding is proposed above window openings. To the west is a sunken terrace enclosed by a woven rectangular mesh balustrade.

Figure 56: A0-002 Axonometric view of proposed changes to the building. Source: Trethowan Architecture, 2025.

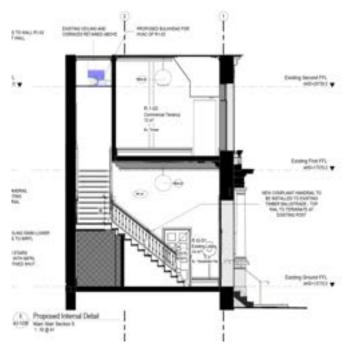
The main stairs in the Existing Lobby R.G-01 of the Victorian building is to be upgraded due to compliance issues. New metal handrails, finished in brushed brass, are to be installed over the existing handrails, and nosing strips are to be adhered to all steps. The under-stair space is to be blocked off and its door fixed shut. At Commercial Tenancy R.G-02, existing walls, architraves, skirtings, and floorboards are to be made good. Above the door, a new wall-mounted split system AC is to be installed. An existing, non-original southern doorway is to be infilled and made good. The eastern opening between Commercial Tenancies R.G-02 and R.G-03 is made good following the demolition of non-original partitions and doors. At Commercial Tenancy R.G-03, vents are installed to the new openings in high levels of the walls for HVAC purposes. Walls, skirtings, and floors are generally repaired following the removal of non-original elements. The proposed east wall opening is to be fitted with a new door. The existing south wall opening is to be infilled and finished, and its skirting to match adjacent existing fabric. At Commercial Tenancy R.G-04, a new ceiling is to be installed with new modern cornice and embedded HVAC ceiling vents. A new service pillar is to be embedded in the northeastern corner of the wall. A new floor is introduced to the entire space, with a finished floor level matching the adjacent R.G-03. To the south, a new wall is constructed, with walls returning to the lift.

Figure 57: A3-517 Section showing works to the original main stair. Source: Trethowan Architecture, 2025.

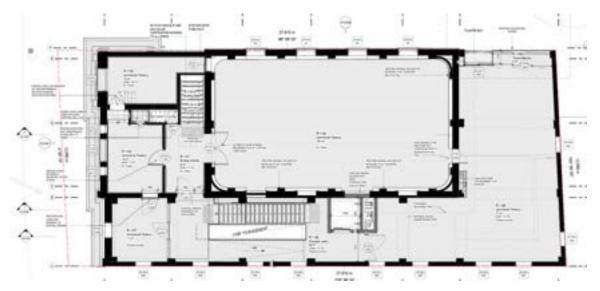
Figure 58: A3-103 Proposed first floor plan. Source: Trethowan Architecture, 2025.

At the western end of the 1980s section is Commercial Tenancy R.1-07. It has a north door that connects to R.1-02. A new glass partition and door are affixed to existing columns, forming its east wall. At Proposed Lobby R.1-06 is a void to the basement, stairs that connect to the upper ground and second floors, and a lift. Commercial Tenancy R.1-05 is an L-shaped, open-plan space at the eastern end. It has a Balcony R.1-05A and a planter to the north.

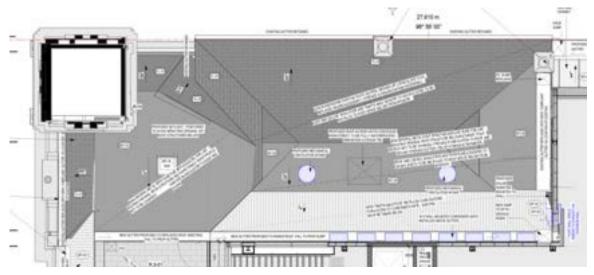
Generally, replacing the existing metal roofing in a like-for-like manner is acceptable from a heritage perspective as this does not introduce any change. New features are proposed to be added to the area, including a new skylight, roof access hatch for safe access, and mechanical ventilation intakes. These features are all essential for the future maintenance and functionality of the place. Physical impacts are mitigated by positioning them to avoid clashing with the existing roof structure. Visual impacts are mitigated by setting them back from the public domain as much as feasible.

Figure 60: A3-105 Proposed roof plan for the Victorian building's southern metal roof. Source: Trethowan Architecture, 2025.

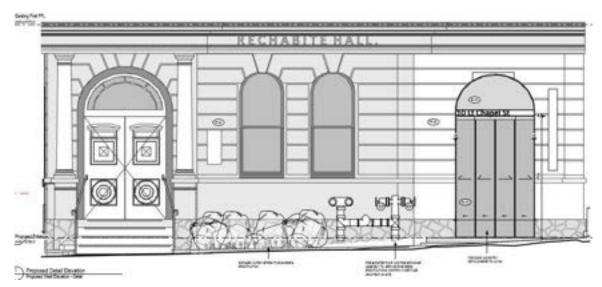
The existing window is proposed to be modified as the front entrance for the 1980s section. The entrance is an arched doorway fitted with glazed double-swing doors. This involves the removal of *contributory* fabric. The work is, however, essential to the ongoing functioning and utilisation of the wider place as it satisfies DDA compliance requirements. Options were considered to locate a new DDA-compliant entrance elsewhere. However, the building is essentially built to all boundaries, and the only other viable point of entry would be from the north façade, which directly adjoins the carpark's driveway and is considered unsafe. Using the original front entrance is not only impractical but would result in extensive change and modification to original detail and fabric. To mitigate impacts arising from the proposed change, the new doorway is designed to be sympathetic to the form of the original entrance. It is also contemporary and minimal through its finishes and materials. These design interventions allow the new door to sit harmoniously with the original opening and 1980s section's front façade, allowing the original entrance to remain untouched and visually dominant.

Figure 61: A3-510 Proposed detailed west (front) elevation, showing the original and new entrances. Source: Trethowan Architecture, 2025.

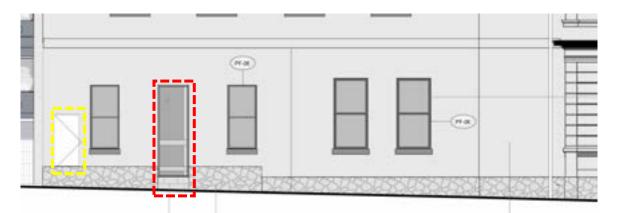
The new electrical panel is required for the ongoing operation of the building. It is required to be in a publicly accessible location. As such, it can either be located at the west (front) or north (side) façade. As it needs to be in a discreet, non-original area, the proposed location is the most appropriate. While it is required for the panel to be finished in powdercoated metal, impacts are mitigated by matching its colour with the surrounding walls so that it blends in as much as possible.

A fixed, glazed panel is proposed to be located between the two reconstructed sash windows. According to historical sources, this area originally had a timber door. This is not reconstructed as a door it is unsafe for the building to directly access the driveway and a faux timber door was considered initially. However, as the room is unable to achieve the required lighting levels in according with the National Construction Code (NCC); where 'natural lighting must be provided by glazing with an aggregate area no less than 10% of the floor area', a glazed solution is proposed. While this articulation deviates from the original design intent, it is necessitated by safety and lighting requirements. Impacts are mitigated by keeping the opening's dimensions and bluestone footing detailing distinguishable yet sympathetic to the original design.

Figure 63: A3-203 Proposed north façade of the Victorian building, note the reconstructed double-hung sash windows, and a new fixed glazed panel in between (outlined in red). An electrical panel is located at the eastern end (outlined in yellow). Source: Trethowan Architecture, 2025.

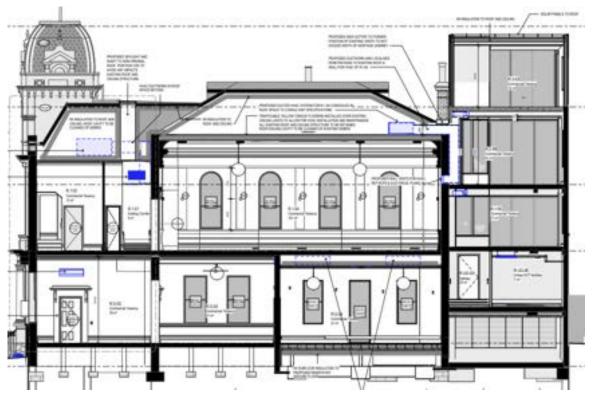
The option of leaving the ducts exposed in the Existing Corridor R1.01 was considered but dismissed due to the applicant's aesthetic preference. The design concept for the Victorian building is for new elements to be presented in a minimalistic aesthetic, which contrasts with the industrial aesthetic for the 1980s portion. Concealing the unsightly ducts with a suspended ceiling appropriately responds to this preference.

It is acknowledged that installing a suspended ceiling at this location has physical and visual impacts. Physical impacts arise from new penetrations and fixings to heritage fabric. This is mitigated by detailing the interventions so that they are as minimal as feasible and do not affect decorative elements such as cornices. On the other hand, while there are visual impacts arising from the changed perception of the height and proportion of the corridor, the intervention is reversible.

Figure 65: A3-253 a section showing the HVAC provisions within the Victorian building and 1980s extension. Source: Trethowan Architecture, 2025.

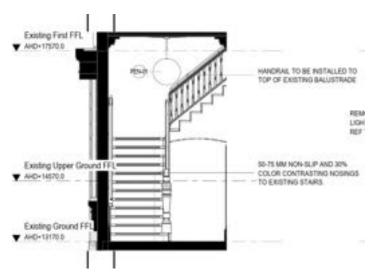
For the building to fulfill as many DDA compliance requirements as feasible, design interventions to the original stair are necessary. Minor impacts have been identified for the addition of new DDA-compliant handrails above the existing balustrade top rails. The option of installing code-compliant, freestanding handrails was considered but dismissed as installing new structures to the steps would lead to an even more detrimental physical impact compared with the current proposal. Additionally, installing freestanding handrails would decrease the width of the stairs, causing other knock-on effects regarding DDA compliance. Another option of raising the existing wall-side handrail was considered but dismissed because it would harm the understanding of its original position while still requiring a code-compliant handrail to the outside top rail. As such, adding secondary handrails is considered a more efficient and comparatively less harmful approach. To mitigate impacts, the design of the new handrails, in brushed brass, has been carefully considered to be sympathetic yet distinguishable as new. This approach was successfully employed in the Former Gollin and Company Building (VHR H0685) and was approved at Alexandria Tea Rooms in Bendigo (VHR H0115).

Similarly, the addition of nosing and tactile to the steps are also necessitated by DDA requirements, which will ensure the building satisfies contemporary accessibility requirements and is functional and inclusive in the long term.

Figure 67: A3-517 Proposed addition of new DDA-compliant features to the original blackwood stair. Source: Trethowan Architecture, 2025.

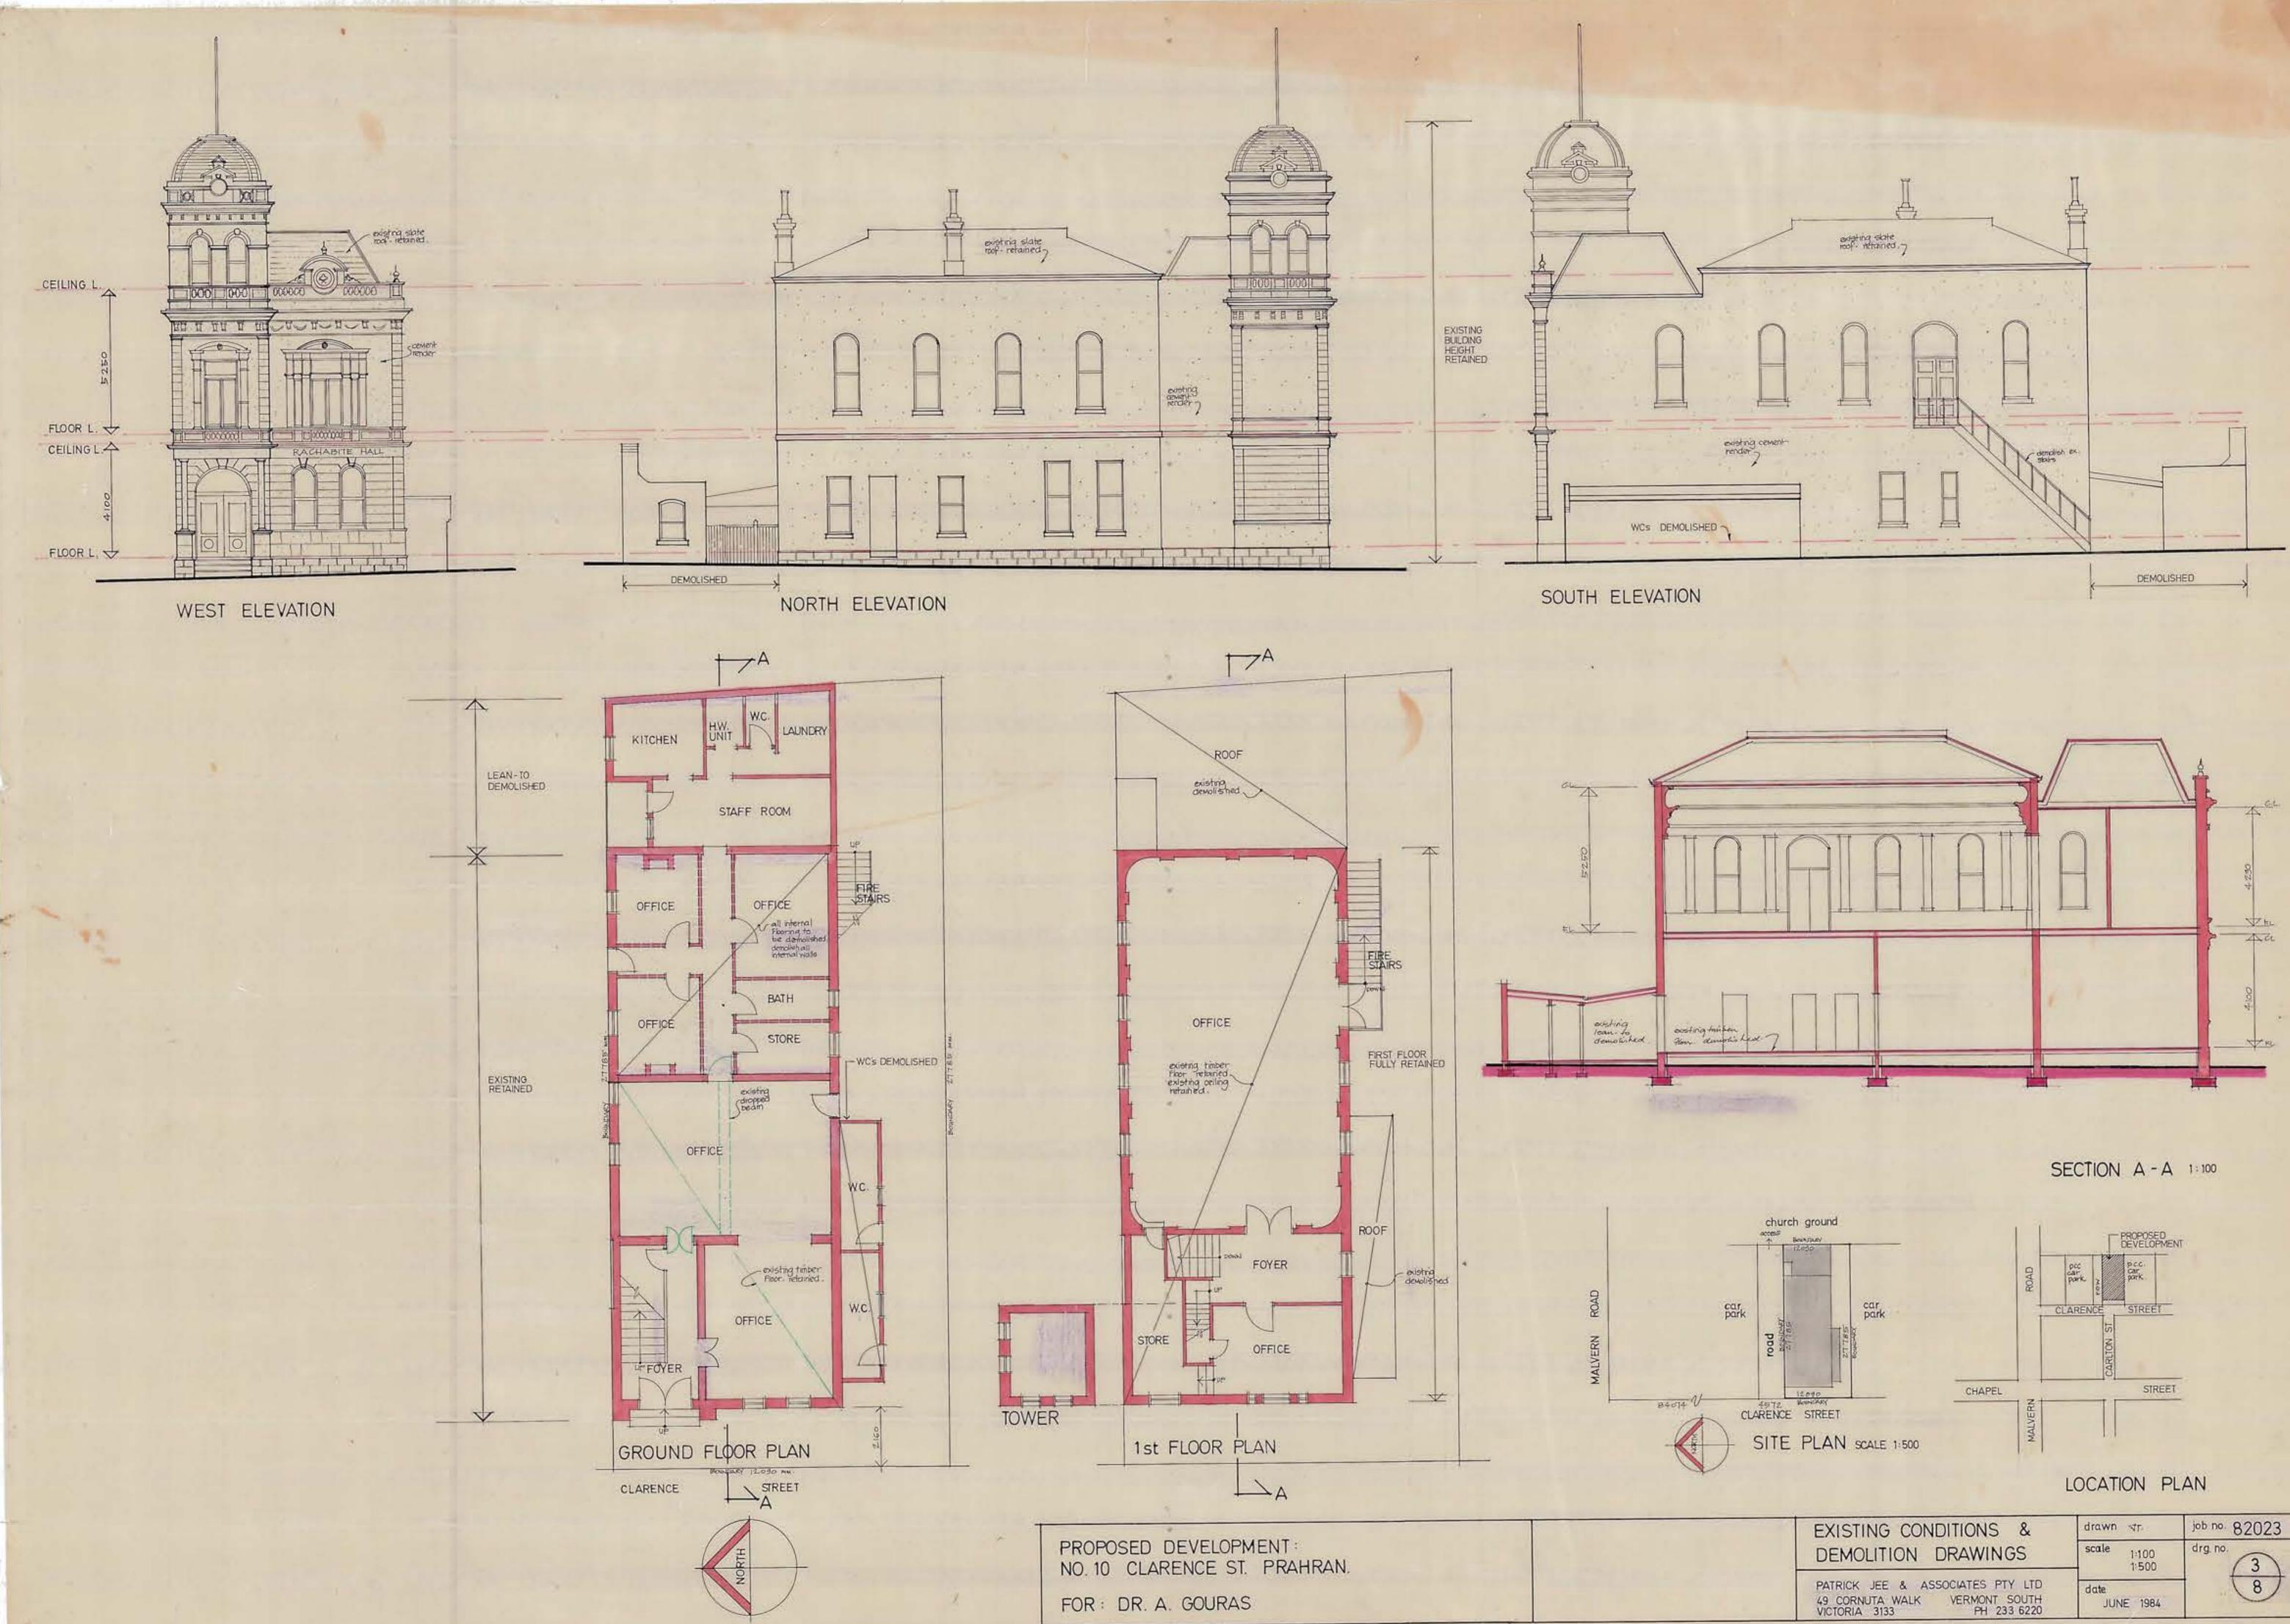
EXISTING CONDITIONS &	drawn str	job no. 82023
DEMOLITION DRAWINGS	scale 1:100 1:500	drg. no.
PATRICK JEE & ASSOCIATES PTY LTD 49 CORNUTA WALK VERMONT SOUTH VICTORIA 3133 PH 233 6220	date JUNE 1984	8

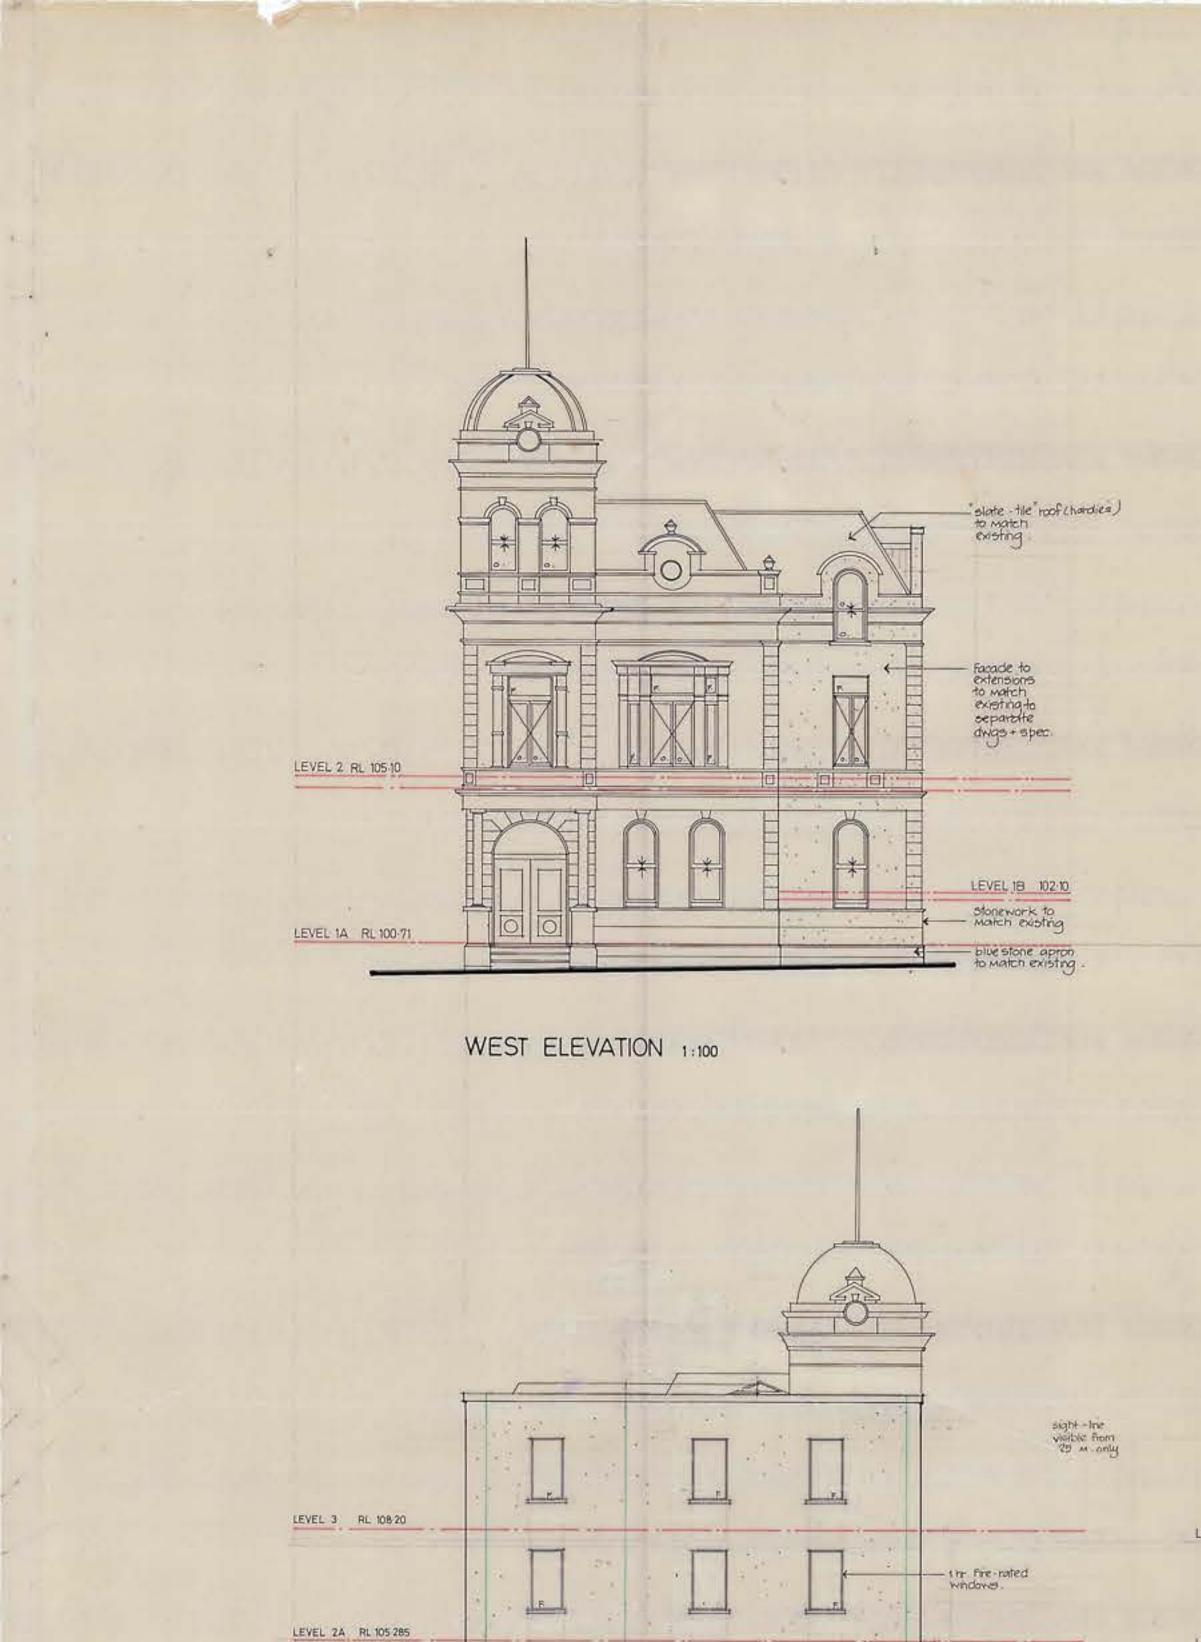
EAST ELEVATION 1:100

- cement render to match existing

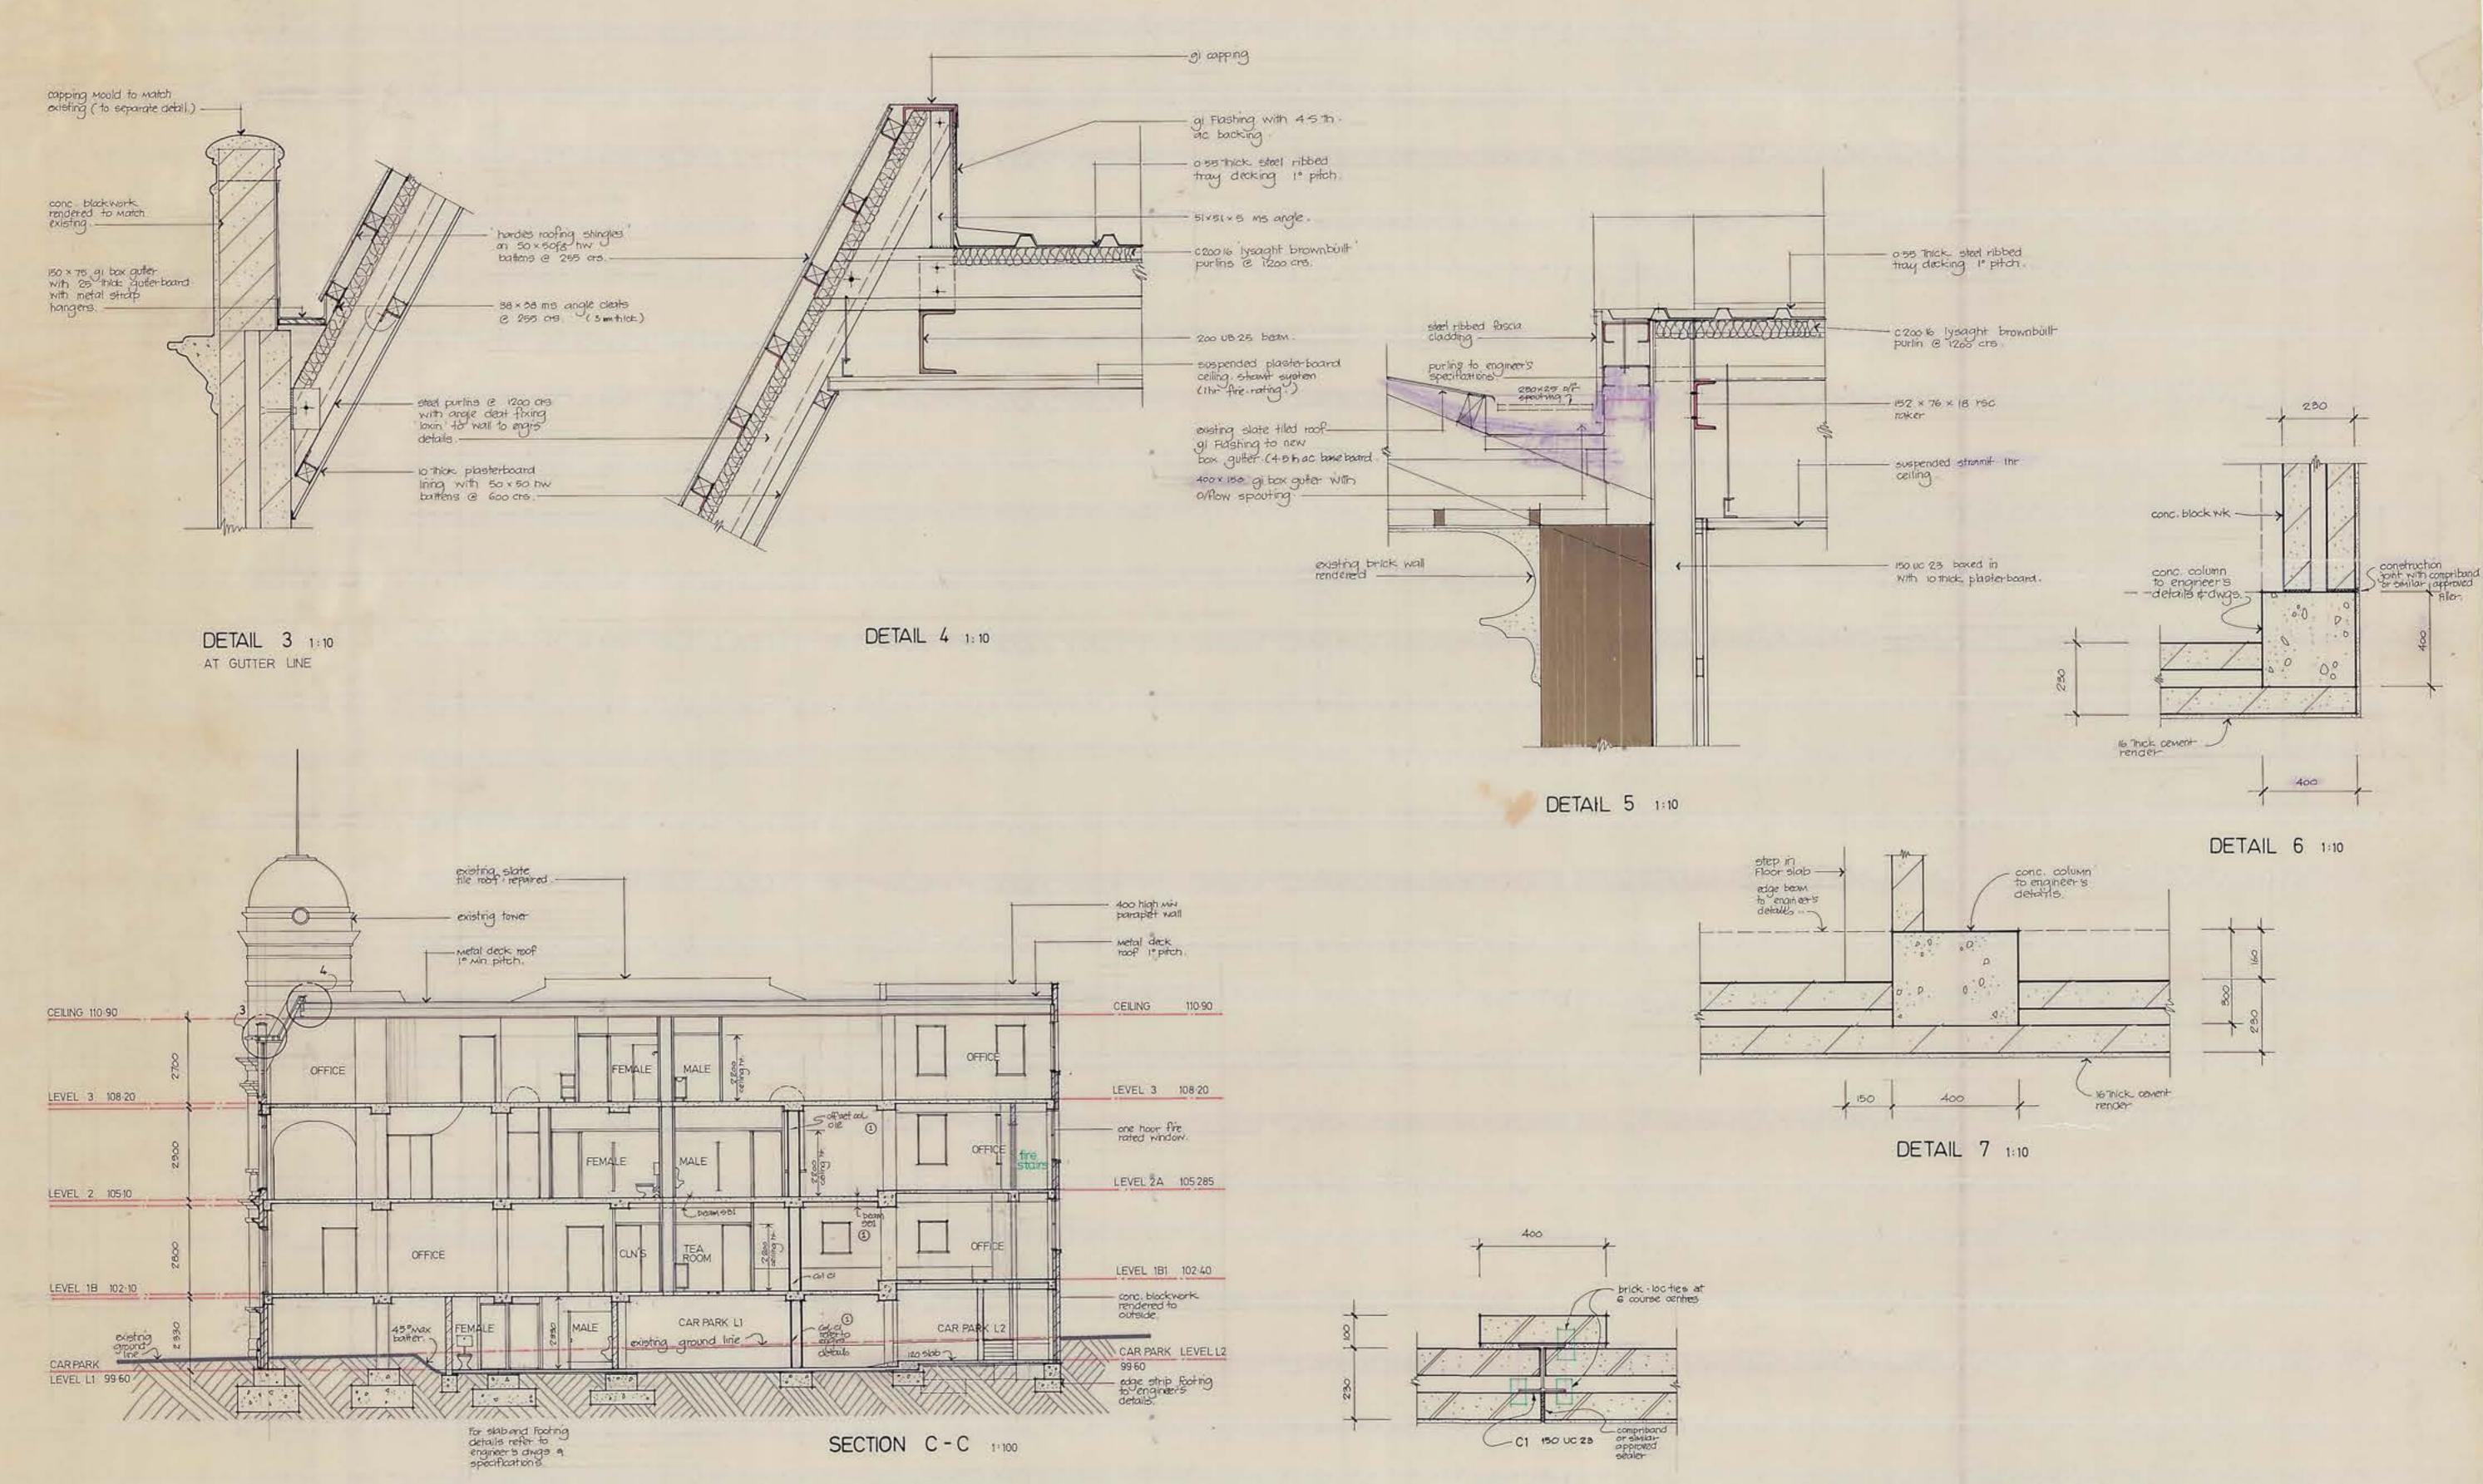
DETAIL 8 1:10 (TYPICAL DETAIL) LEVEL 3

amendments	
(1) 14-11 85 col e beans son revised to east construction procedure and head clearance.	PROPOSED DEVELOPMENT N 10 CLARENCE STREET PRAHRAN FOR DR A GOURAS

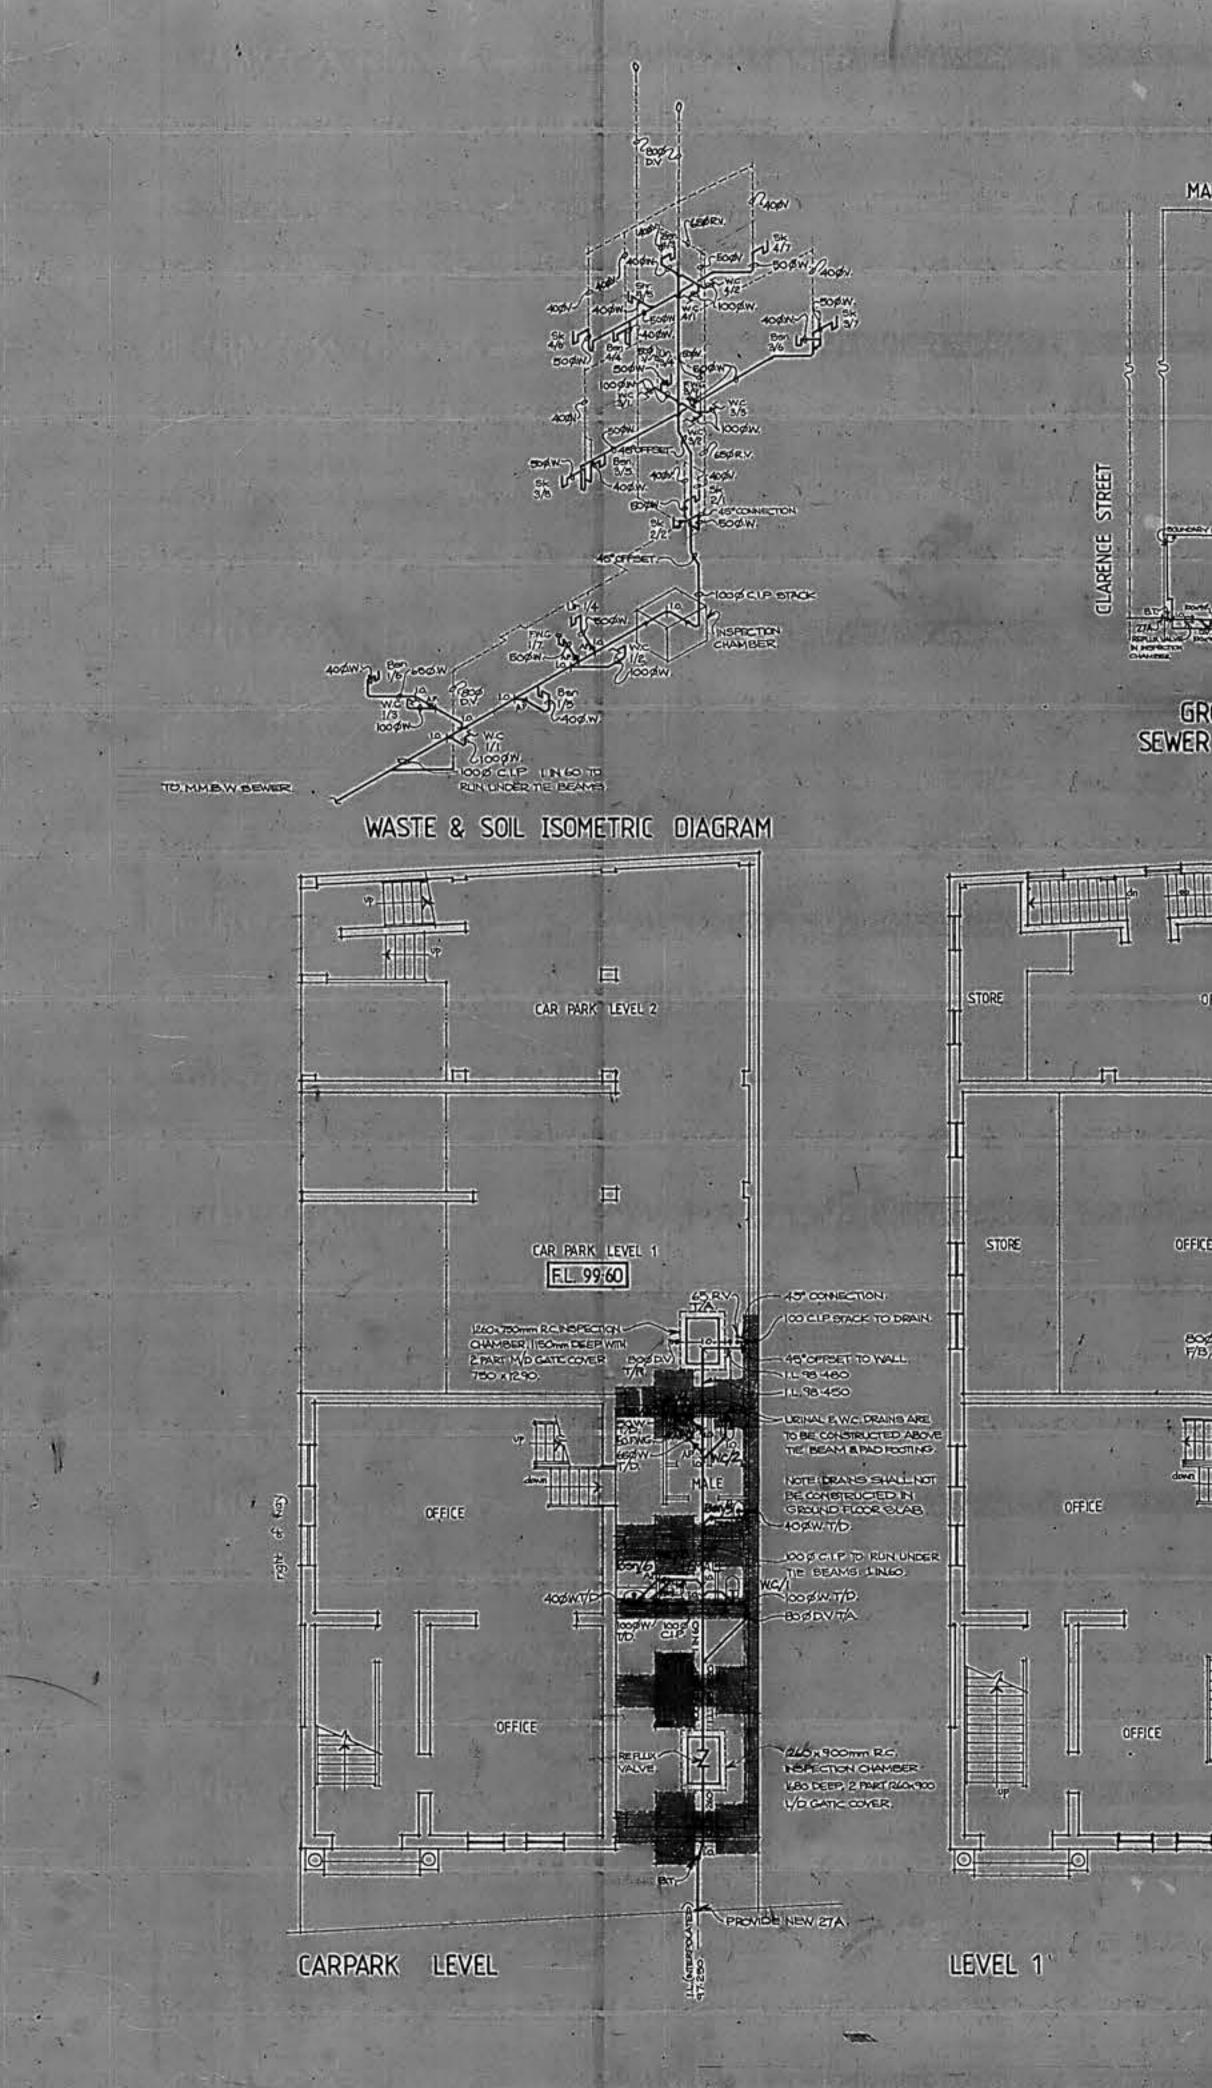
GROUND LEVEL SEWER DRAINAGE PLAN

SEWAGE PIPE.
	VENT PIPE.
W.C.	WATER CLOSET
Ur.	URINAL.
Bsn.	BASIN.
Shr.	SHOWER.
Sk,	BINK.
EW.G	FLOOR WASTE GUL
CIP	CAST IRON PIPER
I.O.	INSPECTION OPEN
