Heritage Impact Statement

Proposed Works at Former Rechabite Hall (VHR H0575) 10 Little Chapel Street, Prahran

AuthorTrethowan ArchitectureDate31 March 2025

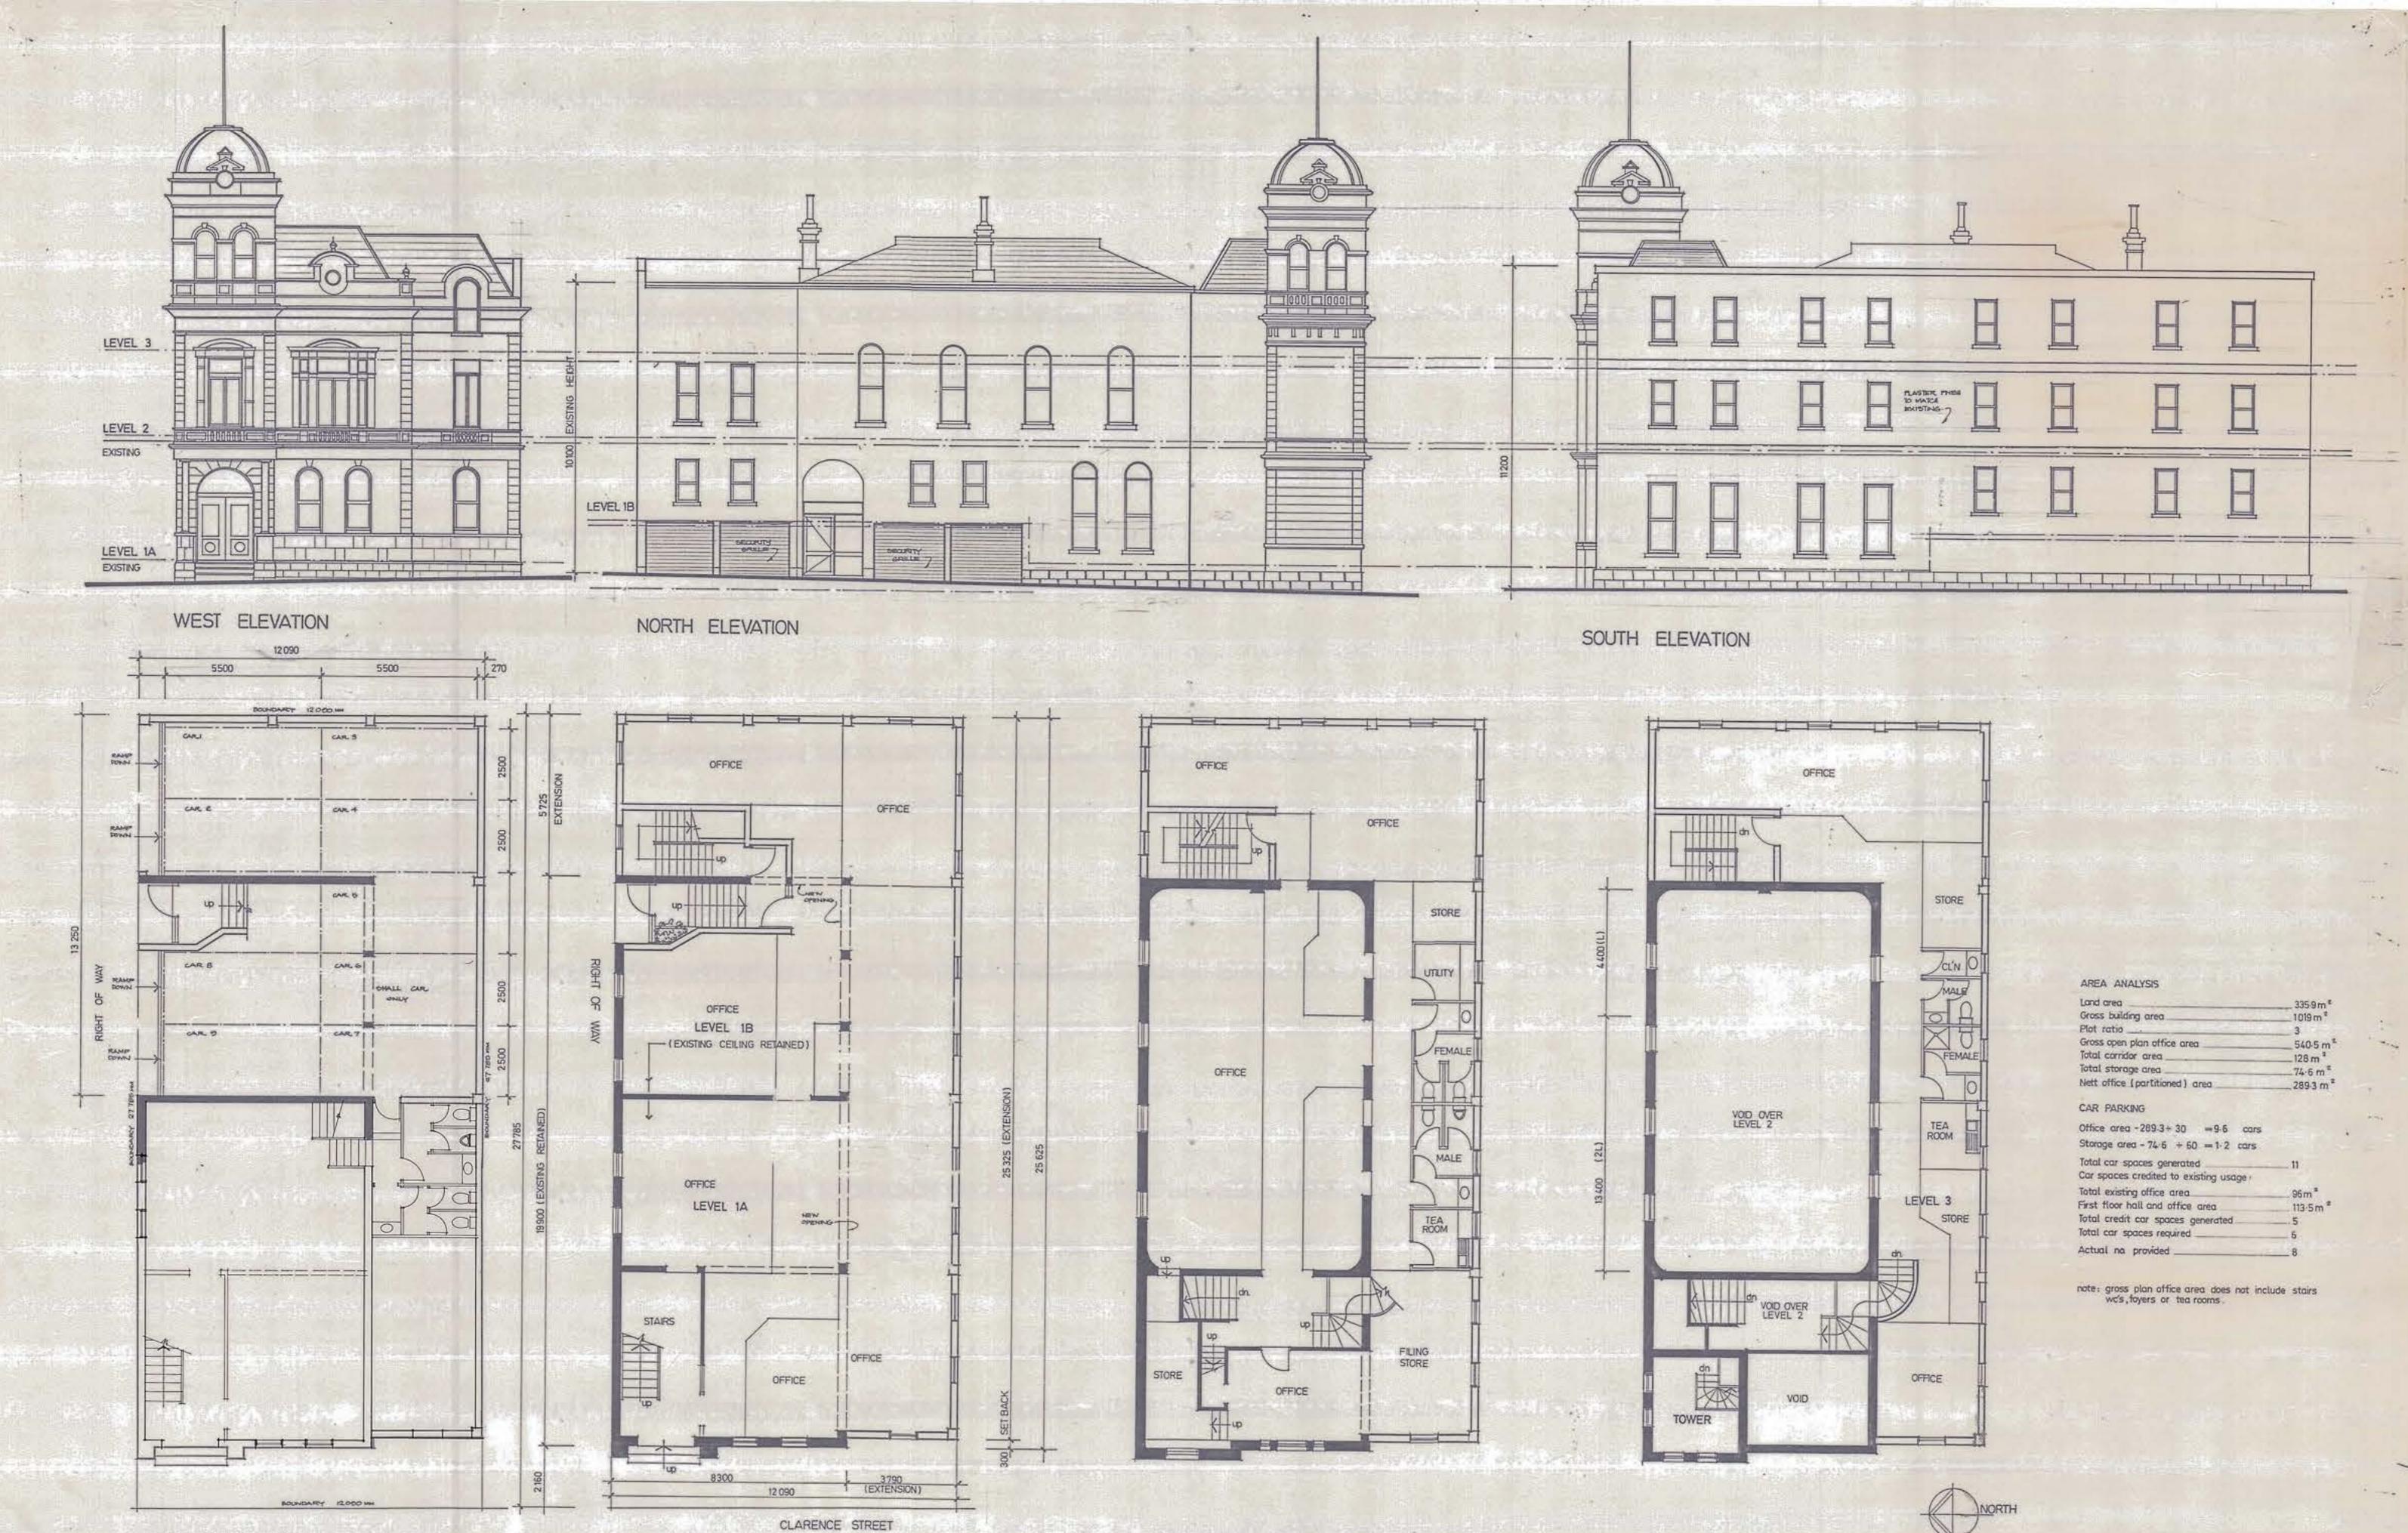
CAR PARK LEVA	FL	drawn : Rae	job no 82023 A
		scale : : 1 : 100	drg no	
	JEE & TENG PTY	ARCHITECTS	date	TP2/2
nt su	505 St Kilda Road Melbourne Vic 3006	tel: 267 2588	JAN 1984	1 2

Land area	335.9 m *
Gross building area	1019 m *
Plot ratio	3
Gross open plan office area	540-5 m ²
Total corridor area	128 m ²
Total storage area	74.6 m =
Nett office (partitioned) area	289-3 m ²
CAR PARKING	
Office area -289-3+ 30 =9-6 cars	
Storage area - 74.6 + 60 = 1.2 cars	
Total car spaces generated	- 11
Car spaces credited to existing usage	
Total existing office area	.96m*
First floor hall and office area	113.5 m *
Total credit car spaces generated	- 5
Total car spaces required	_ 6
Actual na provided	_ 8
