# Salt attack and rising damp

## A guide to salt damp in historic and older buildings

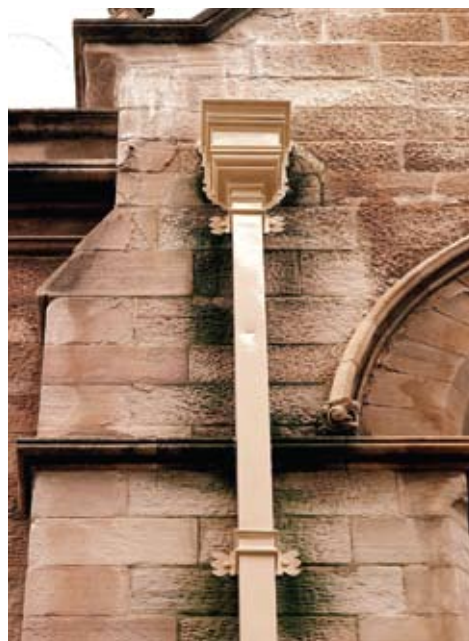
**Figure 14** (right) Two examples of falling damp. Overflow from the blocked rainwater head is made apparent by dark green algae. The coping above the rainwater head is allowing water through to the stones below. Salt attack is causing these stones, above and to the left of the rainwater head, to decay.

The typical debris that builds up in roof gutters and on parapets (such as fallen leaves, bird manure, mosses and dirt) contains weak acids which will contribute to masonry decay by slowly dissolving weaker components leading to progressively more porous and permeable materials. Salts also accumulate on the tops of buildings, not only near the coast, where sea spray is a major factor, but even in central Australia, where wind storms whip up salts from the dry salt lakes and where tiny particles of salt rain from the sky. Though the rates of accumulation of air-borne salt are relatively low, with time a building can absorb sufficient salt to cause damage, particularly when it is all concentrated at one point, such as the top of a blocked downpipe or rainwater head. The importance of regular maintenance of gutters and downpipes cannot be over-emphasised (Figure 14).

evaporates from the wall surface and leaves the salts behind (Figures 4 & 14). Tracing damp back to the point of entry can be difficult, particularly when the masonry is rendered and/or painted and the moisture is trapped behind the render or paint coating.

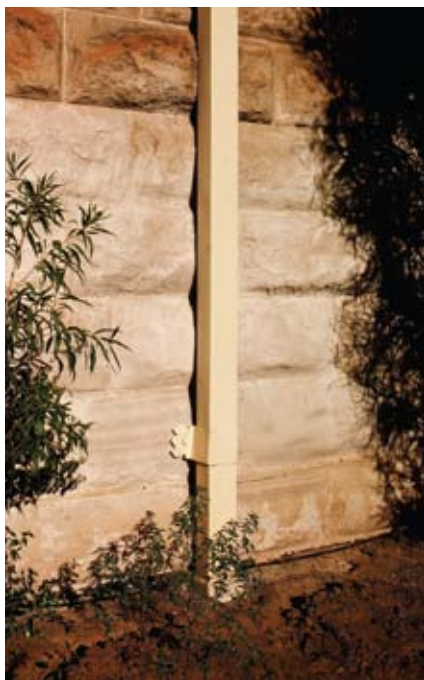
**Figure 24** Garden beds against walls almost guarantee salt damp problems. Here the DPC was buried by 300 mm of soil — five courses of sandstone have been severely damaged.

**Figure 25** Sterile zone between wall and garden — paved with coarse gravel to allow rainfall in and evaporation out. Drainage is provided by an agricultural drain wrapped in geofabric. Garden sprinklers are replaced with drippers and are kept at least 500 mm away from walls.

Gardens against walls are particularly bad — soil levels build up as mulches are added, fertilisers contribute soluble salts and watering by enthusiastic gardeners washes it all into the walls (Figure 24). Garden beds should be pulled back and a sterile zone at least 300 mm wide left against the walls. Sprinkler systems should be replaced with drippers and kept well away from walls (Figure 25).

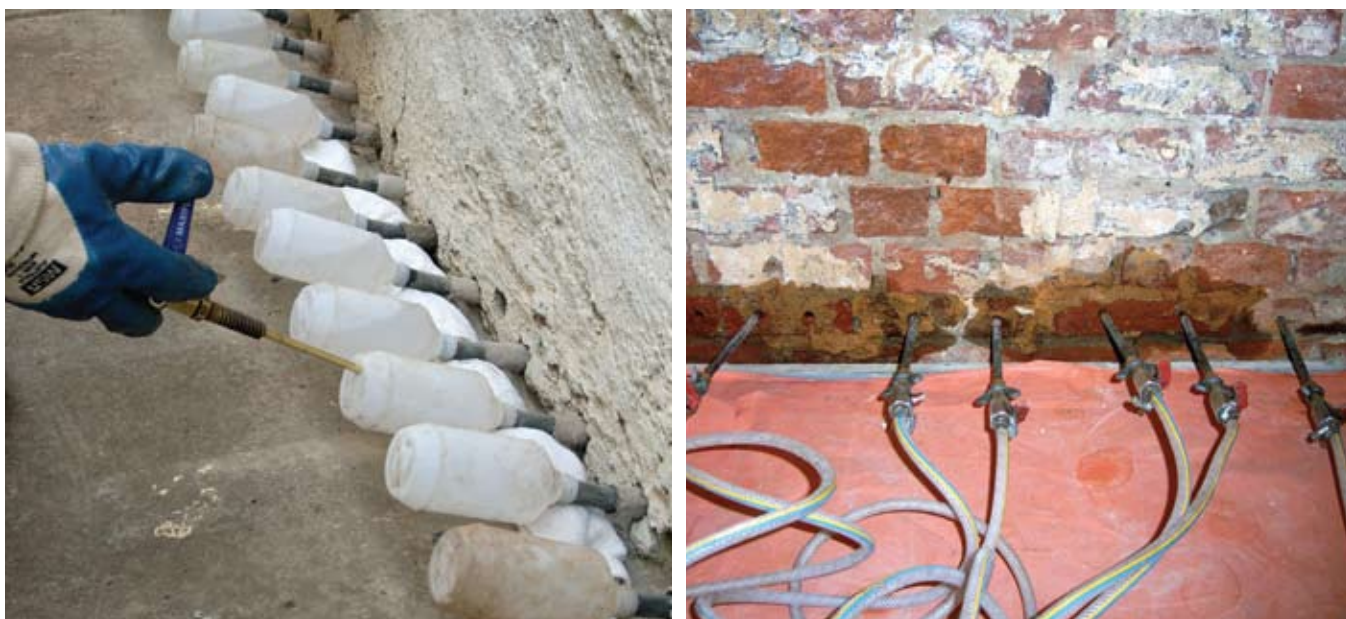
**Figure 41 and 42** Chemical impregnation. On the left: the gravity-fed system in which small plastic bottles are filled with a lance. Depending on the nature of the masonry and thickness of the wall the bottles are filled three and sometimes four times. Open holes just above the drilled line are used to indicate extent of penetration. On the right: low-pressure injection in progress on an interior wall from which plaster has been removed. Note the variation in the permeability of the brickwork; the brick on the left is already saturated and the lance is moved on while the central brick slowly fills with fluid.

Fluid is delivered into the holes by either a tube or a lance depending on whether it is to be gravity-fed or injected under low pressure (Figures 41 & 42). The choice of technique is to some extent determined by the nature of the masonry: gravity-fed diffusion is suitable for porous mortars and soft bricks, while normal bricks can be injected under low pressure (20–70 psi, 150–500 kPa). High pressure injection (greater than 150 psi, 1000 kPa) risks the blowout of weak mortars and imperfect coverage in sound materials due to viscous fingering, a process in which the fluid advances as a series of fingers, leaving gaps between.
