Heritage Impact Statement

Permit Application Amendment Application for
328-330 and 332-334 Clarendon Street, South Melbourne
Emerald Hill Estate (VHR H1136)

Author Trethowan Heritage
Date 22 June 2026

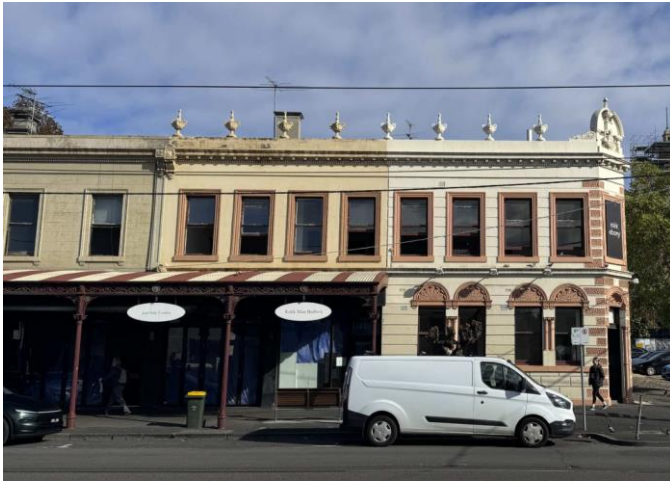
Figure 14: View of the Clarendon Street (east) façade. Source: Trethowan Heritage, 2026.

Externally, the southernmost terrace is plainly decorated and finished in a beige render, with later glazed shopfronts at the ground floor. The central terrace features urns to the parapet and is painted yellow with salmon pink to window surrounds at first floor, and possibly original shopfront elements at the ground floor (north end). The northernmost terrace is highly decorated with urns to the parapet, ashlar render, quoins, scallop arched moulding above openings, pilasters, and a moulded Australian coat of arms to the corner pediment. The building is finished in off-white with salmon pink details, and the decoration extends along the side elevation to Bank Street (**Error! Reference source not found.**).

The southern and central terraces have a cast iron verandah, to match the rest of the registered place. The northern terrace is unusual in the streetscape for lack of a verandah. There are open

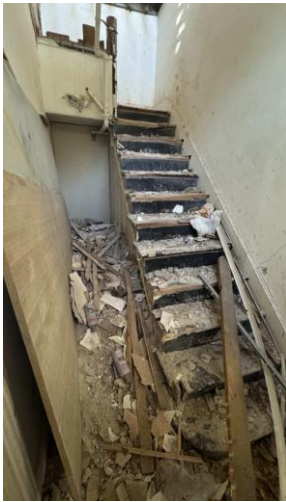
Figure 21: View of northern terrace, one of the central rooms with dilapidated timber staircase. Source: Trethowan Heritage, 2026.

The proposed demolition of internal fabric within the heritage building is generally supportable as it seeks to demolish fabric that had historically been heavily altered or are later elements. The staircase in the northern terrace is proposed to be demolished and may be an original/early element. However, it is currently in highly dilapidated condition and lacks sufficient historical evidence to support an accurate or truthful reconstruction. Its demolition is acceptable.

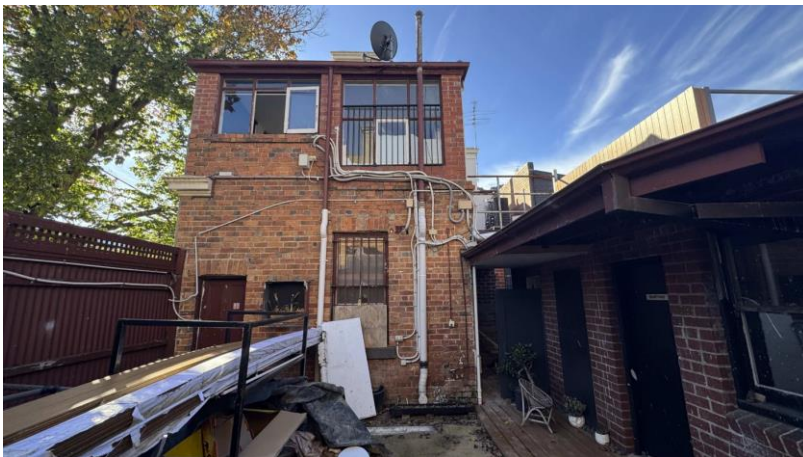
Figure 23: External view of the rear of the northern terrace, with toilets and storerooms to the right. Source: Trethowan Heritage, 2026.

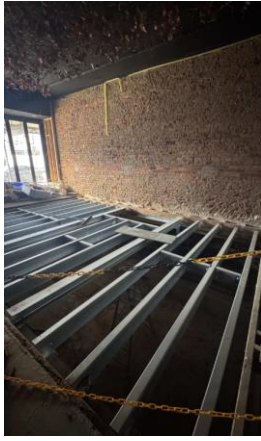
Figure 27: View of the southern terrace's south wall and floor cavity. Source: Trethowan Heritage, 2026.

The southern terrace is accessible from an opening in the central terrace. Similar to the central terrace, it generally has black-painted ceilings and later ceilings. Some wall partitions were demolished and the area supported on steel beams and columns. While the space has concrete floors, a large cavity with bracing is present in the front room, showing an excavated basement. A wall splits concrete steps into northern and southern spaces in the back. The northern space is long and narrow; it has white-painted walls and doors that connect to the rear storage areas which retains kitchen fitout. The southern space contains an original/early timber staircase and associated balustrading and skirtings, and a half-demolished kitchen area with contemporary cladding and joinery. A large section of the south wall is of exposed red bricks, with an infilled brick arch evident close to the Clarendon Street frontage. The section of the wall to the left of the concrete steps remain plastered and painted in blue. At the rear of the kitchen accessible from the northern space is another kitchen and its associated cool room and storage area, still fully furnished. This space opens out to an open yard, with a metal staircase that leads to the first floor.

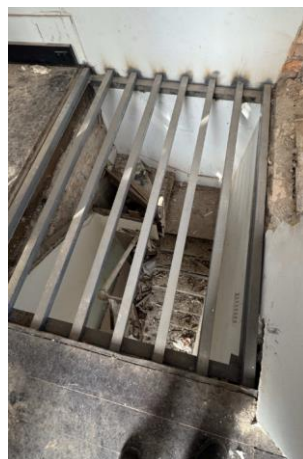
Figure 33: View of the northernmost premise's floor opening, previously a staircase connecting the ground floor. Source: Trethowan Heritage, 2026.

In the northernmost premise are two chimney breasts with fireplaces since boxed out and converted into shelves. An opening in the floor was used to access the now-semi-demolished stair on the ground floor. To the rear of this premise is a later extension with timber-lined ceilings, large casement windows, and timber floors.

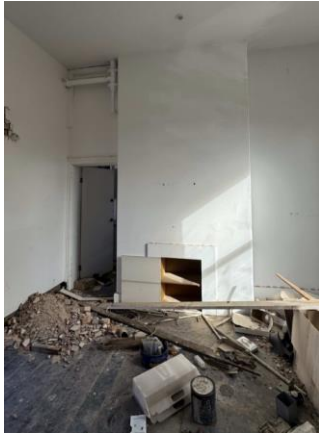
Figure 34: View of one of the northernmost premise's chimney breast and fireplace, now converted into shelves. Source: Trethowan Heritage, 2026.

At present, two fireplaces on the ground floor and four on the first floor are unsealed. Their conditions vary; while some had been refurbished in recent years, some had been stripped back and do not have mantles. They are generally proposed to remain exposed and made good to serve as decorative elements. This is acceptable from a heritage perspective as the fireplaces can continue to be interpreted as part of the heritage building.

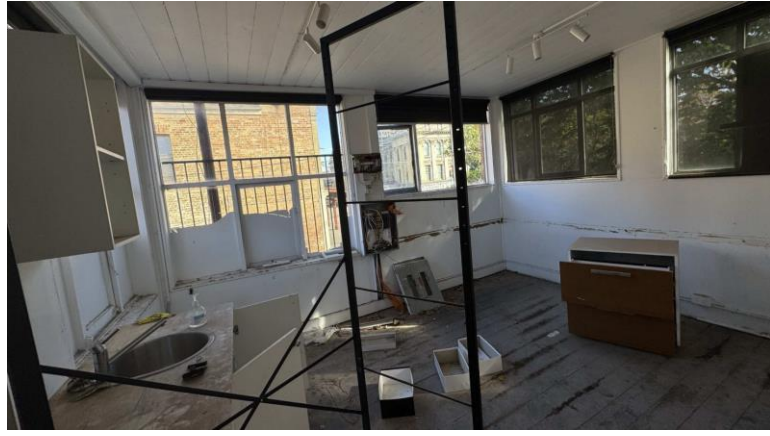
Figure 35: View of the northernmost premise's rear room. Source: Trethowan Heritage, 2026.

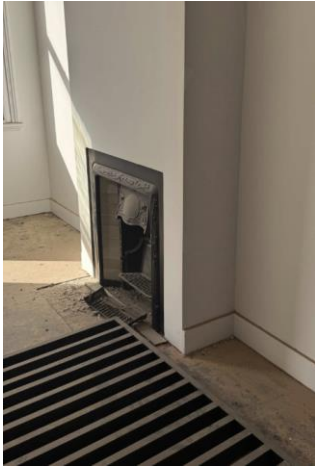
Figure 37: View of the third premise from the north, exposed fireplace. Source: Trethowan Heritage, 2026.

The third premise from the north has no cornices and simple, contemporary skirtings. However, its south wall has a boxed-out chimney breast and exposed fireplace which has been refinished. It has a rear room which had been undergoing partial refurbishment to become something that appears to be a bathroom, with timber wall cladding and concrete floors. There is a rear door that leads to an inaccessible roof deck.

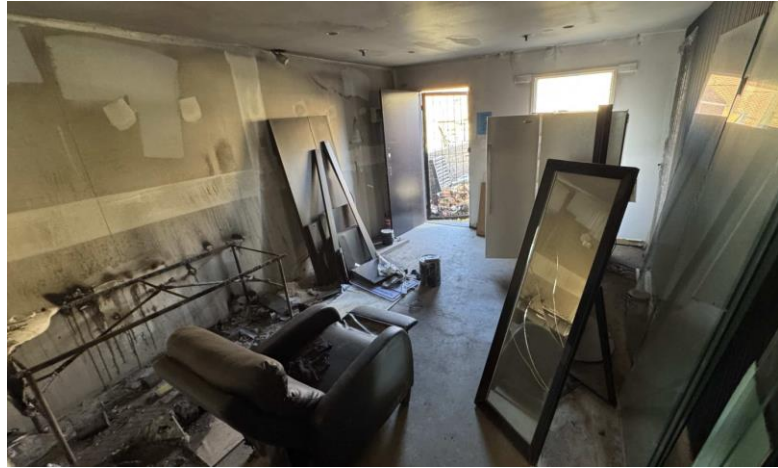
Figure 38: View of the third premise from the north, rear room that had undergone partial refurbishment. Source: Trethowan Heritage, 2026.

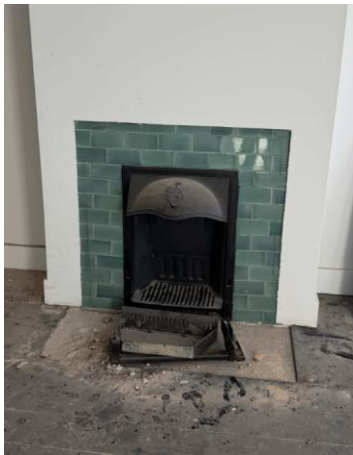
The fourth premise from the north shares similarities with the third, with a boxed-out chimney breast and refinished, exposed fireplace. On its south wall, a doorway was cut out to connect to the southernmost premise, with exposed brickwork and no lintel.

Figure 39: View of the fourth premise from the north, exposed fireplace. Source: Trethowan Heritage, 2026.

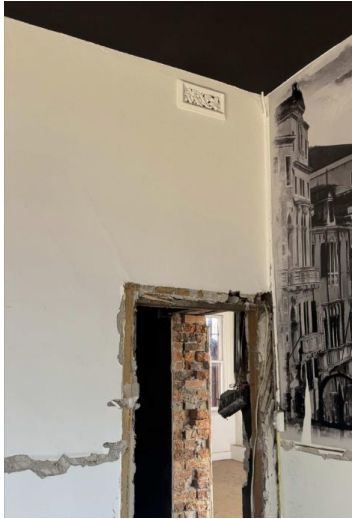
The southernmost premise has a different configuration from the rest of the aforementioned spaces. The front room facing Clarendon Street has a ceiling rose, later ceiling with no cornices, wall vents, a wall mural on the north wall, deep skirtings, and a chimney breast, mantle, and fireplace. The rooms to its rear are relatively plainer and have also undergone ceiling works where skylights were cut out but retain sections of skirtings. The westernmost (rear) room has wall vents, a chimney breast, fireplace stripped of any decoration, and skirtings. All rooms are connected by a hallway which leads to the timber staircase.

Figure 40: View of the southernmost premise, front room's door opening. Source: Trethowan Heritage, 2026.

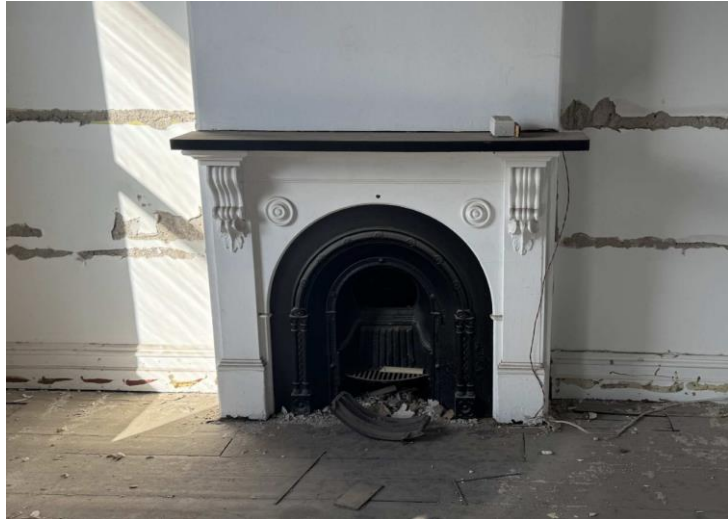
Figure 41: View of the southernmost premise, front room's exposed fireplace and mantle. Source: Trethowan Heritage, 2026.

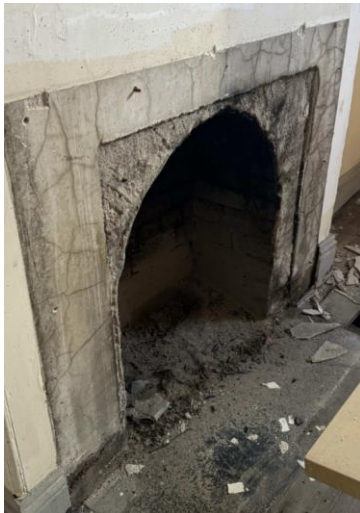
Figure 42: View of the southernmost premise, rear room's exposed fireplace stripped of decoration. Source: Trethowan Heritage, 2026.

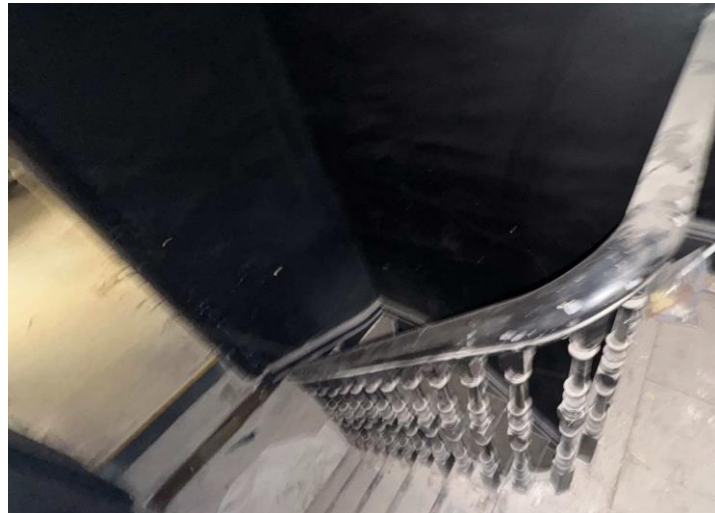
Figure 43: View of the timber staircase at the rear of the southernmost premise. Source: Trethowan Heritage, 2026.

5. Fireplaces and chimney breasts, where not already sealed, are to be retained and made good.
6. Timber staircase and associated balustrading and skirtings are to be retained and made good. As the staircase does not comply with contemporary service standards, it is not to be functional but simply serve as a decorative element. To enable this, both ends of the staircase are to be roped off, and a secondary code-compliant balustrade installed on the first-floor landing. Details of the new balustrade are discussed in Section 4.4.1 below.

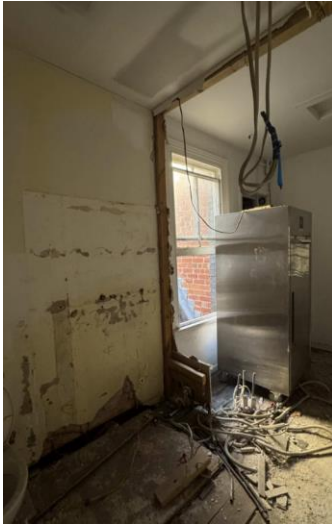
Halfway through the staircase between the ground and first floors is a mezzanine level that comprises a rectangular room which was potentially used as a bathroom and kitchen. Timber flooring remains, but most wall partitions had been demolished. An emergency exit on the west wall opens out to a metal stair to the rear open yard.

Figure 44: View of the southern wall and sash window at the mezzanine floor. Source: Trethowan Heritage, 2026.

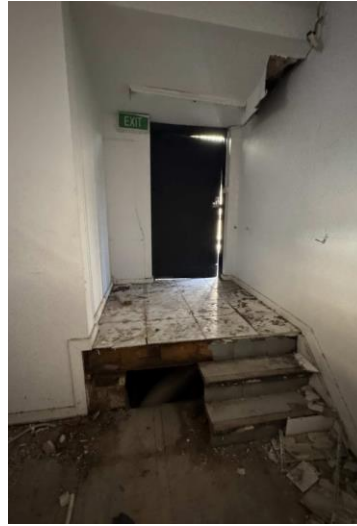
Figure 45: View of the western wall and door at the mezzanine floor. Source: Trethowan Heritage, 2026.

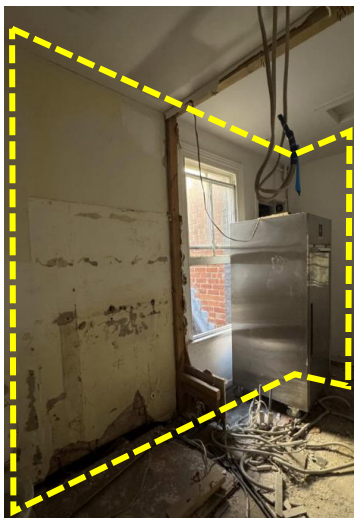
Figure 50: The walls outlined in yellow may potentially be original/early. They are on the mezzanine floor. Source: Trethowan Heritage, 2026.

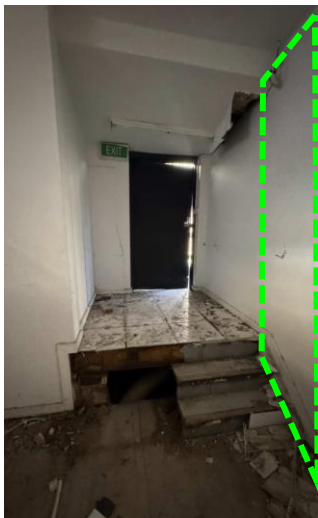
Figure 51: The wall outline in green may potentially be original/early. It is located on the mezzanine floor. Source: Trethowan Heritage, 2026.

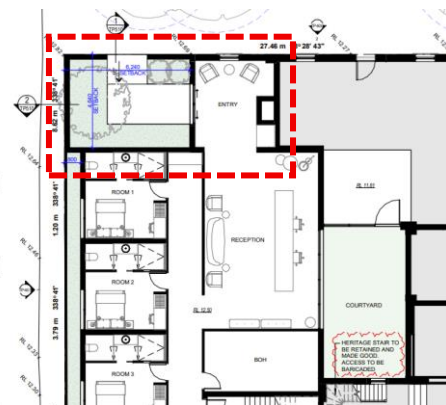
At the northwestern corner of the heritage building facing Bank Street is an existing two-storey extension which is to be converted into the hotel's Entry. At its west façade, it is proposed to infill the existing door opening with bricks, create a new central opening and install new glazed sliding doors, and render and paint the façade in a light and neutral stone colour.

Immediately to the west of this extension is a new design for the existing open yard. Different from the existing layout entered via Emerald Hill Place, new entrance into the yard is via Bank Street. The yard has soft landscaping and an L-shaped footpath that leads to the hotel's Entry.

Figure 53: The new hotel's Entry and adjacent open yard, entered from Bank Street. Source: Embrace Architects, 2026.

The existing two-storey extension at Bank Street is not of heritage significance, and alterations to its fabric would not result in any adverse impact on the significance of the site or the wider registered place. The proposed decommissioning of the existing narrow door opening at the side of the façade and its replacement with a new, centrally located opening represents a more logical and legible intervention. This approach improves wayfinding and arrival sequence, establishes a clear and prominent point of entry, and enhances the functionality of the ground floor by enabling its use as the hotel's primary entrance. Furthermore, the application of render and light stone-coloured paint to this façade would conceal visible inconsistencies and defects resulting from earlier poor-quality works, thereby rationalising its appearance within the broader heritage context.

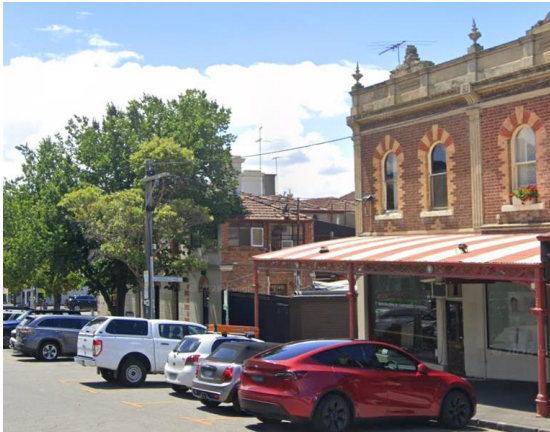
Figure 57: View to the west (rear) façade of the subject site, from South Melbourne Town Hall. Source: Google Street View, 2026.

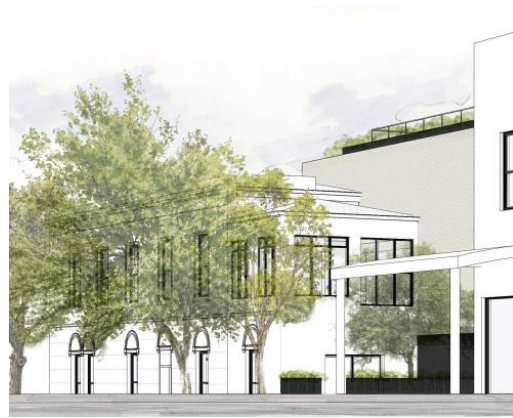
As demolition and new works are proposed for the subject site, which forms part of a wider registered place, there are visual impacts associated with works that are visible externally. Specifically, the new rear extension can be seen from oblique angles from Bank Street. To mitigate impacts, neutral colours of cream, light stone, and black have been selected so that the extension reads as a backdrop to the more vibrant Victorian buildings in the immediate surroundings.

Due to the natural fall of Bank Street, with the subject site positioned at a relatively low point in the streetscape, the proposed rear extension does not present as overly dominant when viewed in context. The sloping topography visually moderates the perceived height of the new built form, allowing it to sit comfortably within the established scale of neighbouring buildings. As such, the proposed height and form are considered acceptable and do not detract from the character or visual coherence of the area.

Figure 58: Mock-up image of the same view from South Melbourne Town Hall. Source: Embrace Architects, 2026.

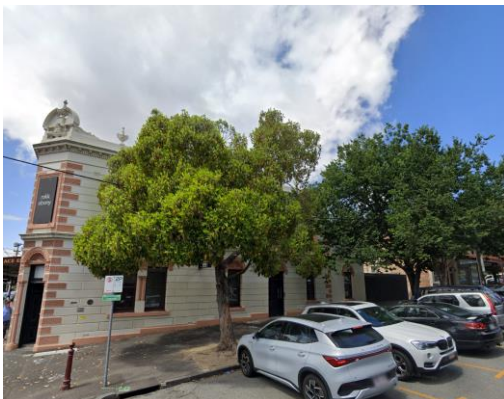
Figure 59: View to the north (side) façade of the subject site, from the intersection of Clarendon and Bank Streets. Source: Google Street View, 2026.

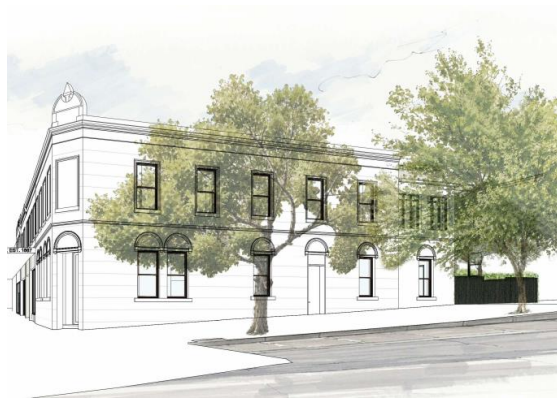
Figure 60: Mock-up image of the same view from the intersection of Clarendon and Bank Streets. Source: Embrace Architects, 2026.
