**EASTERN FREEWAY – HODDLE TO BURKE ALLIANCE**

**HERITAGE IMPACT STATEMENT**

YARRA BEND PARK (VHR H2398) SHARED USE PATH AND  
BRIDGE, AND DRAINAGE OUTFALL

Document number: NEL-WST-NWA-4100-EPH-REP-0003  
Revision: 0  
Date: 13/08/2026

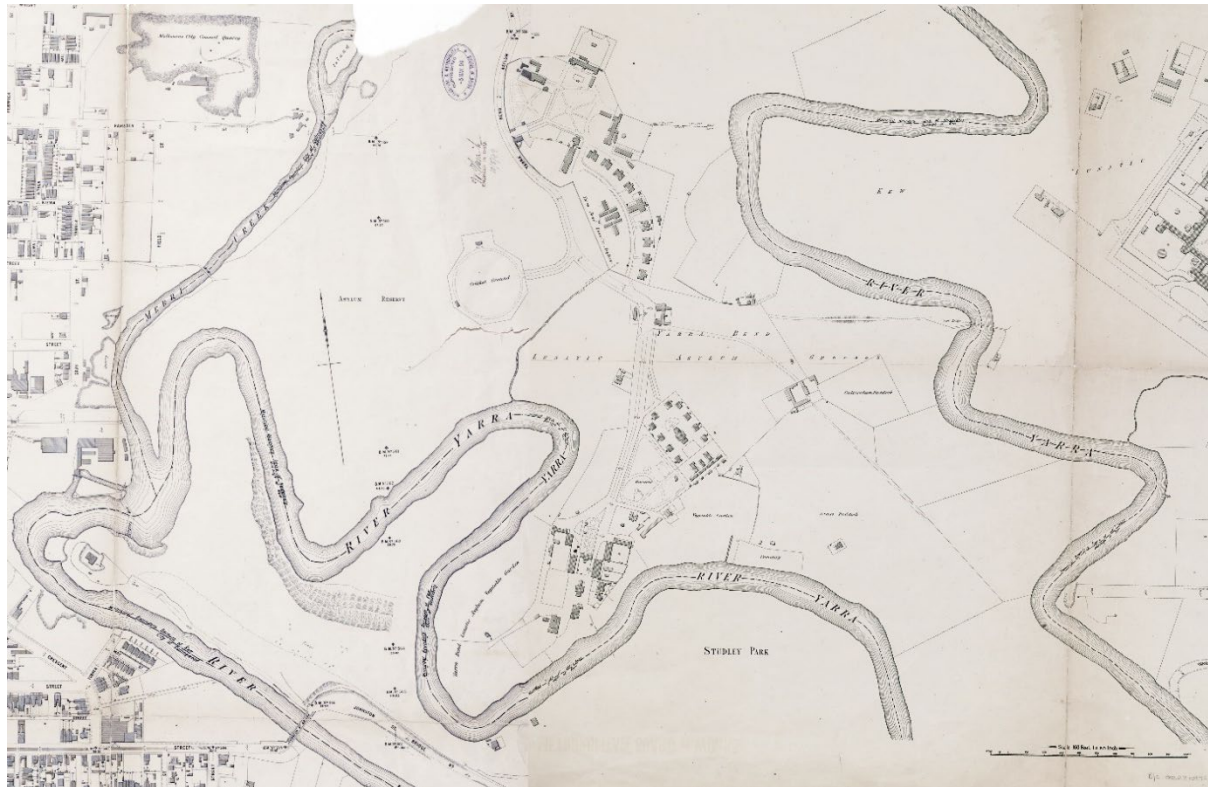
Figure 5: Expansion of the Yarra Bend Lunatic Asylum by 1897 (MMBW 1897a; 1897b)

By 1897, MMBW plans show that the asylum had been expanded to the north, northeast and east since the 1858 map; the map shows many of the buildings and features built under Bowie (Figure 5). The asylum closed for admissions in 1925, with patients being relocated to another facility prior to its closure in 1926 (Darebin Libraries 2025c).

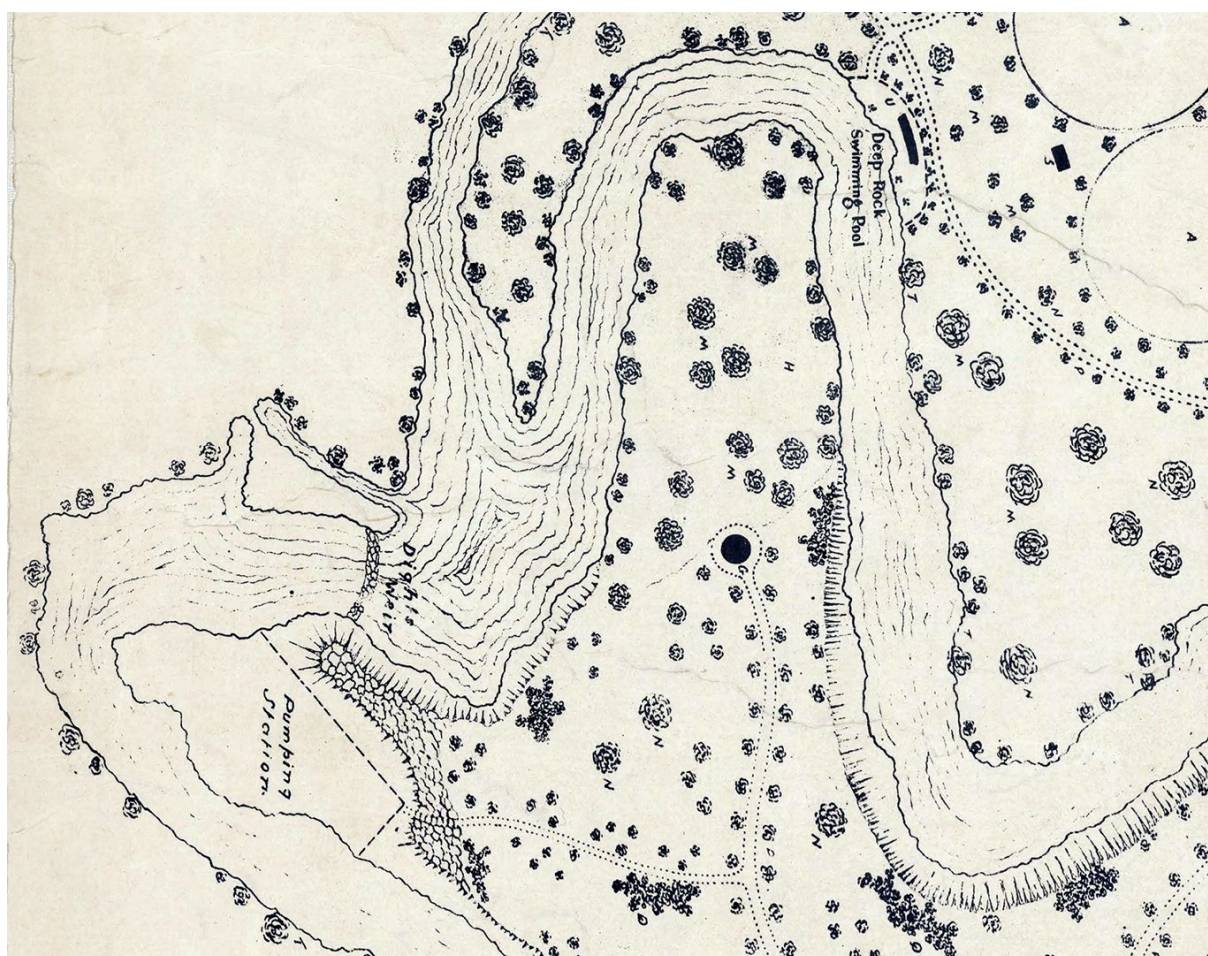
Figure 14: The original meander in the Yarra River between Dights Weir in the west, and the location of Deep Rock Swimming Pool to the northeast of the weir (Linaker 1930)

Originally, there was a large meander east of its confluence with Merri Creek, near the former location of Dights Mill (and Dights Falls/Dights Weir), in the Yarra River which was approximately 460 m from north to south. Deep Rock Swimming Pool used to be situated in the northeast curve, on the east bank of the Yarra, approximately 330 m northeast of the weir (Figure 14). At this time, the confluence of the Yarra River and Merri Creek formed a pincer promontory on the northern bank of the Yarra River near Dights Falls. The former Deep Rock swimming area is within the vicinity of the proposed Drainage Outfall works.

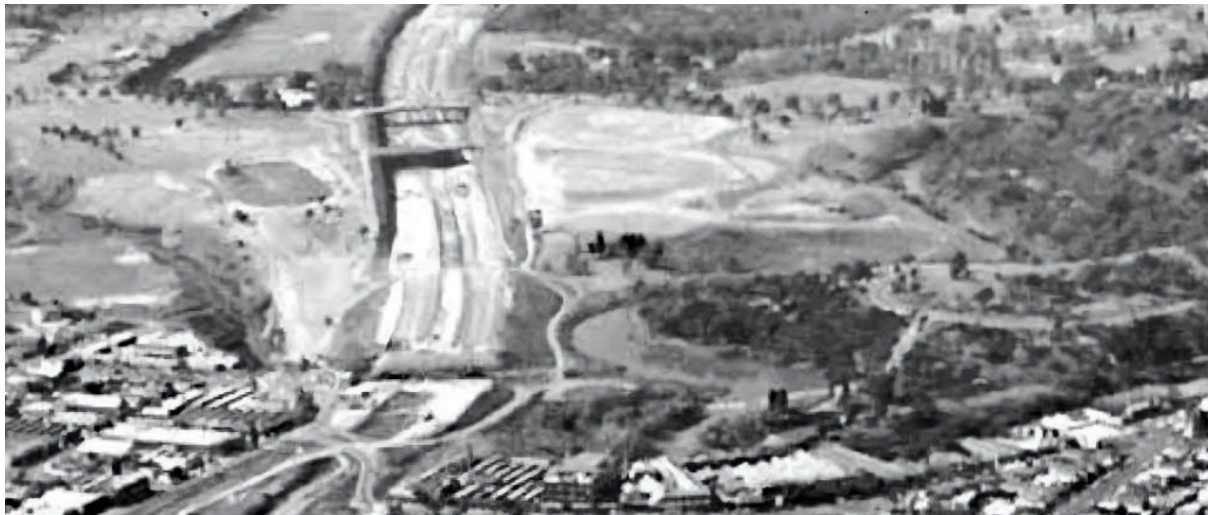
Figure 15: The construction of the Eastern Freeway through Yarra Bend Park, with the truncated meander in the Yarra River shown to the right (Country Roads Board 1975, p. 5)

Bulldozing of the park for the freeway by the MMBW began prematurely in November 1971, and works were halted until the *Eastern Freeway Lands Act* 1971 was later passed. However, the Eastern Freeway works required the realignment of the northernmost portion of the meander in the Yarra River (Figure 15), as the freeway alignment did not follow the 1959 plan. The river was realigned through extensive earthmoving for the construction of a shorter meander channel, which involved filling the unwanted meander, widening the adjacent river confluence, levelling the stream banks and riverbanks and diverting the river along its current path. The present alignment of the Yarra River with a meander which is approximately 350 m from north to south. This section of freeway opened in 1977 (Clark and Heydon 2004, p. 6; Collingwood Historical Society 2013; Lancaster 2018, pp. 288-289).

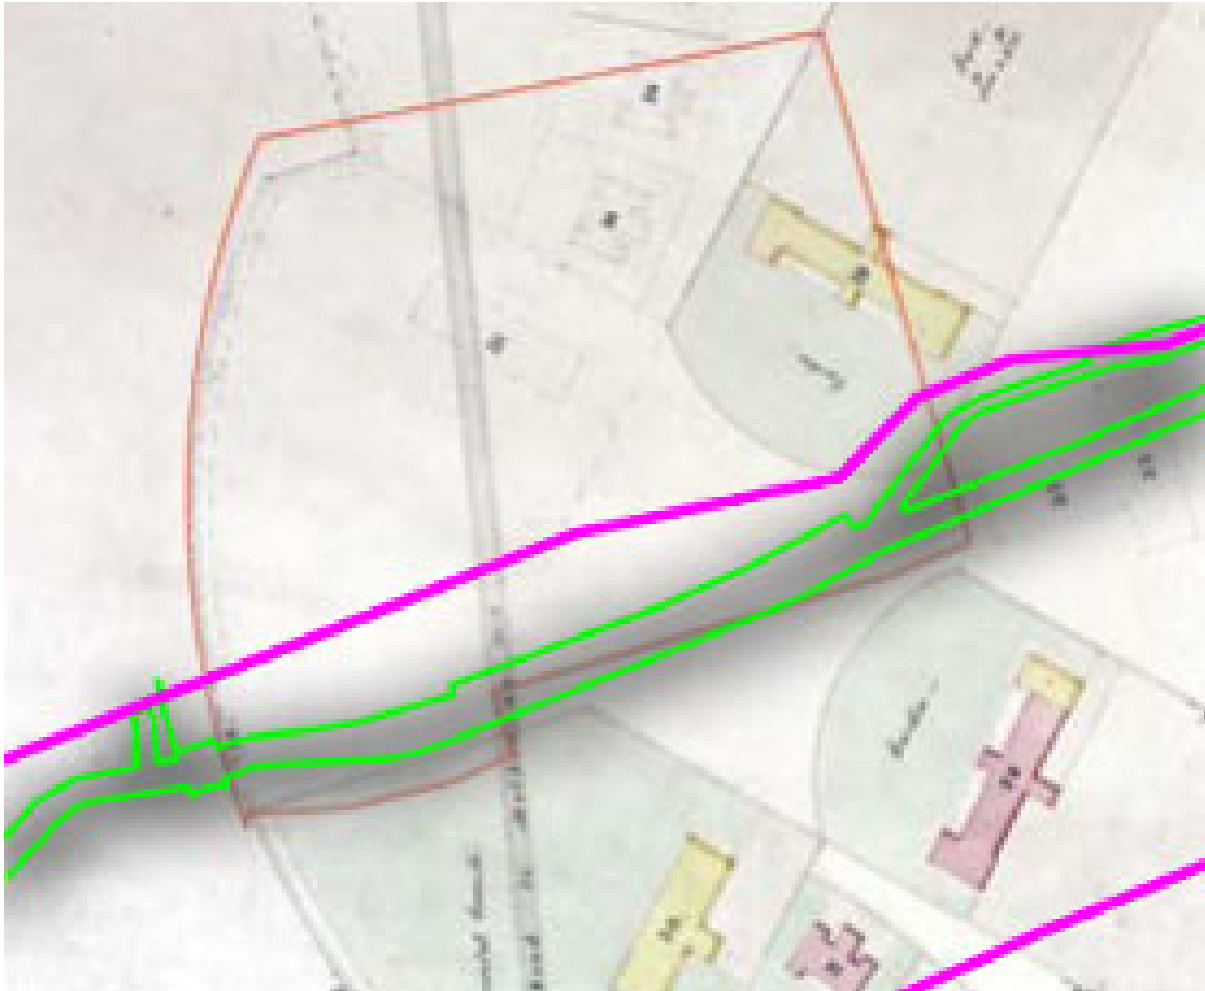
Figure 22: Close up of the 1860 Block Plan with the Alliance Archaeology study area in orange (Alliance Archaeology Pty Ltd 2025a, p. 17), with the approximate location of the project area boundary in pink and SUP works pathway in green

proposed wall, built of brick. Four buildings, which are not shaded in the Block Plan, are also found along the alignment of the SUP, near the southeast corner of the Alliance Archaeology Pty Ltd (2025a, p. 17) study area (two of which are visible in Figure 22). However, the function of these buildings are not identified in the Alliance Archaeology report, and the low quality of these images precludes further identification of these buildings. Importantly, no evidence of these buildings is found in later maps or plans of the site.

The functions of these buildings are not identified by Alliance Archaeology Pty Ltd (2025a, p. 17), and the low quality of these images precludes further identification of these buildings. These four buildings identified in the 1860 Block Plan are no longer present by the 1890 Central Block Plan (Figure 23). Alliance Archaeology Pty Ltd (2025a, p. 29) note that the 'crescent of cottages that were depicted on the 1860 plan as being planned for the area to the north of the hospital do not appear to ever have been built' (referring to uncoloured structures in a crescent at the top of Figure 22). This may also apply to the uncoloured buildings along the proposed SUP route.

The location of the former lodge building (Figure 44, Figure 45) is the only building known to have been constructed along the southern boundary of the study area. Alliance Archaeology Pty Ltd (2025a, p. 29) note that the uncoloured crescent of cottages in the 1860 Block Plan (see Figure 22) appear not to have been built, which likely applies to the uncoloured buildings noted along the SUP route in the 1860 Block Plan. The entrance gate and lodge building plans confirm that the former lodge is within proximity to the SUP pathway.

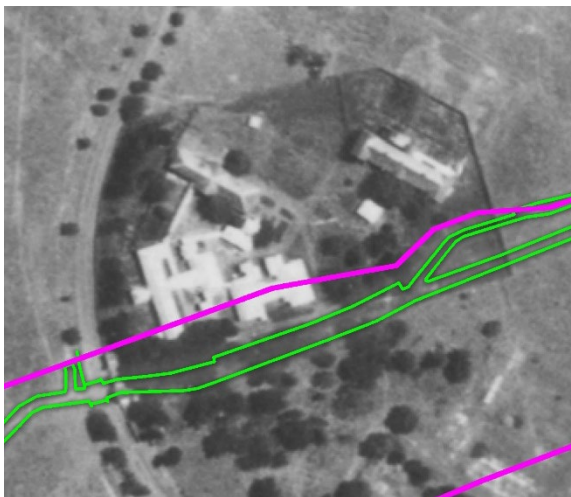
Figure 28: 1931 aerial imagery of Fairhaven Venereal Diseases Clinic, with the project area in pink and SUP works pathway in green (BlueSphere Environmental 2022, Appendix A) showing intersection with the gate lodge building and running adjacent to a tree planting opposite the lodge building

In 1931, imagery shows that the clinic complex was roughly rectangular in shape, defined by walls, except where it curved adjacent to the roadway in the west and in the northeast. Trees appear to have been deliberately planted along the west side of the roadway opposite the clinic complex. The main building complex was in the southwest, near a separate area attached to the southwest where the entry was situated adjacent to the roadway. A large secondary building in the northeast. Several trees are spread across the complex, including at the entry, covering the two entry buildings, although the western end of the lodge is just visible (Figure 28).

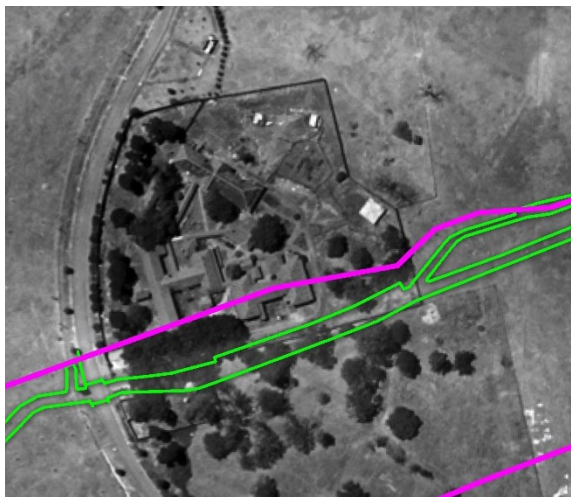
Figure 29: 1945 aerial imagery of Fairhaven Venereal Diseases Clinic, with the project area in pink and SUP works pathway in green (BlueSphere Environmental 2022, Appendix A) showing intersection with the gate lodge building and with a single, younger tree opposite the gateway to the clinic

By 1945, little appears to have changed in the southwest section of the complex, but the second building is no longer extant. The walls of the complex were realigned westwards after the removal of the secondary building. The lodge is still present in the southwest, but the trees along Yarra Bend Road are fewer in number and smaller than in 1931 (Figure 29).

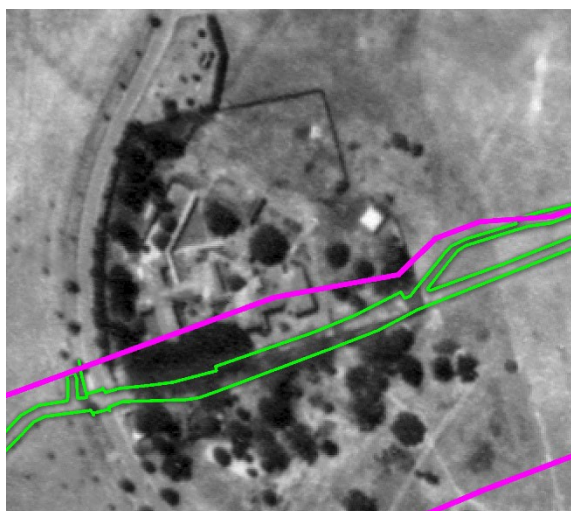
Figure 30: 1951 aerial imagery of Fairhaven Venereal Diseases Clinic, with the project area in pink and SUP works pathway in green (BlueSphere Environmental 2022, Appendix A) showing intersection with the gate lodge building and with a single, younger tree opposite the gateway to the clinic

By 1951, little change is evident within the complex, although the gate lodge building is not clearly visible due to the low resolution of the imagery. Pathways can be seen criss-crossing the area to the south of the complex. The smaller trees, one of which is on the edge of the main SUP pathway on the west side of the roadway, are shown to be maturing (Figure 30).

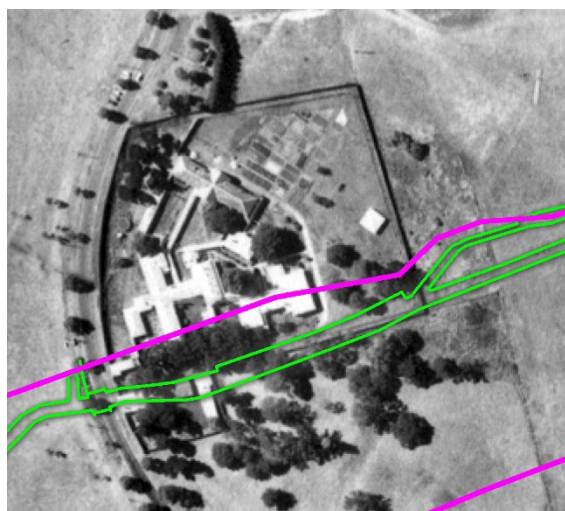
Figure 31: 1960 aerial imagery of Fairlea Women's Prison, with the project area in pink and SUP works pathway in green (BlueSphere Environmental 2022, Appendix A) showing intersection with the gate lodge building and with a single, younger tree opposite the gateway to the clinic

By 1960, the main complex appears to remain predominantly the same, although several new buildings can be seen within the entry area in the southwest. The walls have been squared off in the northeast, and vegetable gardens established. Both gateway buildings, including the lodge, and the tree are clearly present in the southwest (Figure 31).

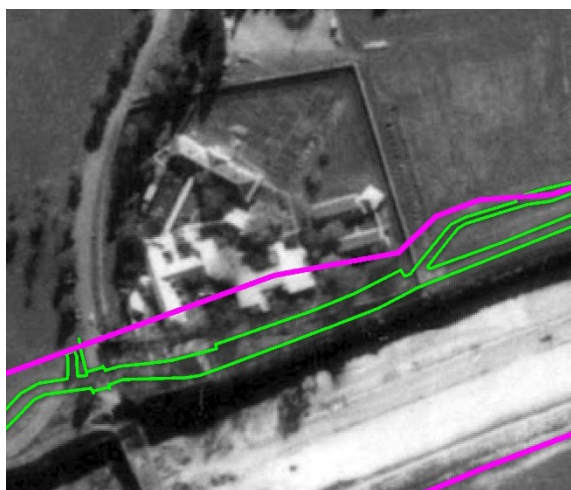
Figure 32: 1974 aerial imagery of Fairlea Women's Prison, with the project area in pink and SUP works pathway in green (BlueSphere Environmental 2022, Appendix A) showing intersection with the gate lodge building area and with a single tree opposite the prison gateway

By 1974, work on the Eastern Freeway had begun, cutting through the original entry area to the complex. The buildings within this area, which includes the lodge, are not clearly visible and may have been removed during freeway works. Two additional buildings are east of the main building complex. The tree opposite the gateway is still present (Figure 32).

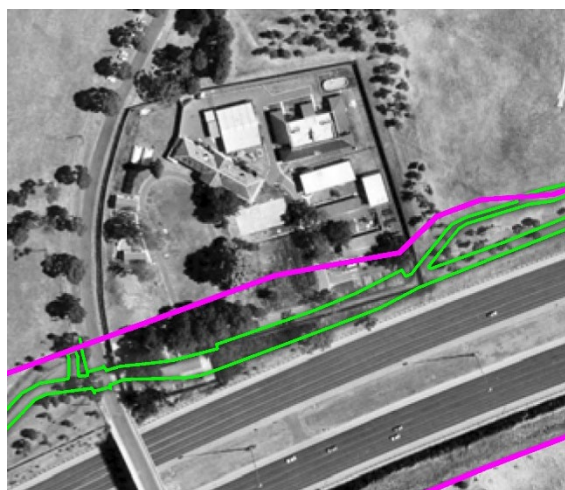
Figure 33: 1984 aerial imagery of Fairlea Women's Prison, with the project area in pink and SUP works pathway in green (BlueSphere Environmental 2022, Appendix A) showing intersection with a later building near the gateway and with a single tree opposite the prison gateway

By 1984, the prison walls had been reestablished around a truncated entry area in the southwest. The main building complex was demolished, apart from a single building near the northern wall, and a series of buildings along with a small track or yard established around the property. A new, larger building is present where the lodge used to be. The tree opposite the gateway is still present (Figure 33).

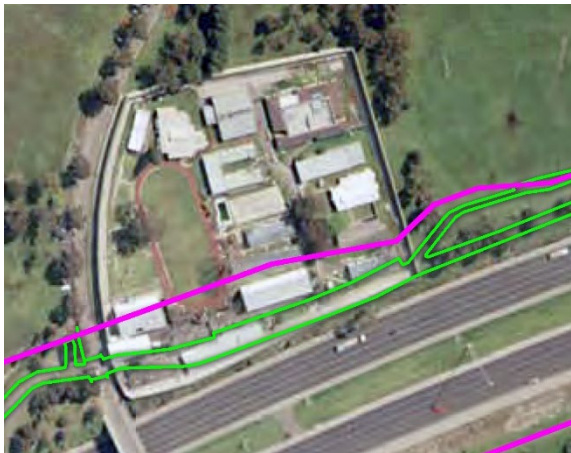
Figure 34: 1991 aerial imagery of Fairlea Women's Prison, with the project area in pink and SUP works pathway in green (BlueSphere Environmental 2022, Appendix A) showing intersection with two later buildings near the gateway and southern wall, and several trees (including the previously identified single tree) opposite the prison gateway

By 1991, the one remaining historical building had been removed, replaced by additional buildings surrounding the track, except for a small open space west of the track. The southern wall was also realigned to encompass the entry area. Neither of the original gateway buildings are present. Many of the trees within the property have also been removed, but the tree opposite the gateway is still present, although two younger trees are adjacent to it in the west along the main SUP pathway (Figure 34).

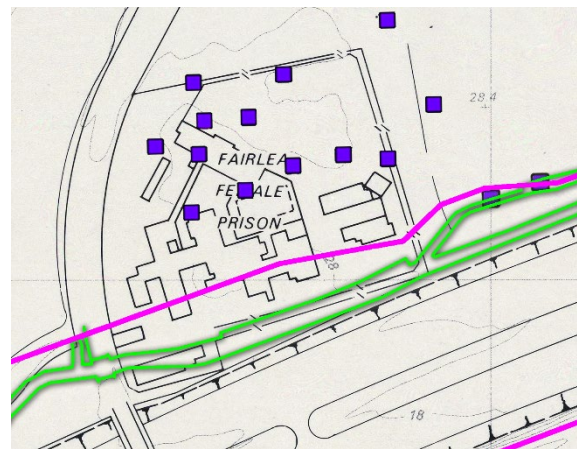
Figure 38: 1981 MMBW plan of Fairlea Women's Prison, with the project area in pink and SUP works pathway in green, and STPs with historical rubble/foundations in purple (MMBW 1981)

The historical rubble and foundations identified in these STPs were noted as being associated with the former Fairlea Women's Prison (Dugay and East 2019). The STPs with historical finds generally align with the former hospital ward and associated buildings and the L & N wards in the northern part of the asylum complex (Figure 37), the main prison complex buildings (Figure 38, Figure 39), and the buildings which were constructed after the 1982 fire (Figure 40). In the area of the gateway entrance of the Former Fairlea Women's Prison, no historical remnants were identified during CHMP 15838.

STPs did not identify any rubble or foundations at the former location of the building evident in aerial imagery between c.1933-1950, or from the prison complex evident in the 1981 plans or 1960 aerial imagery. There were no historical finds within proximity to the proposed SUP pathway in Western Oval STPs 1, 2, 3 or 6, or Eastern Oval 1, 2, 3 or 4.

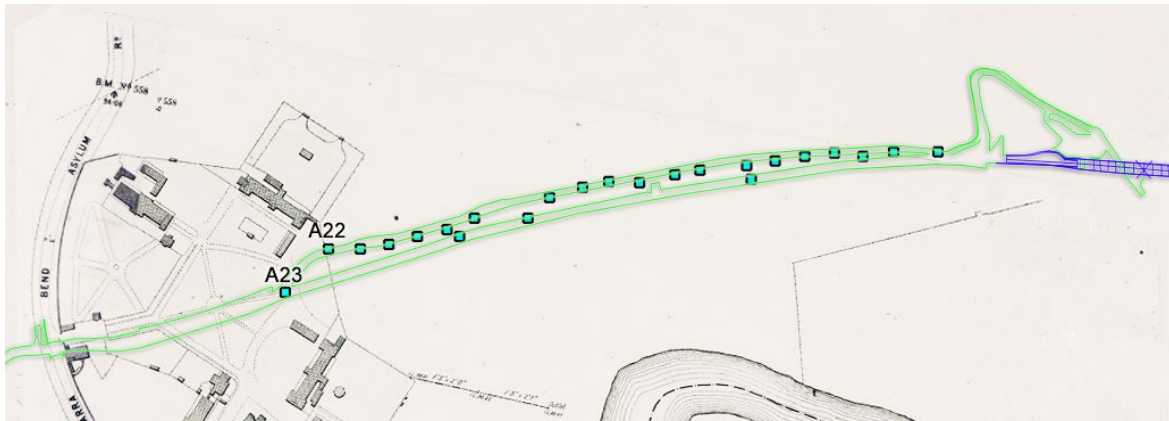
Figure 41: Approximate location of the TA 19 (Main Yarra Trail) STPs marked in cyan, overlying the 1897 MMBW plans, with the SUP works in green (pathways) and blue (bridge) overlying the plan (MMBW 1897b)

Within **TA 19 (Main Yarra Trail)**, the SUP pathway intersect with, or are immediately adjacent to, all of the test pits A1 to A23. Two of the 23 STPs excavated (A23 and A22) are within the former asylum footprint (Figure 41).

A23, which is situated at the location of the end of a former pathway, was excavated to a depth of 180 mm, adjacent to a drain. The stratigraphy comprised a disturbed topsoil layer of very dark greyish brown friable humic silt with grass and roots to 160 mm, with industrial bluestone screening present, overlying dark grey, firm silty clay base to 180 mm.

A22, which was situated on a flat, modified land surface at the location of a former fence line of the asylum, was excavated to a depth of 200 mm. Its stratigraphy comprised brown, friable clayey silt top layer to 180 mm, overlying very dark grey, firm silty clay base layer which was noted as being devoid of modern materials.

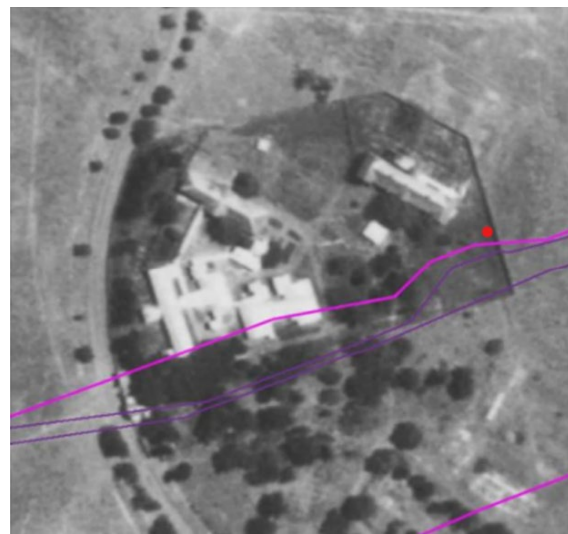
Figure 48: 1931 Aerial imagery of Fairhaven Venereal Diseases Clinic, with the project area in pink and the dual ITS alignments in purple, and the unexpected find #1 location in red

The unexpected find was located at the southwest corner of Fairlea Oval West, Yarra Bend Park, Fairfield, situated in the subsurface beneath a grassed area on the edge of the Oval, immediately outside to the north of the fenced project area (Figure 46). The location of the unexpected find in relation to the historical development and use of Yarra Bend Park appears to be near an external fence associated within the L & N Wards of the Yarra Bend Asylum (Figure 47). A substantial fence is also evident in an aerial image from 1931 (Figure 48).

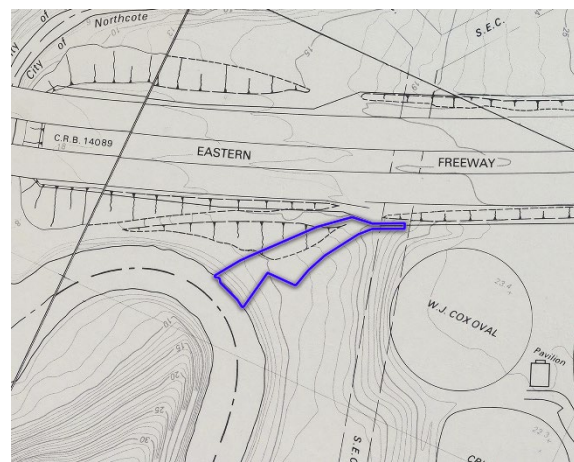
Figure 59: 1981 MMBW plan of Yarra Bend Park, with the Drainage Outfall works area in blue (MMBW 1981) showing the truncated meander in the Yarra River and the new park layout

By 1981 the MMBW plans (Figure 59) show the redesigned park, after the construction of the Eastern Freeway. This includes the truncation of the northern end of the meander in the Yarra River to allow for the Eastern Freeway batter slope, as well as the establishment of several ovals to the east of the proposed works area. The final design has the freeway further south, with a different access road and batter slopes, and more truncation of the Yarra River, than in the 1966 plan. The proposed Drainage Outfall works area is situated between the new Yarra River meander and the freeway.

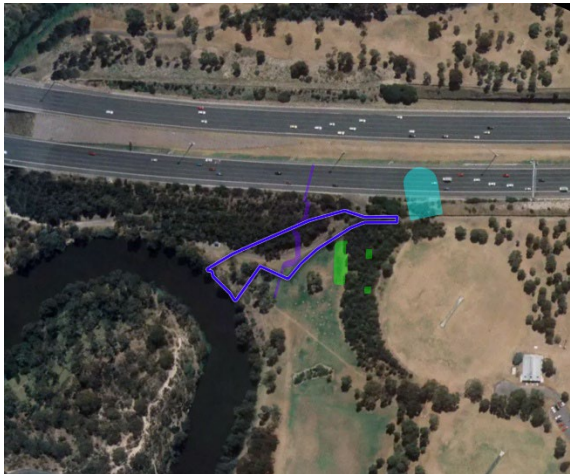
Figure 65: 2001 aerial imagery of Yarra Bend Park, with the Drainage Outfall works area in blue (Geoscience Australia 2026), showing the works area as being situated between the truncated meander in the Yarra River and the Eastern Freeway, with the location of the former terraces (lavender), clubhouse buildings (green), and the nearby complex with U-shaped wall (cyan)

By 2001, the main change in and around the proposed Drainage Outfall works area comprises the growth of trees on the batter slope along the northern side of the works area. A pathway is seen crossing through the proposed works area, running along the southern boundary of the batter slope. Trees have grown thickly between the former main clubhouse building location and the sporting oval, placing the two smaller club buildings within this growth, but there is no evidence of any building footprint found in the aerial imagery (Figure 65).

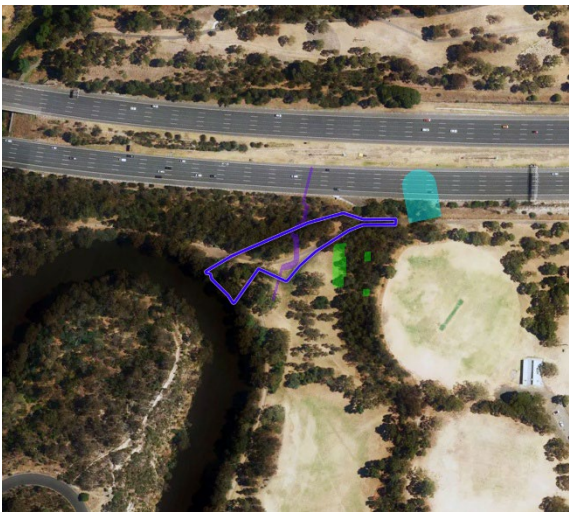
Figure 66: 2014 aerial imagery of Yarra Bend Park, with the Drainage Outfall works area in blue (Geoscience Australia 2026), showing the works area between the truncated meander in the Yarra River and the Eastern Freeway, with the location of the former terraces (lavender), clubhouse buildings (green), and nearby complex with U-shaped wall (cyan)

By 2014, few changes are evident the proposed Drainage Outfall works area, beyond the growth of the trees at its southern end along the Yarra River. Additional tree growth is visible south of the proposed works area (Figure 66).

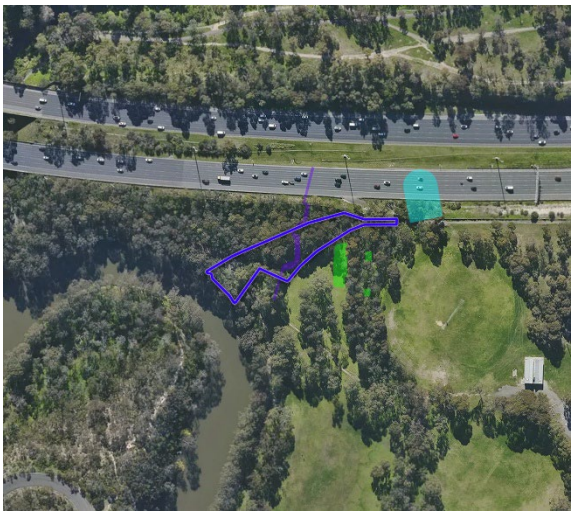
Figure 67: 2025 aerial imagery of Yarra Bend Park, with the Drainage Outfall works area in blue (Geoscience Australia 2026), showing the works area between the truncated meander in the Yarra River and the Eastern Freeway, with the location of the former terraces (lavender), clubhouse buildings (green), and nearby complex with U-shaped wall (cyan)

By 2025, changes within the proposed Drainage Outfall works area comprise the growth of trees, resulting in greater tree cover of the area, although the path is still present through the area. Similarly, there are little changes around the proposed works area, including no evidence of any building footings around the location of the former swimming club buildings (Figure 67).

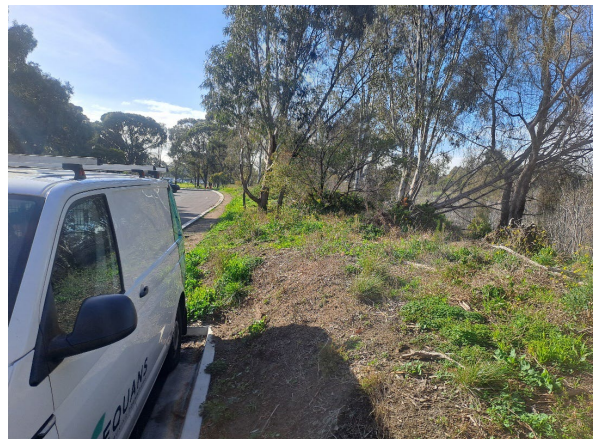
Figure 81: View to the east, between carpark and the Eastern Freeway, showing ground disturbance caused by carpark construction, and mound of soil pushed into the verge (image: D. Wintershoven 29/07/2025)

To the east of Yarra Bend Road is the new carpark for the Fairlea Reserve Netball Courts. Constructed ran from 2021 to 2025, and the spoil and rubble from its formation has been pushed into the row of trees and shrubs adjacent to the Eastern Freeway (to the southeast) (Figure 80, Figure 81 and Figure 82), as confirmed by Google Street View imagery dating to December 2021 (Google 2026). The carpark is roughly 150 m long and the proposed SUP works will be installed adjacent to the carpark, between the carpark and the Eastern Freeway.

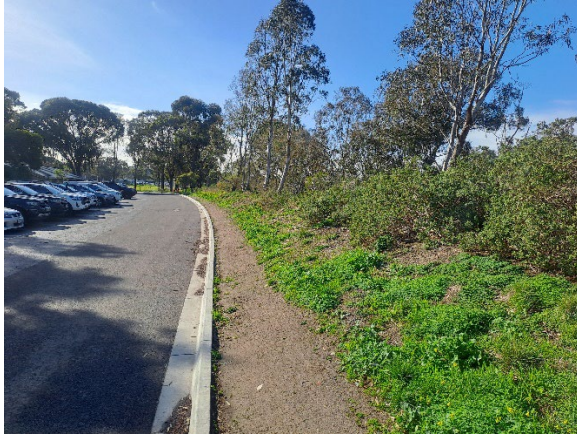
Figure 82: View to the east, between carpark and the Eastern Freeway, showing ground disturbance caused by Fairlea Reserve Netball Courts carpark construction, and soil pushed into the verge. (image: D. Wintershoven 29/07/2025)

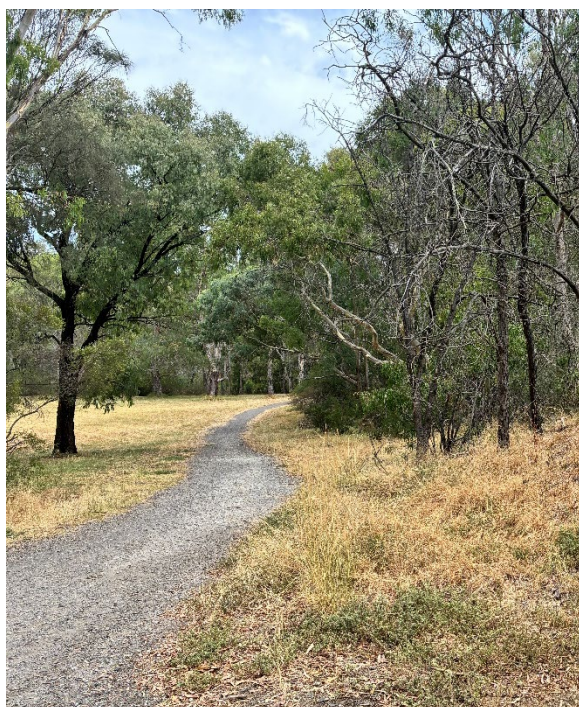
*Figure 88: View from the Main Yarra Trail at the northern end of the Drainage Outfall works area, facing southwest (image: A. Dube 04/02/2026)*

The northern side of the Main Yarra Trail is covered by trees on an embankment leading up to the Eastern Freeway. The land to the south of the trail is gently sloped from its highest point in the northeast down towards the Yarra River in the southwest, with a flatter section between both ends of the works area (Figure 88).

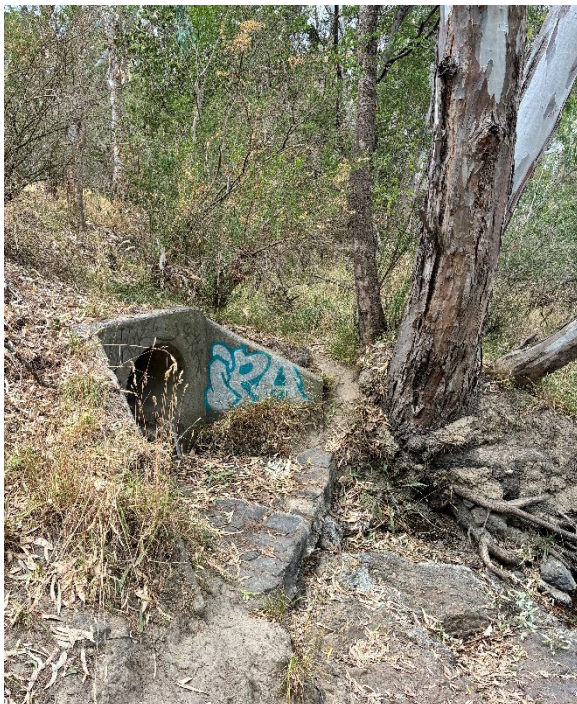
Figure 92: Concrete stormwater drain outlet on a bluestone platform adjacent the Yarra River, facing southeast (image: A. Dube 04/02/2026)

The southern end of the Drainage Outfall works area contains an existing concrete stormwater drain outlet, sitting on a bluestone platform (Figure 92). Watermarks on the outlet show that water from the outlet runs down the slope to the Yarra River (Figure 93).

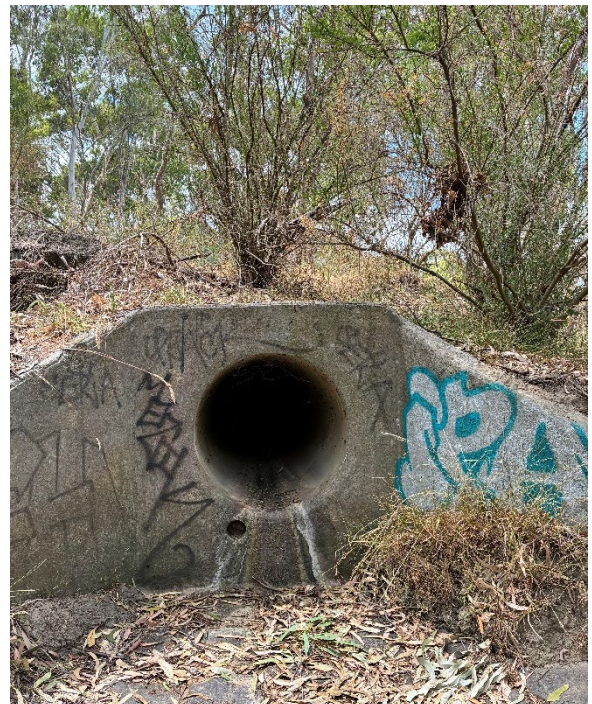
Figure 93: Concrete stormwater drain outlet on a bluestone platform adjacent the Yarra River, facing northeast (image: A. Dube 04/02/2026)

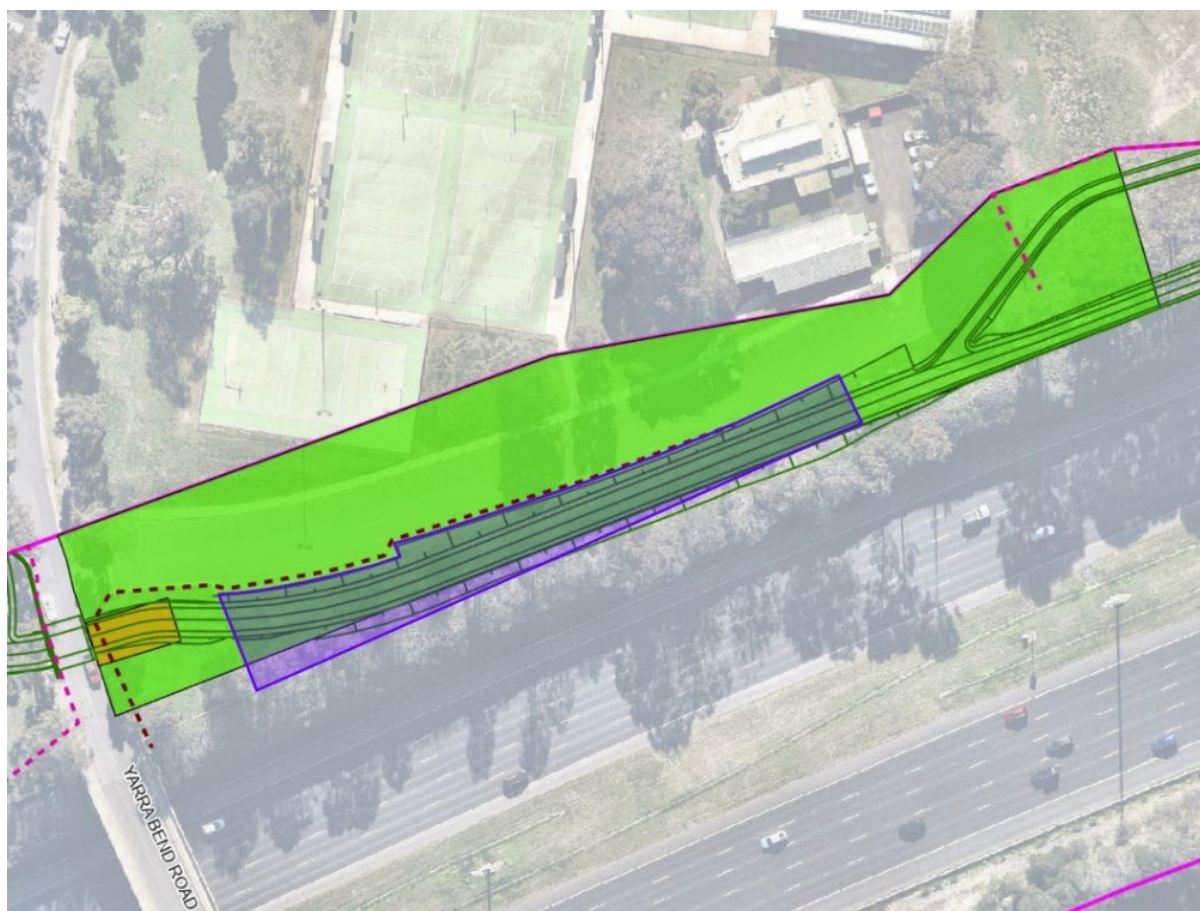
Figure 103: Location of the Fairlea Reserve Netball Courts carpark earth mound in relation to the identified areas of low (green) and moderate (orange) archaeological potential

An existing mound of earth – resulting from the construction of Fairlea Reserve Netball Courts carpark through soil being pushed into the verge – will be removed for the SUP works (Figure 82, Figure 103, Figure 104, Appendix J). Mound removal will be undertaken with an excavator. The mound will be removed to the level of the existing car park. Mound material will be removed from site allowing for the SUP construction to occur.

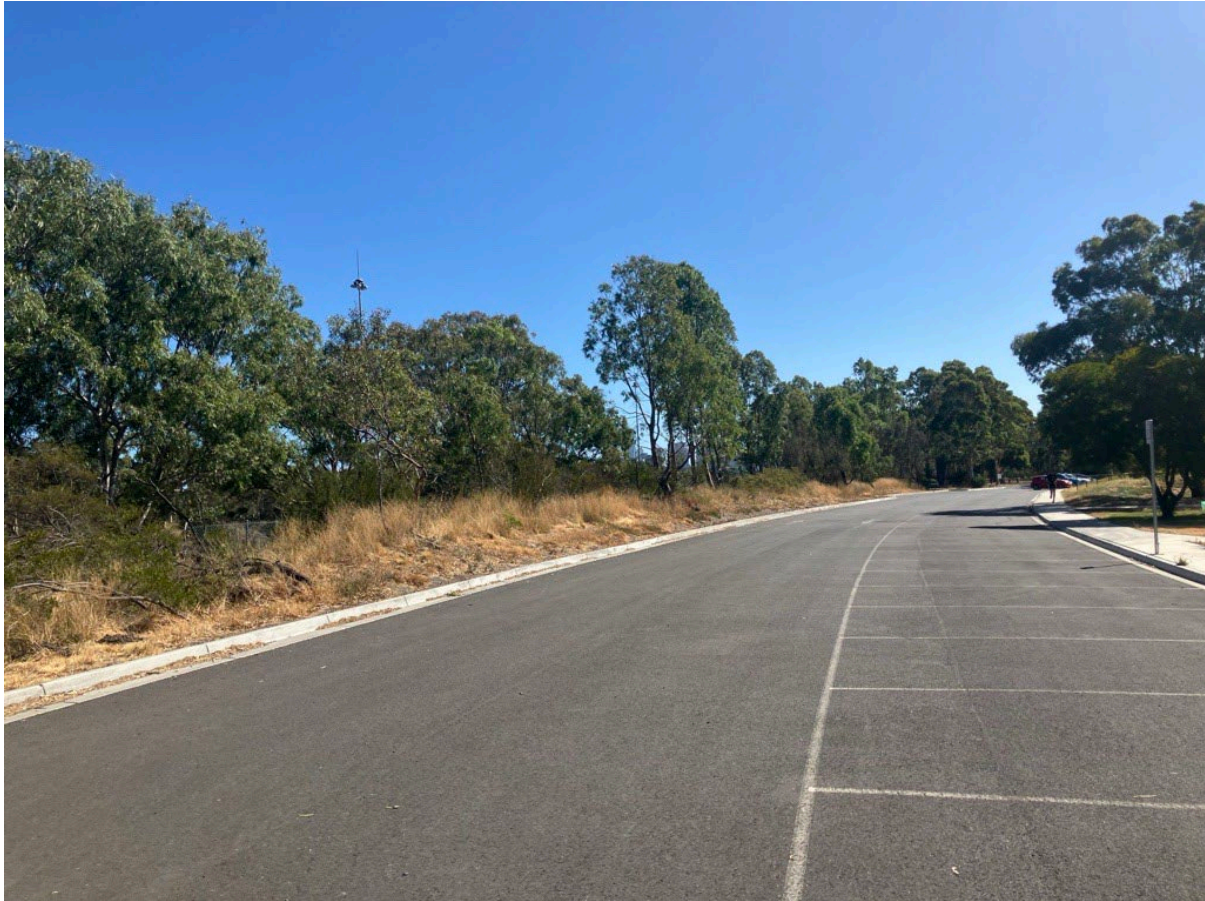
Figure 104: Fairlea Reserve Netball Courts carpark, with the earth mound on the left (image: A. Lagat 16/07/2026)

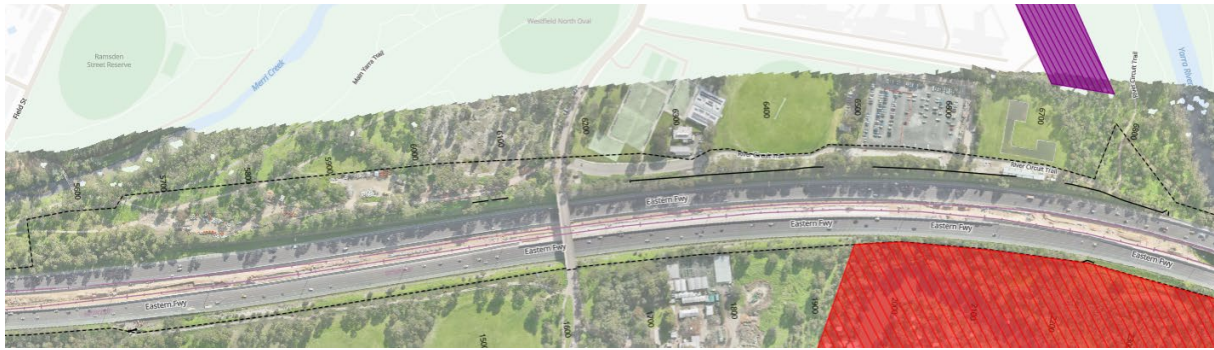
Figure 106: Location of permanent fencing works for the project

Removal of the existing fence where it conflicts with the proposed SUP pathway. Supply and installation of a new permanent fence immediately south of the existing fence line, in accordance with the approved project drawings and specifications. The existing fence will be removed only where required to facilitate the SUP construction, with the new fence reinstating the boundary function following completion of the works (Figure 106).
