# Woodfull Pavillion (B9)

## Royal Agricultural Showgrounds H1329

HERITAGE ACT 2017 PERMIT APPLICATION

HERITAGE IMPACT STATEMENT

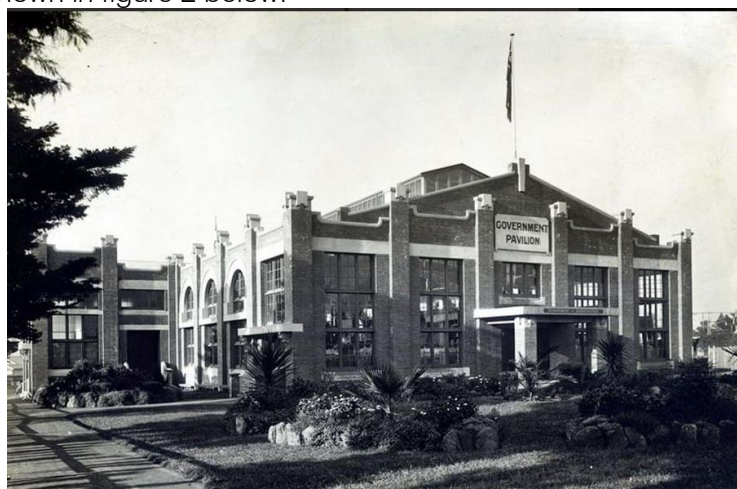
**Figure 2,** Woodfull Pavilion / Government Pavillion west facade (Melbourne Royal)

The Woodfull Pavilion was built in 1918, designed by Billing Peck & Kempter Architects. The building is located within the south-east end of Royal Agricultural Showgrounds extent of registration. The Flemington Racecourse train line runs along the southern boundary of the showgrounds. The signage as the Government Pavillion is visible as shown in figure 2 below.

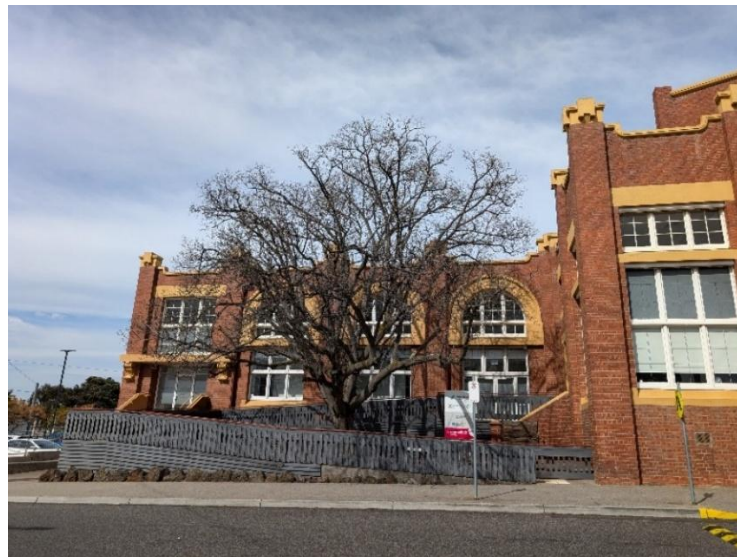
**Figure 3,** Government Pavilion, part north elevation (October 2024)

The Woodfull Pavillion is a brick building originally designed as a single volume exhibition hall for the annual Royal Agricultural Show. The facade has contrasting render bands on the window sills, heads and parapet tops. All elevations have a near symmetrical pattern and consist of fixed windows that span vertically between expressed columns. The current entrance to the building is all located on the north elevation for the two separate tenancies. Timber accessible ramps flank both ends of the north facade as shown in Figure 3 and Figure 4.

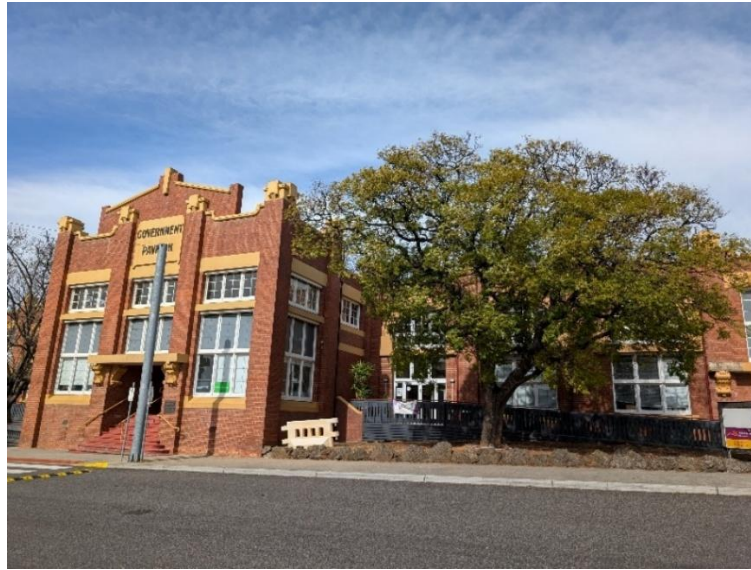
Figure 4, Government Pavilion north elevation (October 2024)
