Abbotsford convent conservation works – Good Shepherd Chapel

PRELIMINARY | NOT FOR CONSTRUCTION

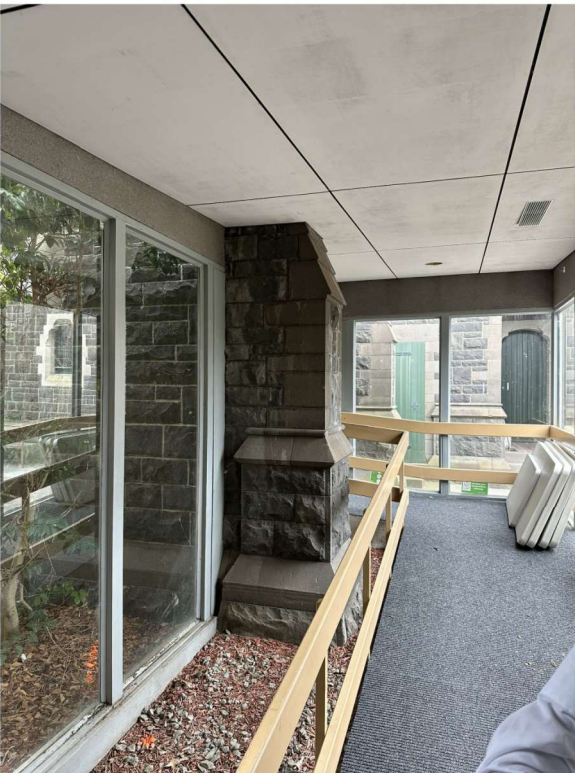
1. Demolish link at southwest corner of church and the associated concrete ramp, roof, handrails, glazed walls and landscaping.
2. Carefully remove any roof flashing and other materials joining the link directly to the church.
3. Remove any redundant conduit or pipes in the area of the link.
4. Demolish existing landscape and update to proposed landscape designs.

5. Gently clean all surfaces, seeking not to remove patina but to provide a clean base similar to surrounding external wall surfaces.
6. It is noted that some of the link's walling elements have been cut to shape around the stone, and thus may have resulted in only minor damage from fixings, whereas other areas are more likely to have been cut to introduce flashings or other wall seals.

7. Undertake repairs as required to basalt and Sandy Bay freestone, using basalt and freestone to match existing where indent repairs are required. For smaller areas of damage, mortar repairs with mortar prepared to match the colour of the stone may be appropriate.

8. If the freestone to the doorway is damaged, this will need to be reviewed and an appropriate repair determined.
9. Repoint stone to match adjoining external walls surfaces, taking care to provide a continuous matching appearance to the new and old pointing. The southern face of the building in the immediate area of the link has grey pointing with a white tuck. The west face may be pointed differently. Where possible, original or old tuckpointing should be retained, with repairs pieced in to match.

10. Ensure copper downpipe to south face of church, above existing link, is in good order and draining well. Repair as necessary.
