*Re: Former Wesleyan Church, 340-350 Sydney Road, Brunswick (VHR H1144)*  
*Permit Application P42205*

This letter was prepared on behalf of the permit applicant. It responds to issues raised in the RFI dated 13/04/26, as well as the submission from the City of Merri-bek.

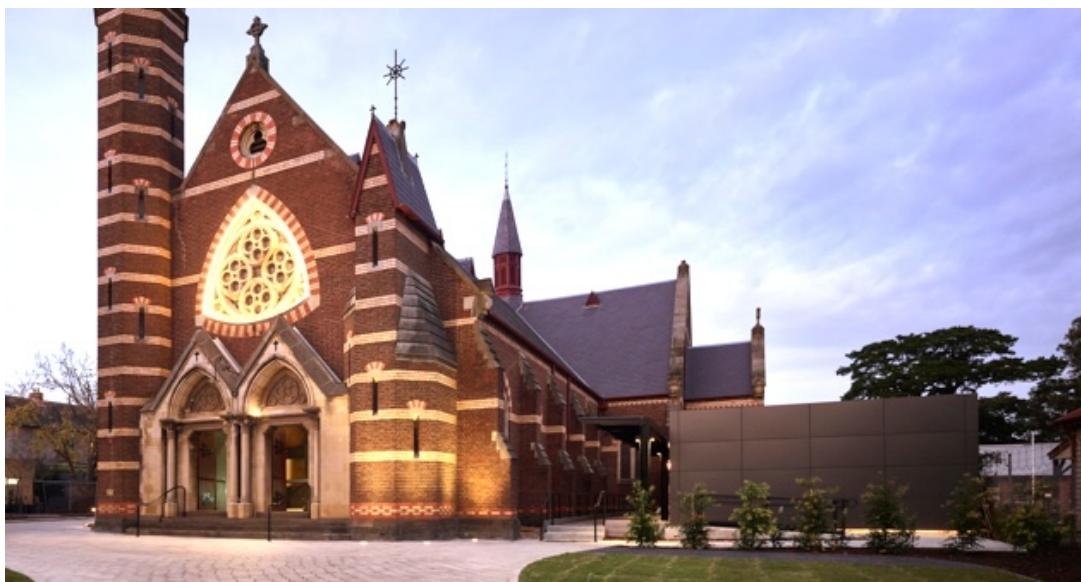
*Former St Georges Uniting Church, converted into a performing arts centre with a modern/dark metal clad toilets and change rooms visible to the right.*

The proposed toilet block addition is of rendered brick construction with a dark grey finish providing a visually recessive outcome. This is similar to the award winning scheme for the adaptive reuse of St George's Uniting Church, St Kilda (P32267), whereby toilets and changing rooms were provided in a separate, dark coloured building of simple contemporary design – albeit in that instance the new building was clearly visible from the primary frontage to Chapel Street.
