# HERITAGE IMPACT STATEMENT

## Former Little Sisters of the Poor Home for the Elderly (H1950)

**March 2026 RFI Amendment**

Former Little Sisters of the Poor home for the Aged.

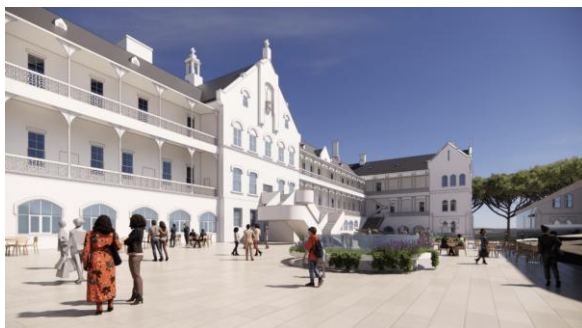
Figure 17 October 2023 presentation – hard-paved flat platía with glass pavilion illustrating loss of significant heritage features.

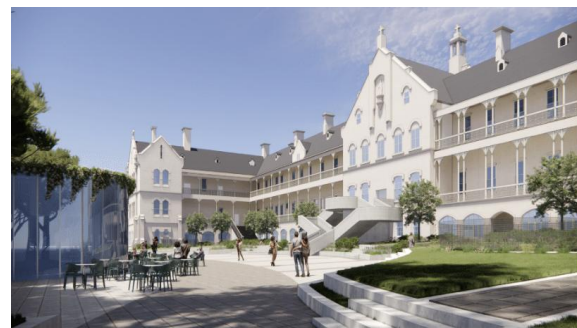
Figure 21 September 2024 presentation – resolution of landscape forms achieved, though limited architectural connection between the Monastery and the glass pavilion

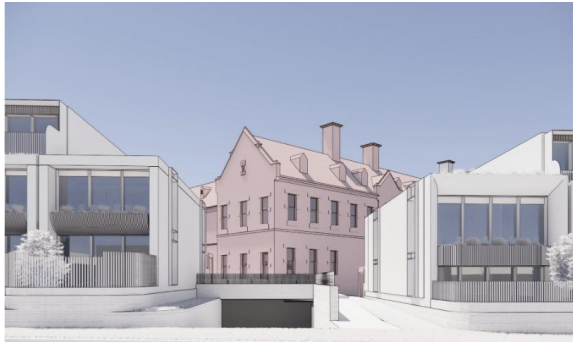
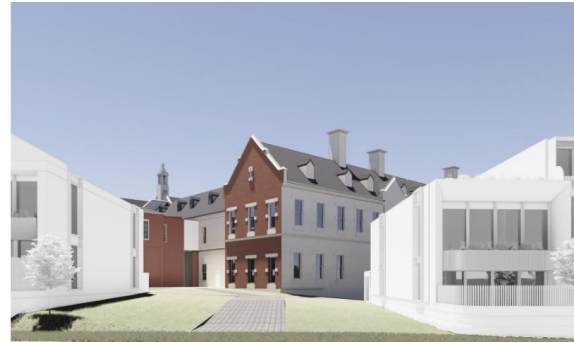
*Figure 18 September 2025 – images showing changes following the first workshop. The carpark entry has been relocated and views to the Monastery have been opened up. The main path orientation still relates to the street rather than the Monastery.*

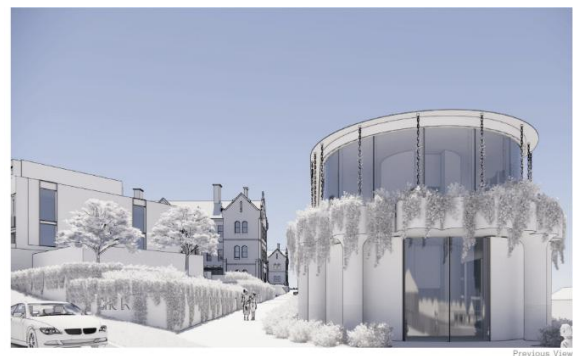
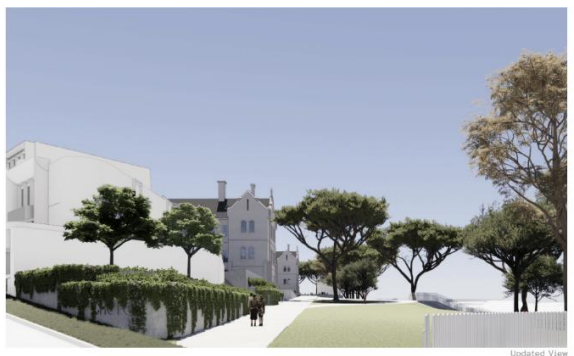
*Figure 21 August 2024 – restaurant and substation removed, improving sightlines to the Monastery*

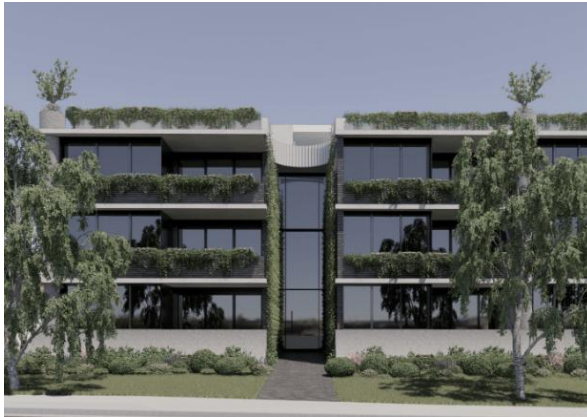
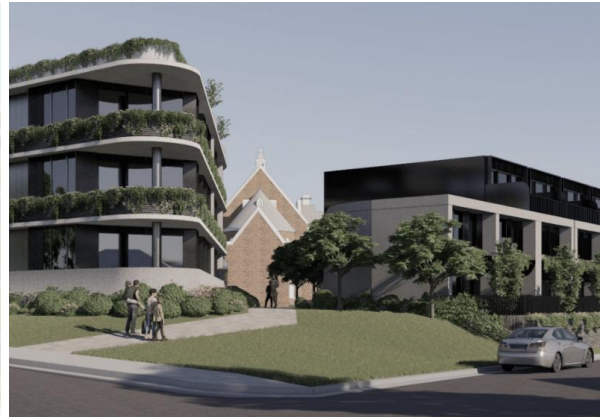
Figure 22 April 2024 apartments – minimal vertical definition, no discernible references to the architectural language of the monastery, the relationship of buildings at the corner unresolved.

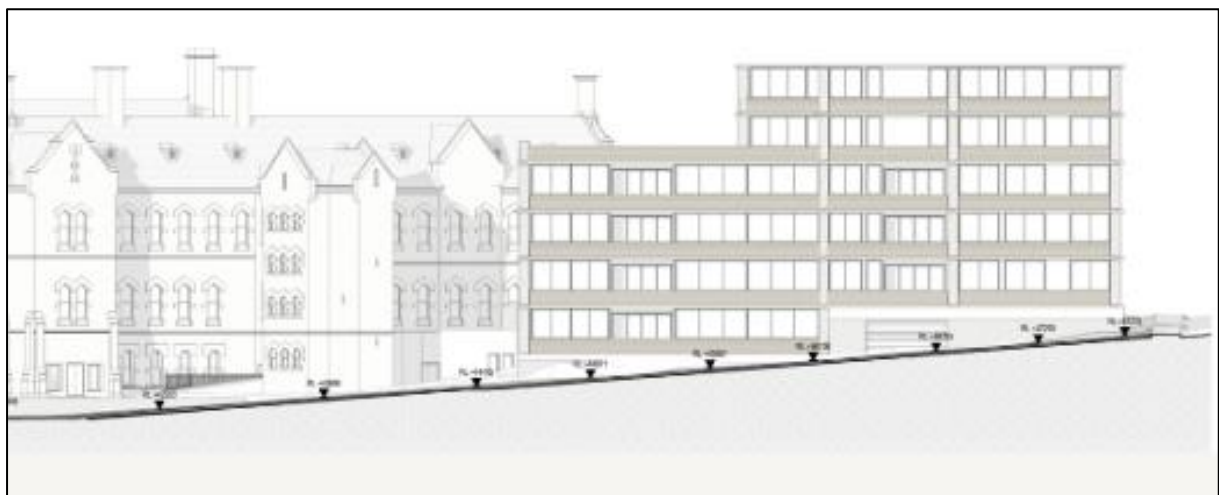
Figure 25 August 2024 – the architectural and spatial relationship between buildings is unresolved, and the south-east corner presents a back-of-house character.

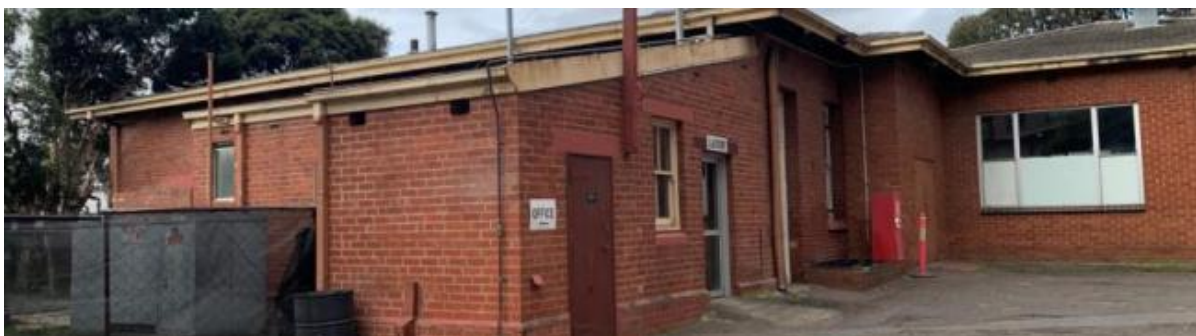
Figure 29 West elevation is currently used as a workshop and contains an early iron beam – no original roof forms

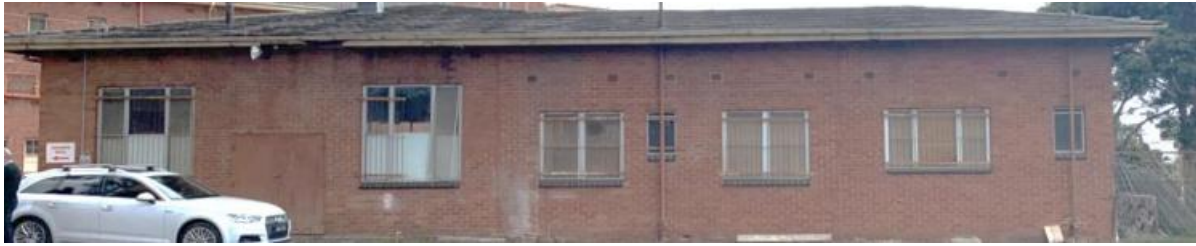
Figure 30 East Elevation of former child care building – a later addition to the laundry

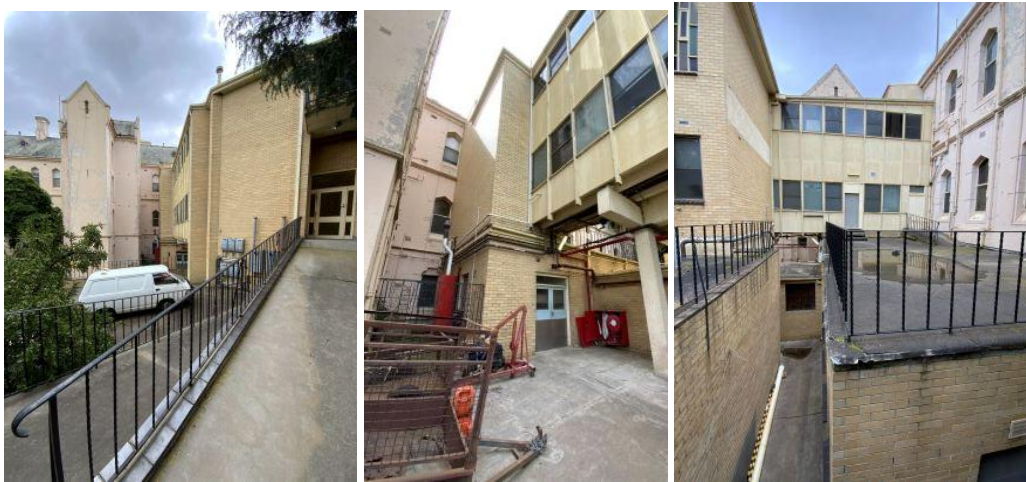
Figure 35 South side of new wing basement and link from south north side of new wing and link

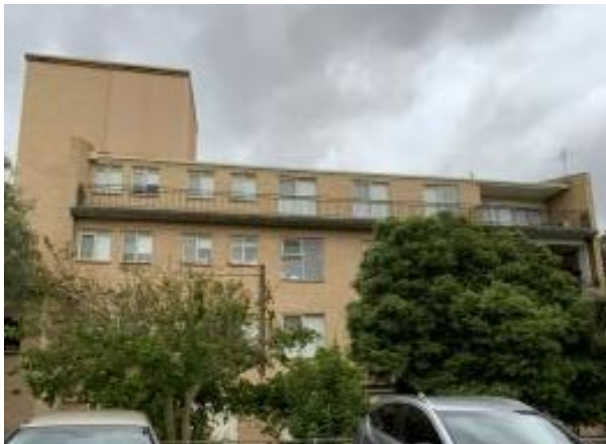
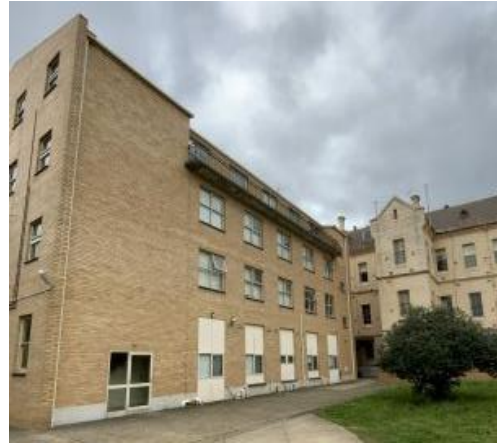
Figure 36 north elevation

south elevation

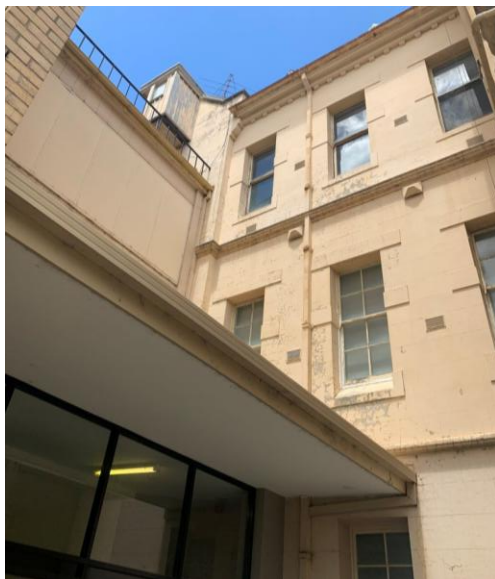
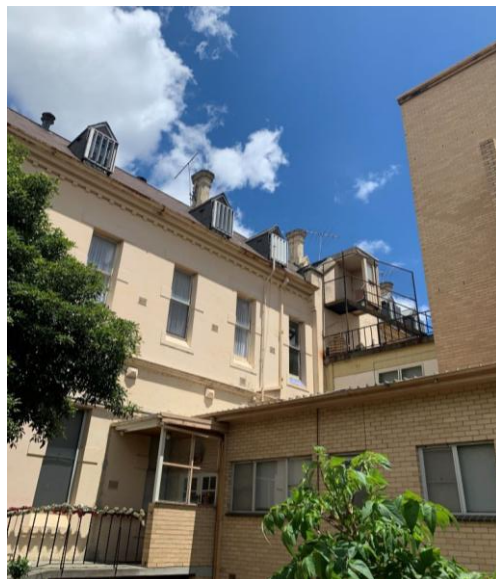
Figure 37 west side of connecting link

east side of connecting link

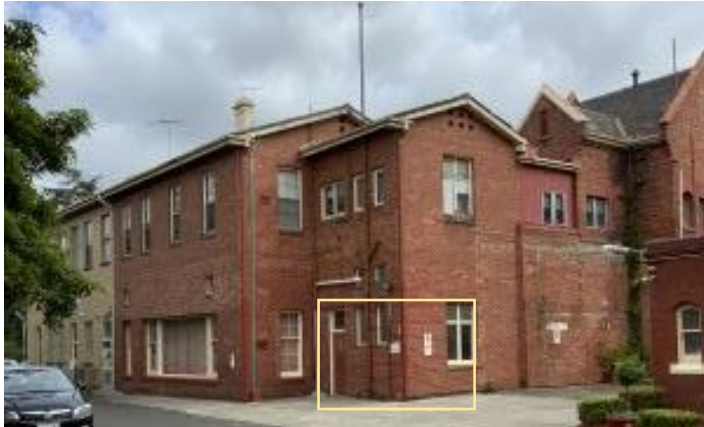
Figure 31 Additions at the north end of the south wing  
approximate location of 1907 bldg outlined in yellow

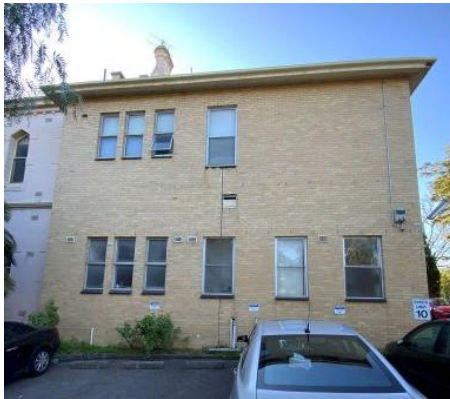
Figure 39 1960s addition at the end of the south wing

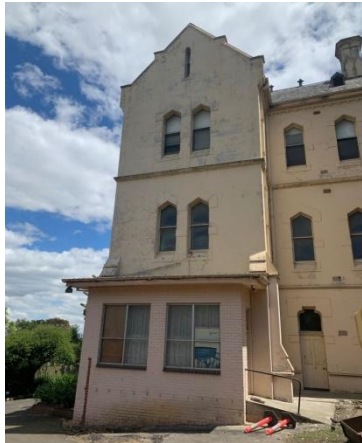
Figure 32 Ramp and brick addition to be demolished

The CMP recommends that elements which detract, distort or diminish the cultural significance of the place are removed. The addition will be removed and the elevation restored.

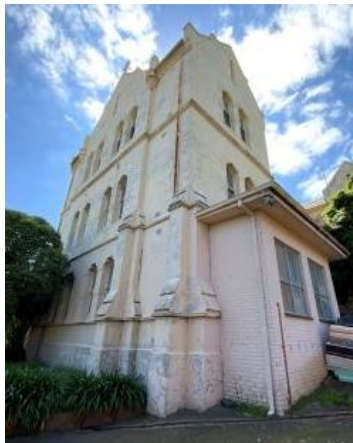
Figure 33 KUD demolition plan

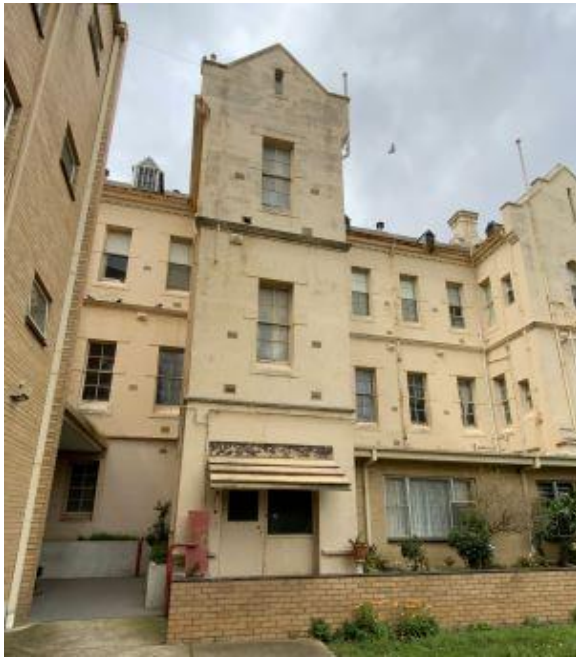
Figure 34 Demolish single-storey addition beside ablutions block and awning

The CMP recommends the removal of all elements that detract from, distort, or diminish the cultural significance of the place. The additions will therefore be demolished, and the original elevations reinstated.

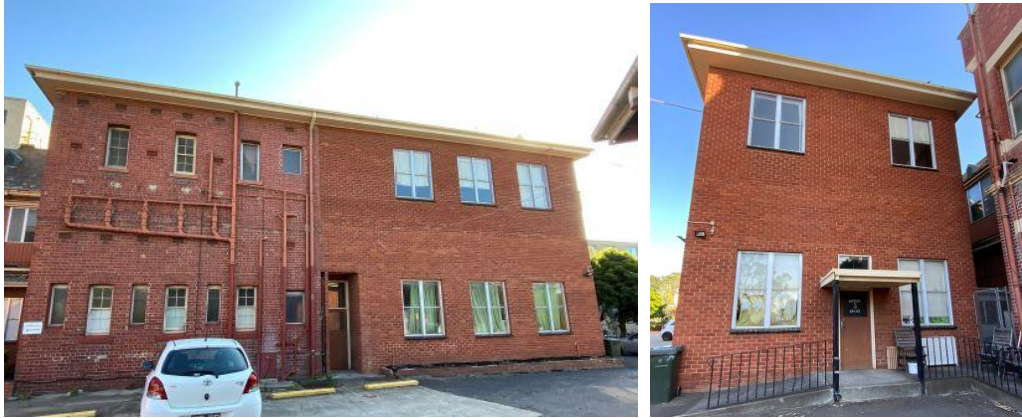
Figure 36 Original structure on the left, later addition on the right

West end of addition

The CMP recommends that elements which detract, distort or diminish the cultural significance of the place are removed. The additions will be removed. The roofline and elevations will be reinstated.

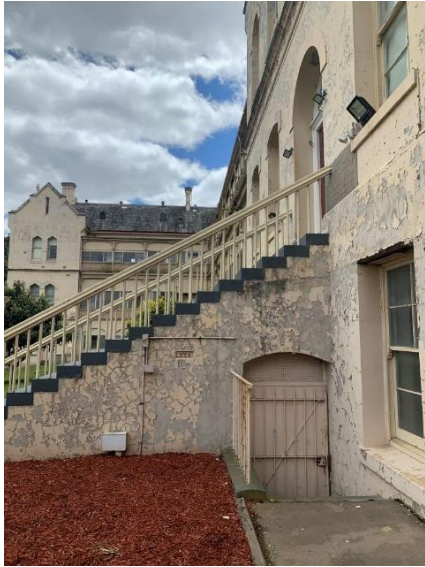
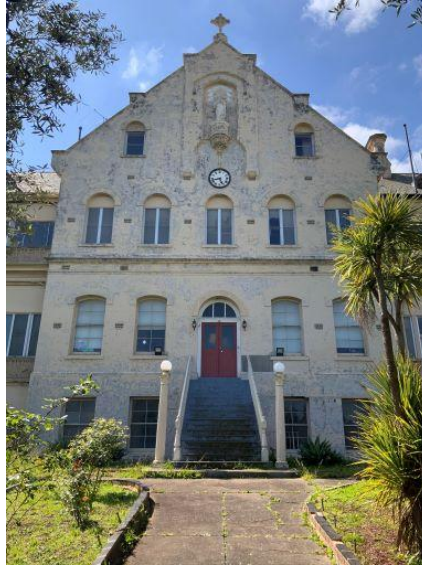
Figure 39 Forecourt stair side elevation

Figure 40 front elevation

The stair has no landing, is unsafe for use, and provides no direct entry to the church. It is currently disused.

The existing narrow stair, which replaced the earlier ornate double staircase around 1896, is paradoxically both significant and deleterious. While historically illustrative of the Sisters' circumstances, it is functionally and aesthetically inadequate, unsafe, and inaccessible for elderly or mobility-impaired users.

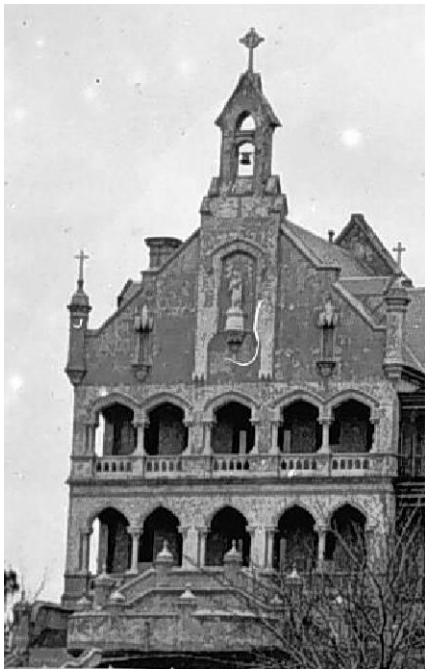
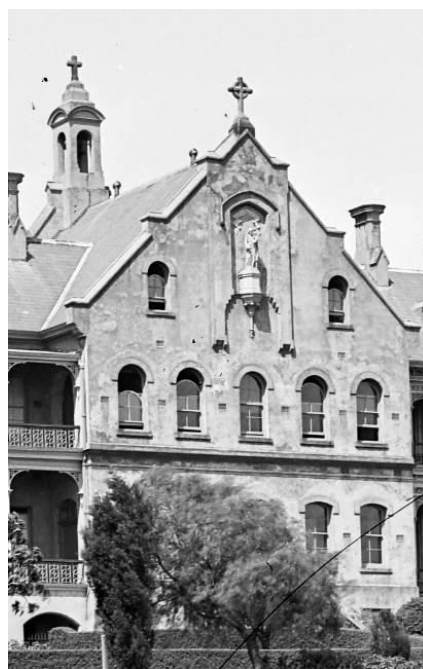
Figure 41 Façade of chapel in 1890

Façade of chapel in 1895-6

During the later phase, under architect James Curtin, the design was considerably simplified to provide additional accommodation. The revised façade introduced a more substantial belltower set back from the front plane, replaced the niches flanking the statue of St Joseph with round-headed windows, and infilled the arcades with rendered walls and rows of round-headed and segmental-

arched windows. The original grand staircase was removed and replaced with a modest straight flight of steps.

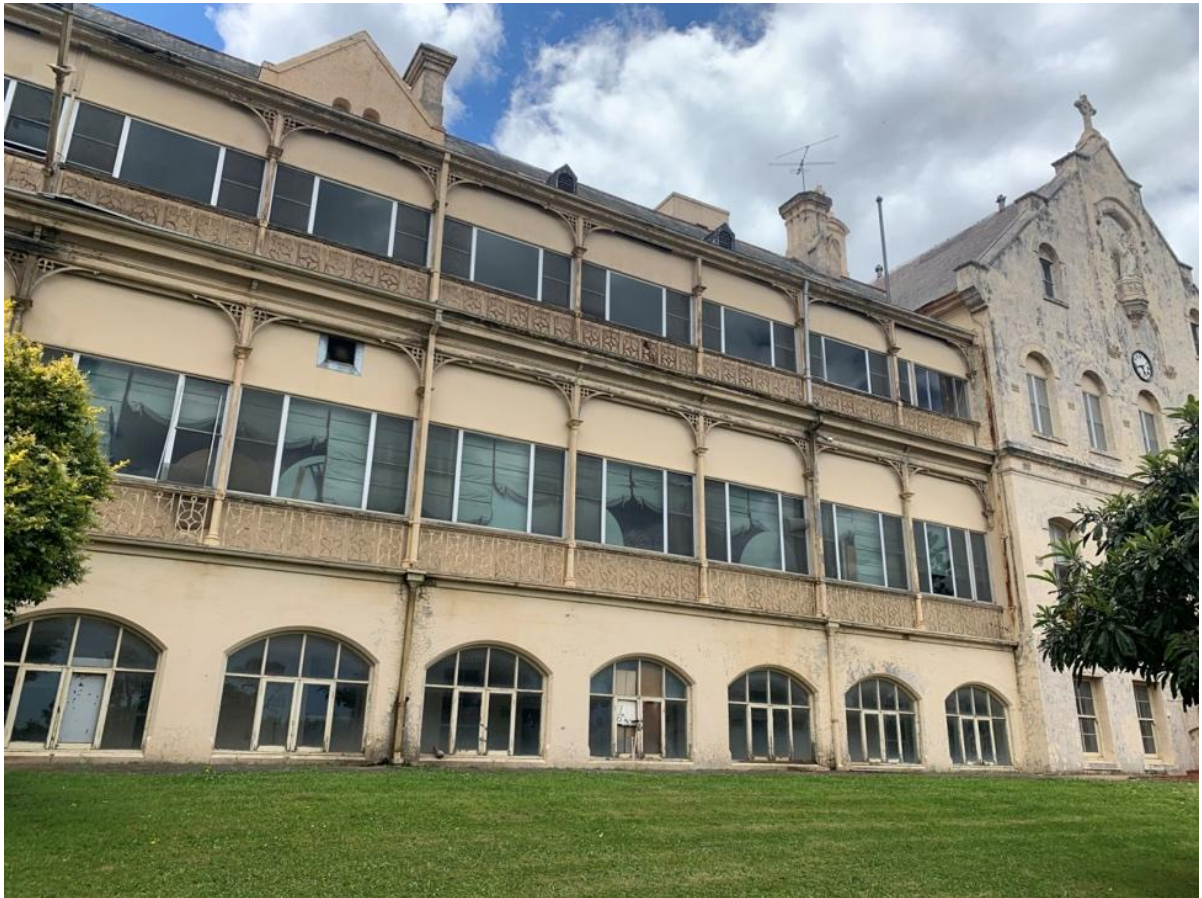
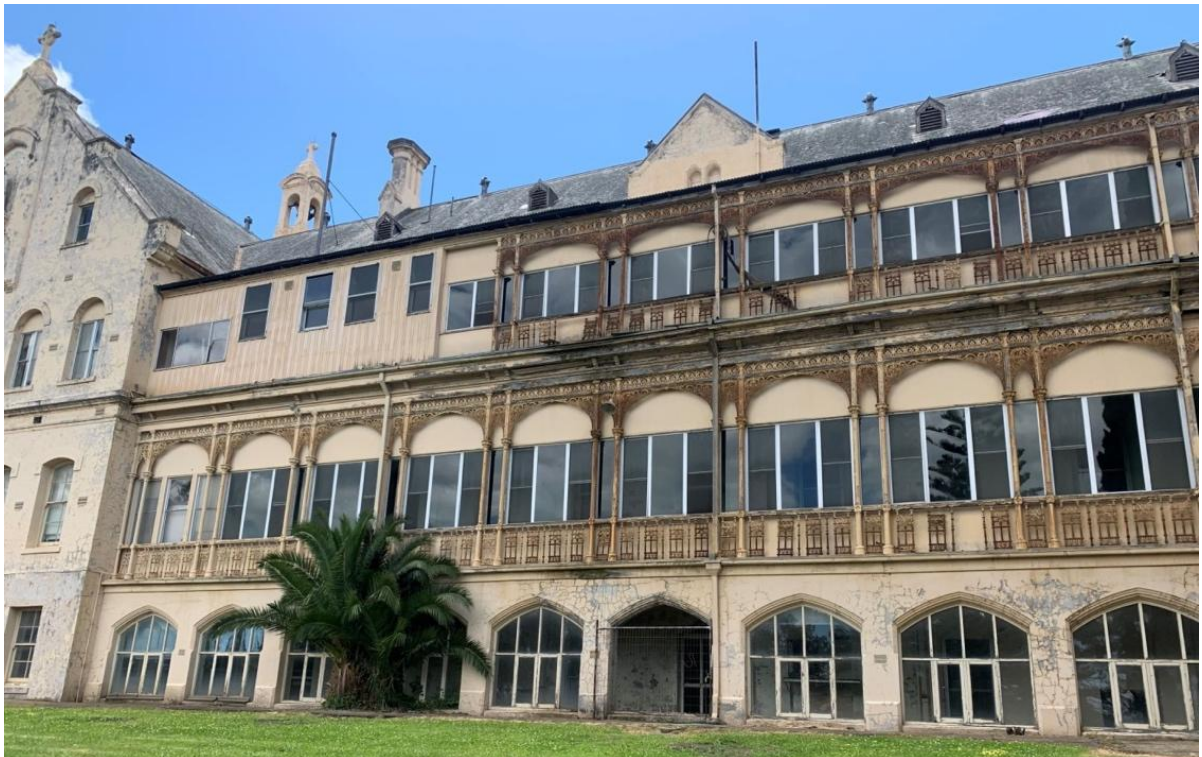
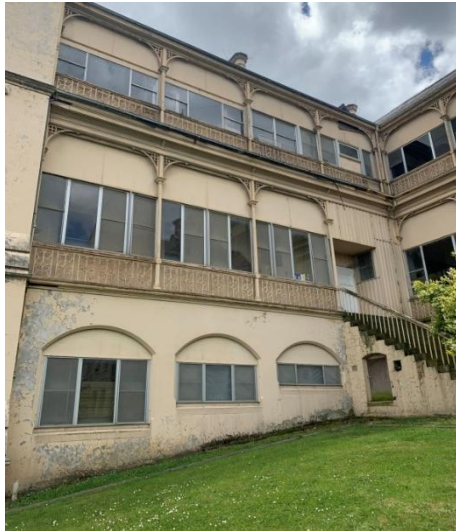
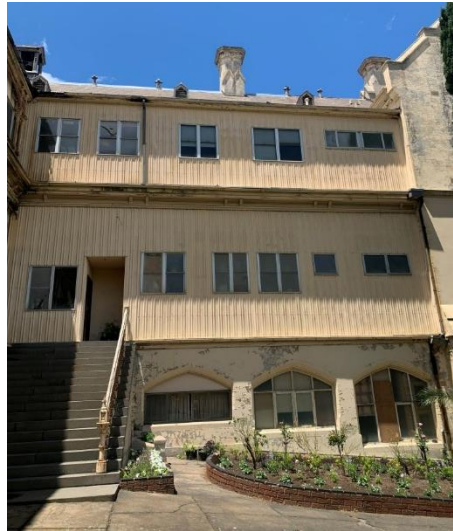
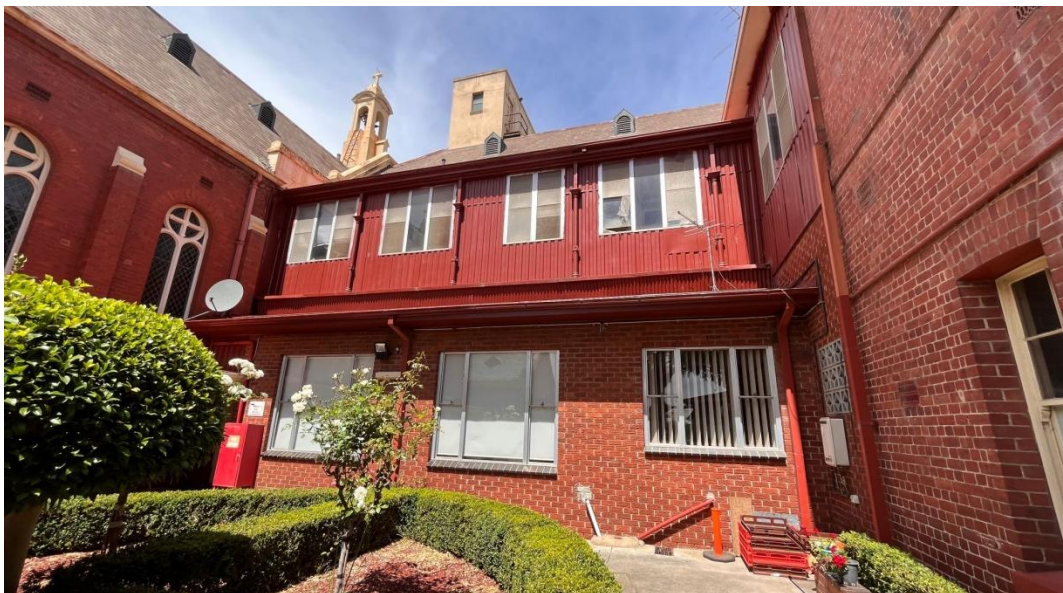
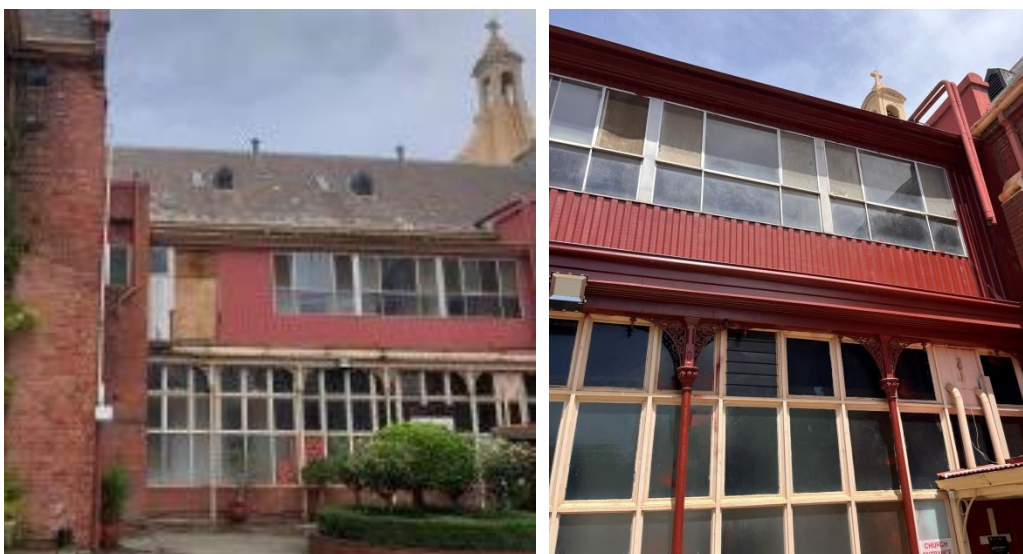
Figure 42 North link south side/berm

Figure 43 South link south side to berm

Figure 44 North wing verandah to berm

Figure 45 South wing verandah to berm

Figure 46 North link north side

Figure 47 South link north side

All walls enclosing the verandahs are in poor to very poor condition. The verandahs themselves are unused. The loggia windows are in good condition, but the loggia space is also currently unused.

The CMP recommends that elements which detract from, distort, or diminish the cultural significance of the place be removed. Accordingly, all non-original verandah infill elements will be demolished. The original balustrade system and verandah posts will be conserved and reinstated.

The removal of the infill materials will enable the reconstruction of the cast-iron lace balustrades, restoring the building's original form and cross-ventilation system. All verandah balustrade panels and filigree have been temporarily removed for safety reasons, as many were at risk of collapse. The cast-iron work will be repaired at ground level and reinstated. Verandah posts, which feature fewer interstices, will be conserved in situ. Where elements have been lost or structurally compromised, replacements will be fabricated in accordance with the conservation methodology outlined in Appendix O.

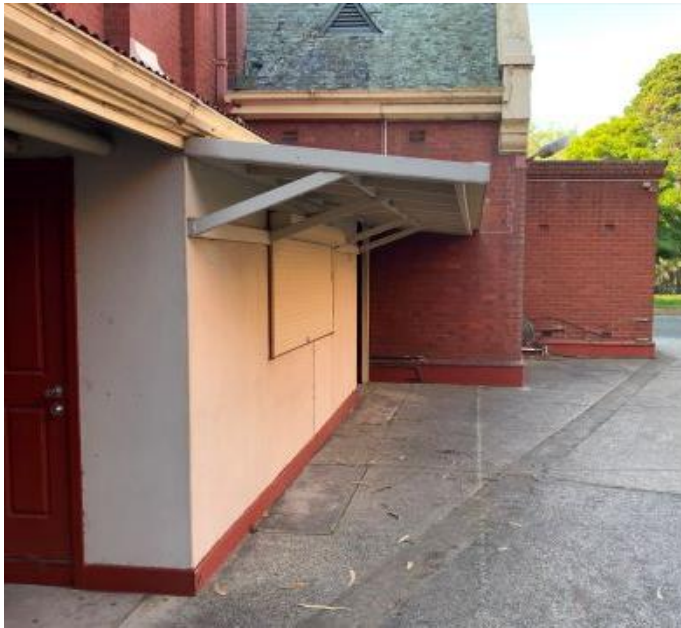
Figure 48 built-in section of verandah on east side of the church

The CMP recommends that elements which detract from, distort, or diminish the cultural significance of the place be removed. Accordingly, the kiosk will be demolished.

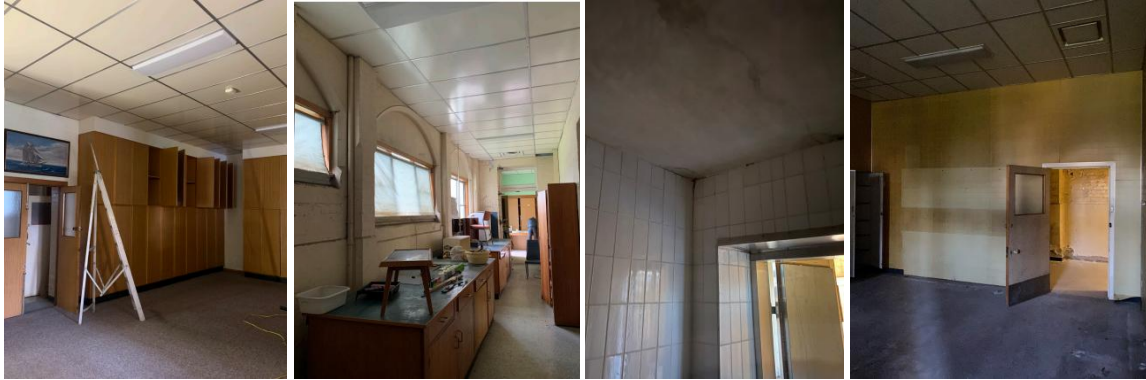
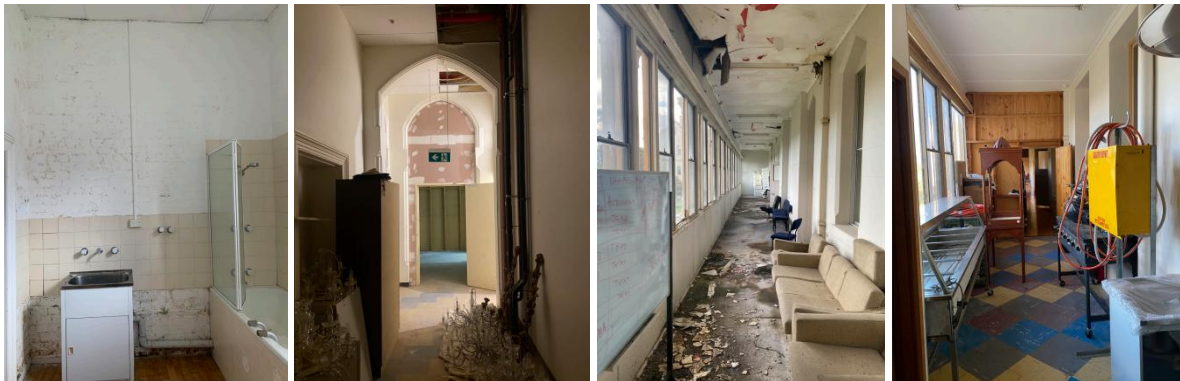
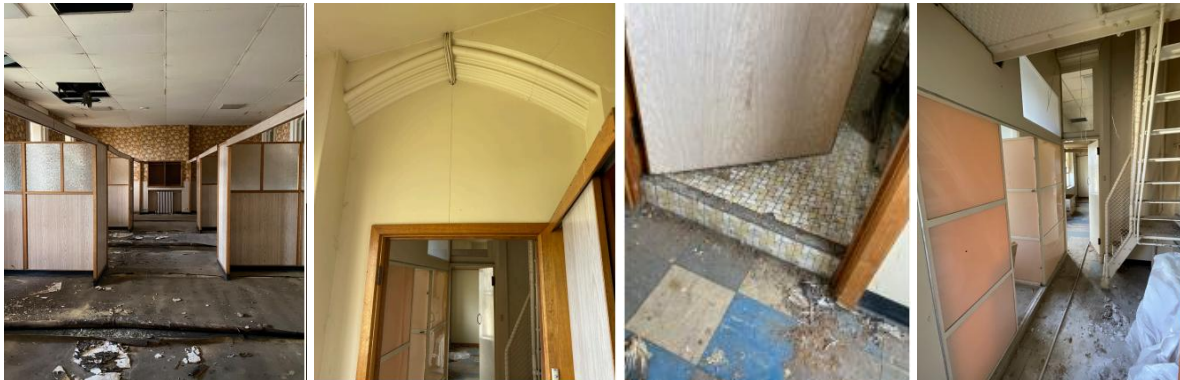
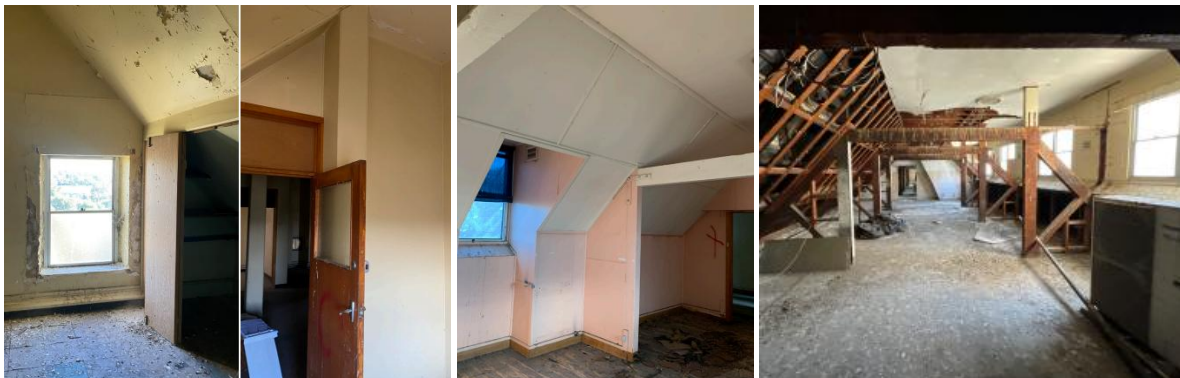
Figure 49 Basement

Figure 50 Ground Floor

Figure 51 Floor

Figure 52 Attic

The mid to late twentieth-century bedroom and bathroom fitouts are now in very poor condition. Many of the modifications, including suspended ceilings, partition systems, and bathroom fittings, have been partially or roughly removed, causing damage to original fabric. Areas that remain in use have been stripped back to the original materials and made good.

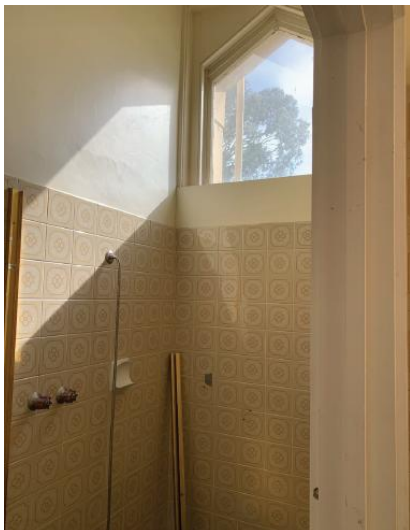
Figure 67 Current condition of G.112 and G.111

The CMP identifies these rooms as early sanitary areas. Their original features are not known, but both have undergone multiple modifications. Room G.111 has been entirely gutted, and the window in G.112 has been covered by a stud wall. The removal of these walls will not disrupt an understanding of the building's planning or diminish its heritage significance.

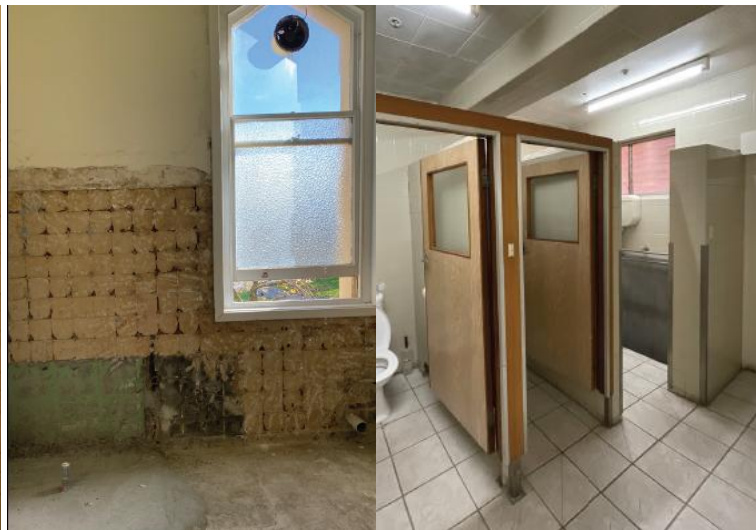
Figure 68 South link ablutions G.11A

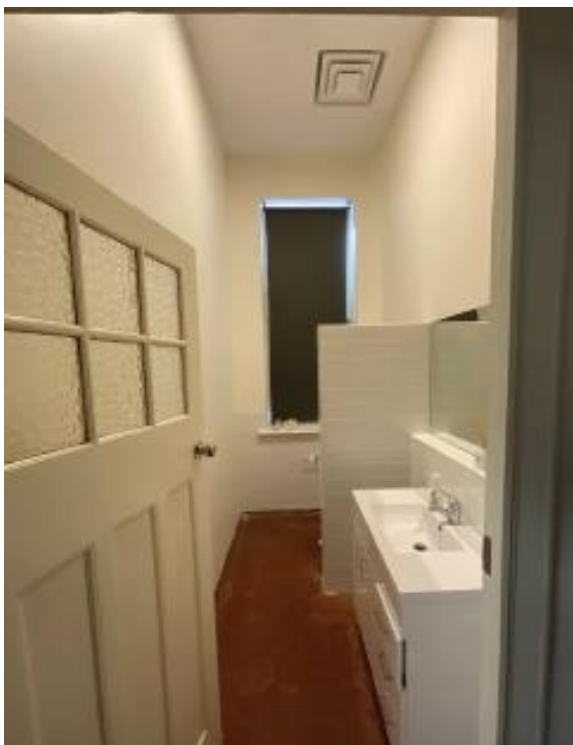
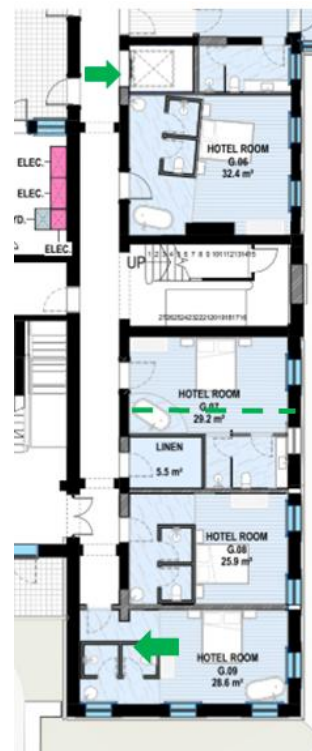
Figure 57 Corridor with bathroom infill

3&4 = arrow, 4 = dotted line

The corridor in this area has already been modified (refer to Figure 57), and the proposed opening is unlikely to cause further adverse impact. Due to limited space, a shallow nib will be formed in render to mark the position of the original wall.

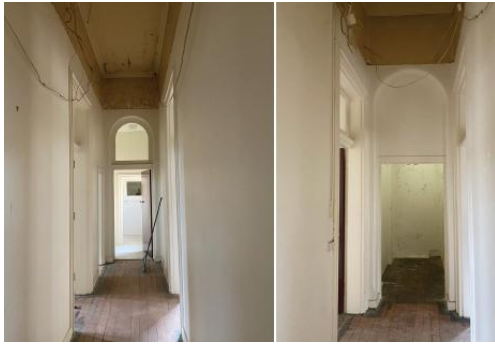
Figure 73 North pavilion corridor

Three minor changes are proposed to the corridor walls. These are not expected to impact the rhythm, proportion, or character of the space. The arched openings will continue to define and dominate the corridor's architectural expression.

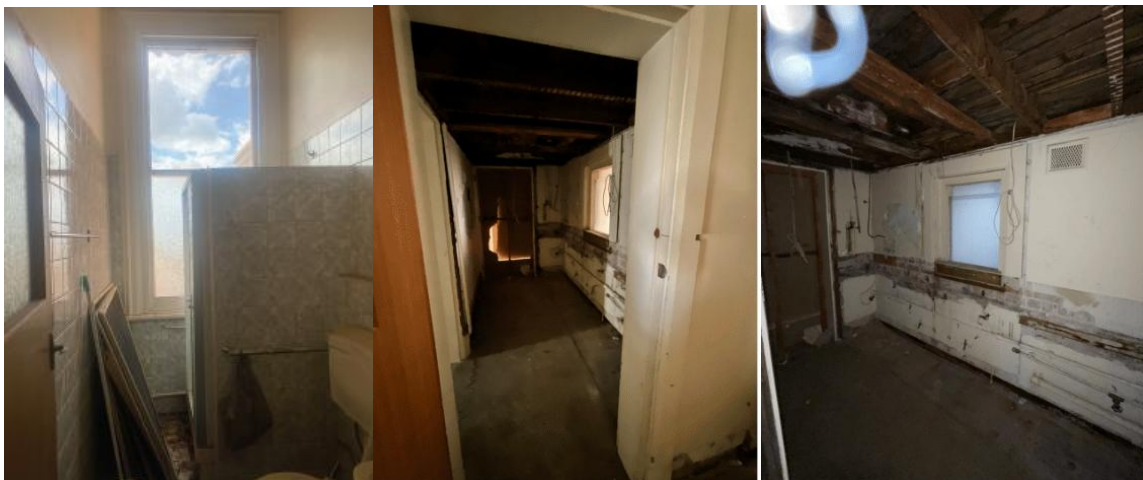
Figure 74. Bathroom installed in the corridor space

Figure 75 Room 1.115 – images from CMP

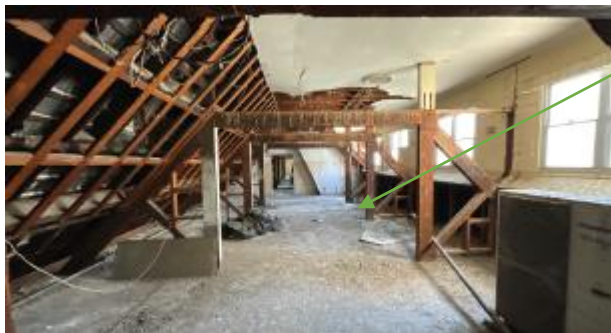
Figure 63 Section of modified wall on right to be partially removed.

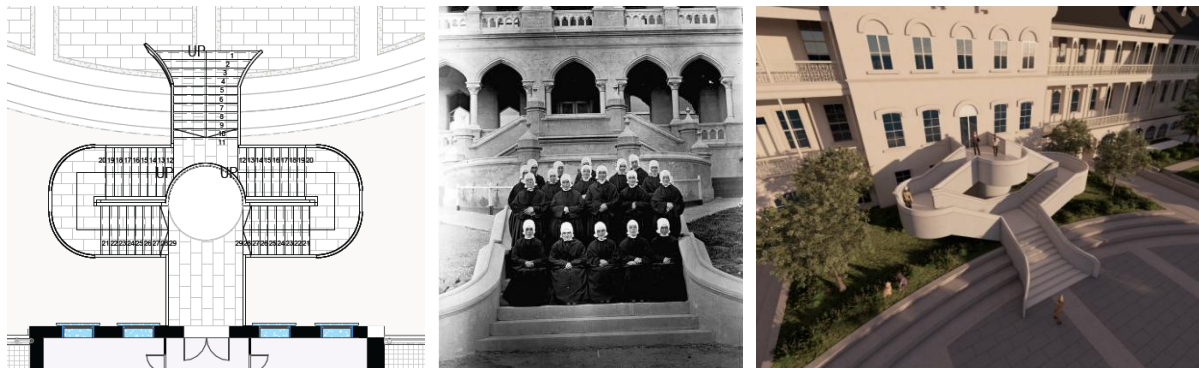
A new central stair will be constructed to re-establish a functional and dignified connection between the church and the new *platia*. The stair will form a highly visible and defining element of the west façade. Its form draws inspiration from the original double stair shown in historic photographs.

The central platform will be large enough to allow several people to stand and address a gathering in the *platia*. The return flights will sit within the edges of the central oratory wall. The off-form concrete finish will complement the rendered masonry of the Monastery. The design is contemporary but sympathetic in both scale and materiality.

Figure 84 New stair plan; 1892 photo of Little Sisters on front stair; proposed front stair

The reinstatement of the main west stair will re-establish this as the principal and ceremonial entry to the building, as originally intended by the architect. It will encourage the use of the main church doors rather than the secondary side entry on the east elevation. The central landing will once again provide a platform for clergy to address gatherings in the *platia*, echoing the use depicted during the building's opening ceremony.

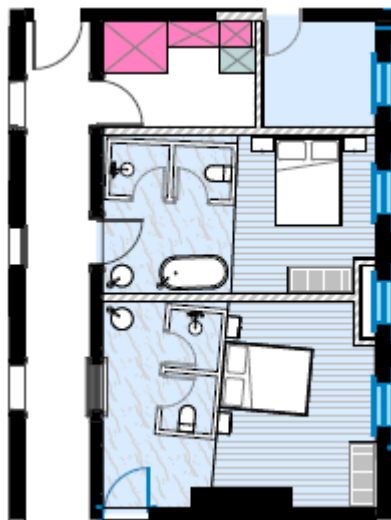
Where it has not been possible to align new walls between existing windows, the windows will be concealed from the interior but will remain visible externally. An opaque film will be applied to the glazing to maintain the building's external appearance.

Figure 88 Typical bedroom plan showing windows retained but concealed by internal wall

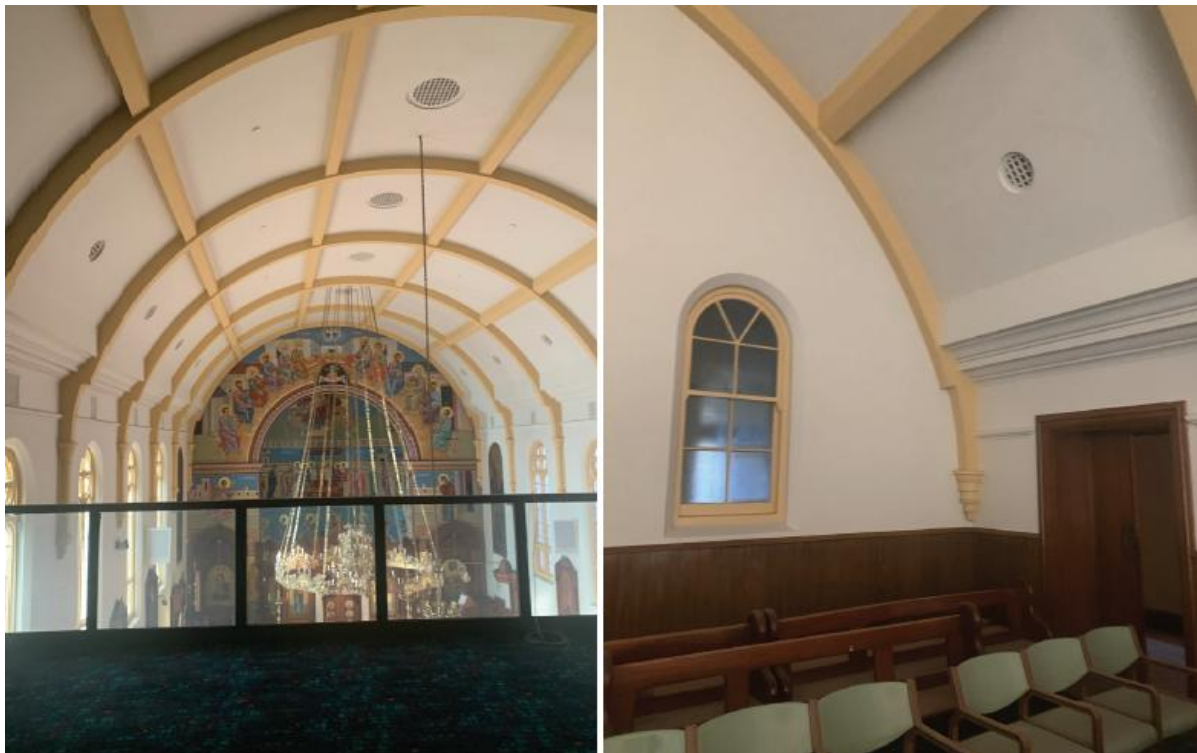
Figure 90 Looking east toward the apse from the balcony, showing the back wall of the balcony.

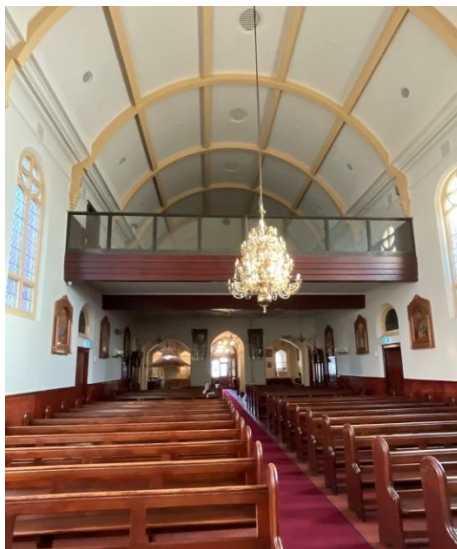
A new balustrade of vertical fins will replace the existing glass handrail, providing a sense of enclosure and screening between the balcony and the nave. The design of the original balustrade is unknown, and the proposed form is intended as a respectful contemporary interpretation.

The proposed glazed wall and new balustrade will form a modern layer within this modified setting. The new glazed wall will sit adjacent to the rib directly behind the handrail. The glass will be covered with a digiglass print of byzantine iconography for dramatic effect. The depth of the balcony and the rows of ribs will still be visible through glass. The existing glass handrail will be replaced with balustrade made of fine metal fins which will give the impression of porosity while obscuring most of the activities above.

Figure 91 Section through church nave showing new glass wall and balustrade.

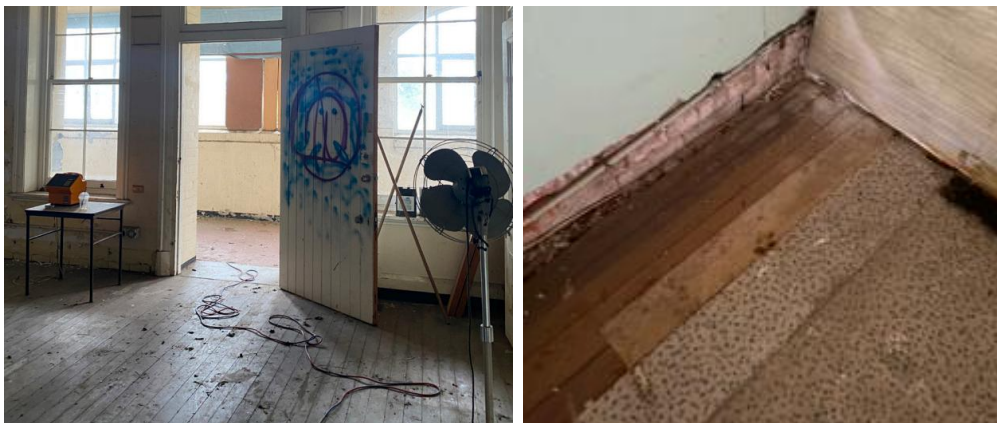
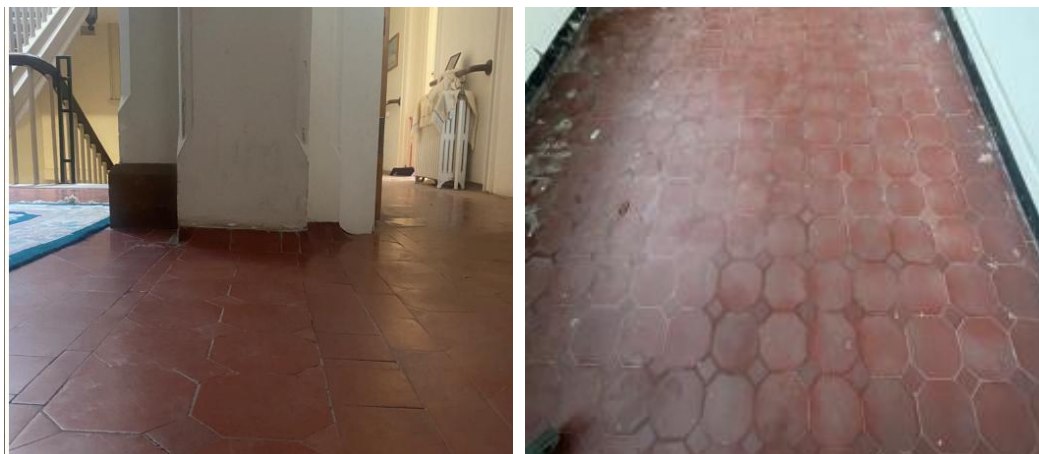
Figure 96 Various floor types.

Room B40.2 – Basement timber, tile, and bluestone sill; Room 1.83 – Timber floor and lino.

Room 1.114 – First floor, stage 2 and infill; Room G41.3 – Typical example.

The basement floors have been modified over time and may originally have been timber, which subsequently failed (see Room B40). Corridors are now finished with terrazzo, laid over an early concrete slab—some poured in situ and some as tiles. The poured terrazzo is in good condition; the tiled sections are generally in good to fair condition.

The upper floors typically comprise 30mm-thick timber boards. The original finish in the dormitories is not known, but there is no level change between the tiled corridors and the uncovered timber floors in the dormitory areas. Some floorboards have been cut for service runs, but visible sections are generally in good condition.

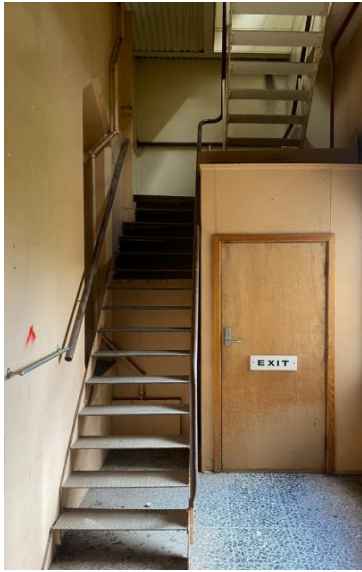
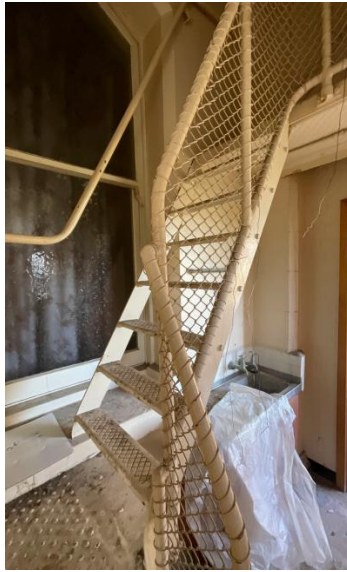
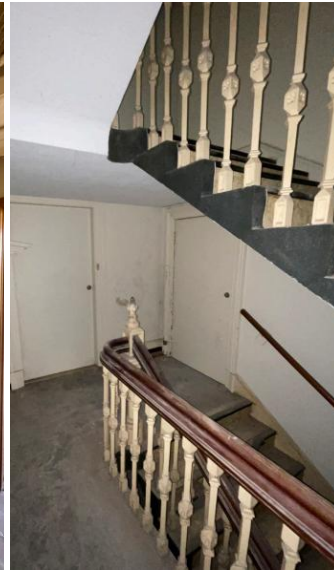
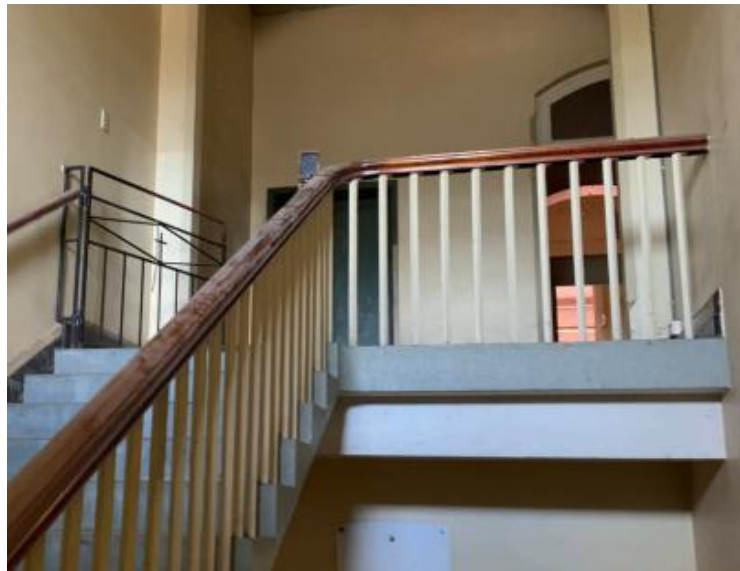
Figure 69 Various stair types  
Steel access stair, south wing

Steel stair to attic

Stair 1, bluestone landing, vinyl and nosing over bluestone treads, ornate cast iron balusters

Stair 3 timber flight to attic  
Figure 98: Various stair types

Square iron balustrades to lino-covered timber stair

The timber stairs to the attic are original and therefore significant, but they are standard Victorian timber staircases typical of many buildings of the period. They are contributory but not essential to the integrity, character, or heritage values of the place.

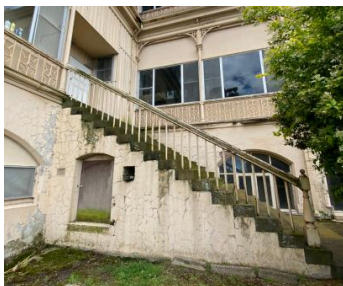
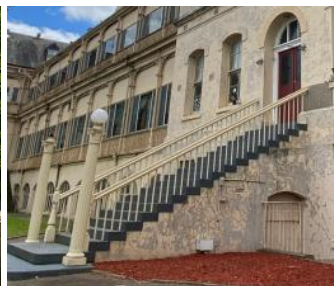
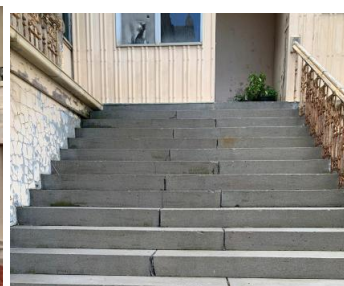
Figure 99: Central stair with bluestone treads and square cast-iron balusters
