# HERITAGE IMPACT STATEMENT

## Former Little Sisters of the Poor Home for the Elderly (H1950)

**March 2026 RFI Amendment**

Former Little Sisters of the Poor home for the Aged.

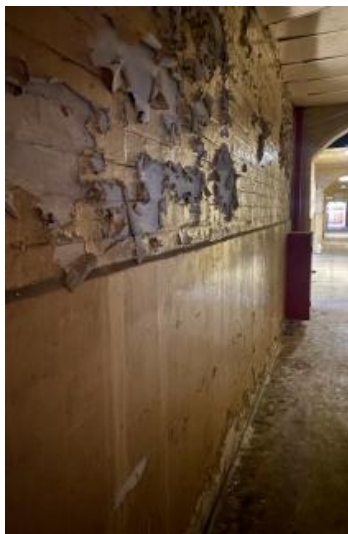
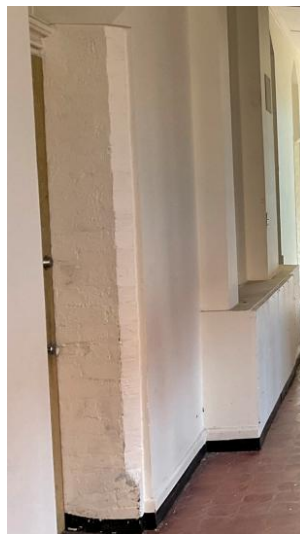
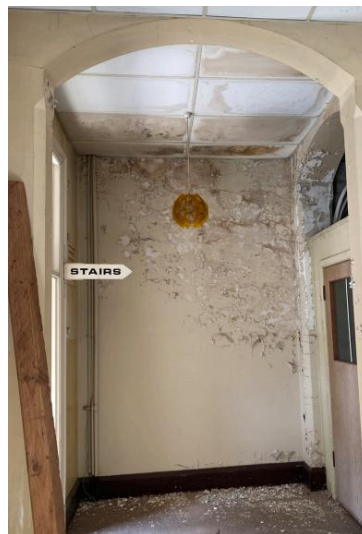
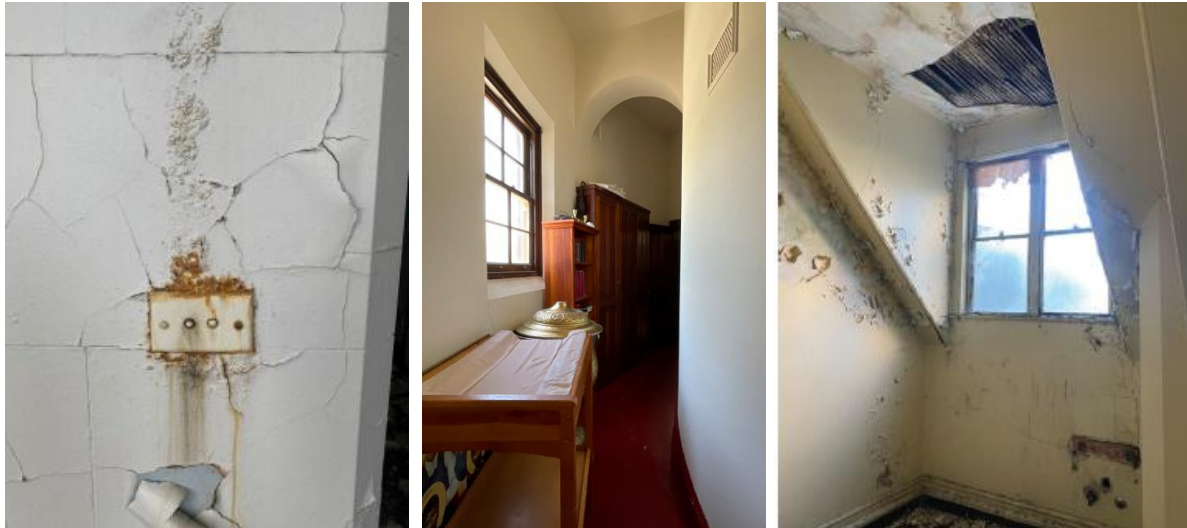
*Basement corridor*

*Ground floor north verandah*

*First floor north corridor*

*Figure 70 Examples of paint finishes*

Ground floor, south verandah

Figure 100: Examples of paint finishes

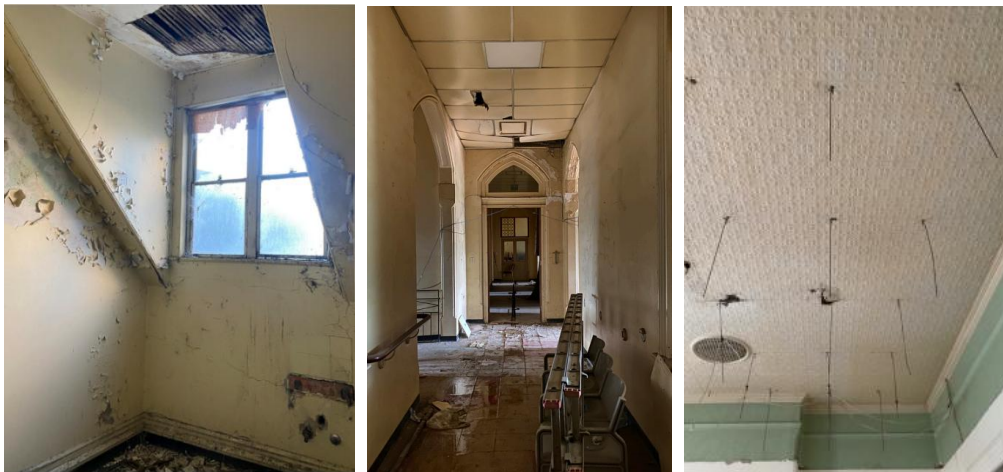
Figure 101: Various ceiling types

Attic – plaster and lath; later suspended ceiling in Stage 1; pressed metal ceilings in Stage 3; timber ceiling in basement; corrugated iron barrel vaults below cindercrete lining.

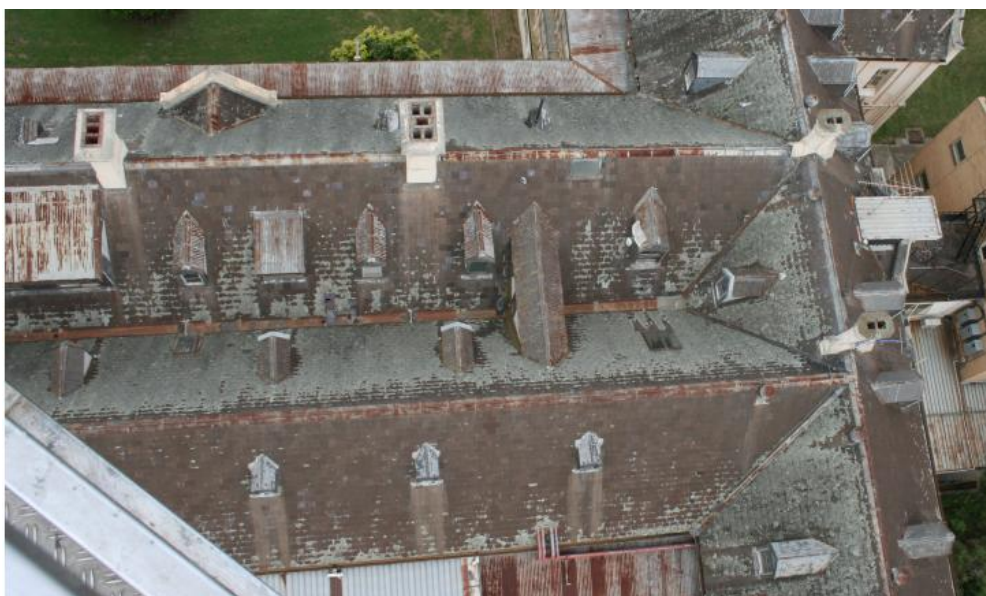
*Figure 106 Aerial photo of the north link demonstrating typical condition of roof elements*

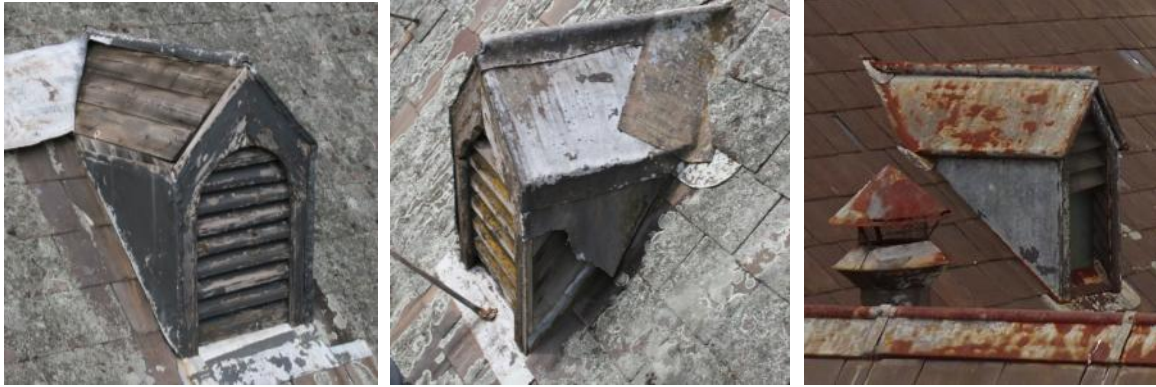
Figure 109 Various dormer vents showing failing lead cladding and rusting galvanised iron, ridge vent visible

Roof ventilation is provided by small timber-framed dormer vents with metal flashings, sheeted roofs, and timber louvres. The roof vents are generally in poor condition with extensive weathering and corrosion. The roof also incorporates metal ridge vents which differ slightly between building stages.

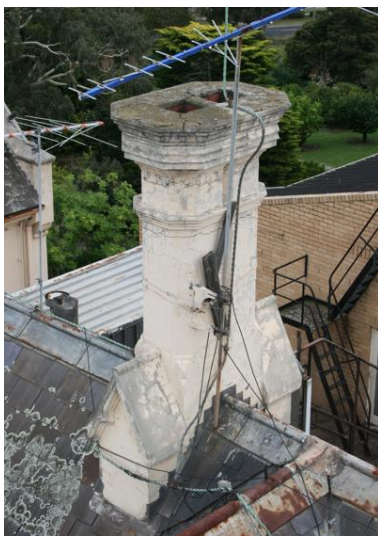
The rendered chimneys feature corbelled caps and copings with small gablets at their bases. One chimney has been extended, but all others remain in their original configuration.

Figure 110 Typical chimney

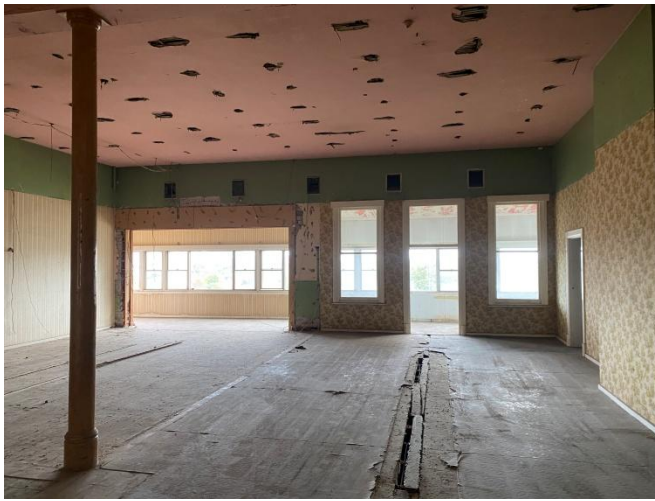
Figure 71 Existing condition of function room (1.103), wall to be removed on the right.

The amalgamation of three rooms into one large ballroom and the insertion of steel portal frames will alter the spatial character of this part of the building. However, the rooms in question have

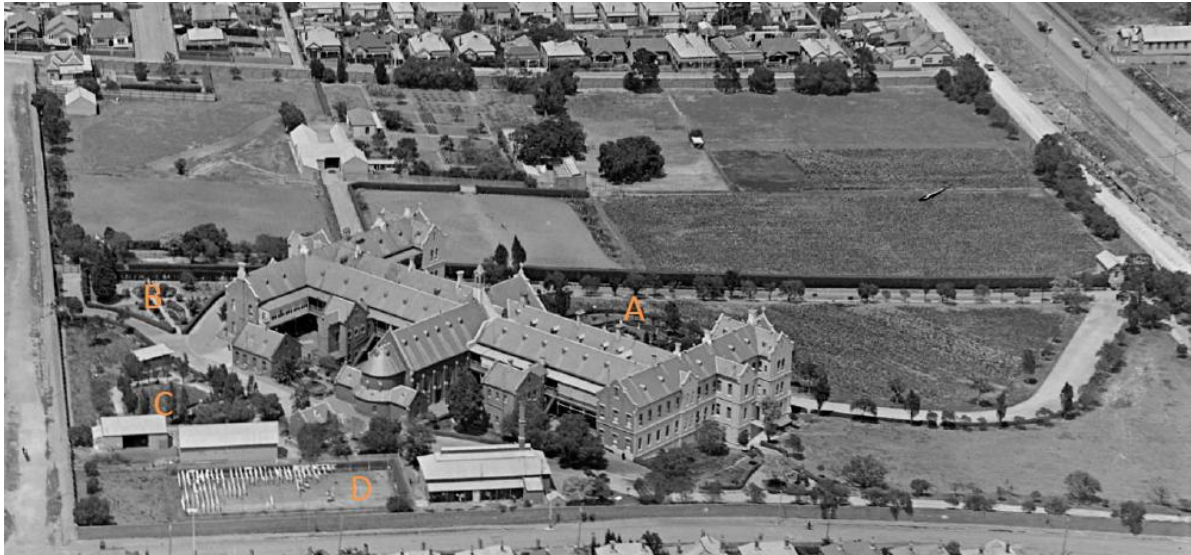
Figure 115 1928 Pratt aerial photograph of the site.

A – formal garden with a statue on the central axis of the church

E – ceremonial drive

F – farmland

The 1928 Pratt aerial photograph reveals three distinct areas of formal landscaping that punctuate an otherwise functional setting. The most prominent garden occupied the central axis of the monastery, now the site of the Greek Australian War Memorial. A circular lawn surrounded by cypress trees and a perimeter path was located to the south of the mortuary chapel, and a triangular garden with a statue was positioned near the current site of St Justin's Wing. These gardens suggest a modest but intentional approach to landscape design, reflecting both monastic formality and the domestic routines of the institution.

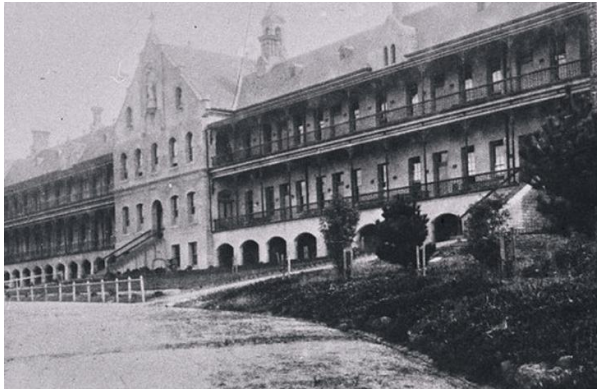
*After completion of the third stage, loggia still open*

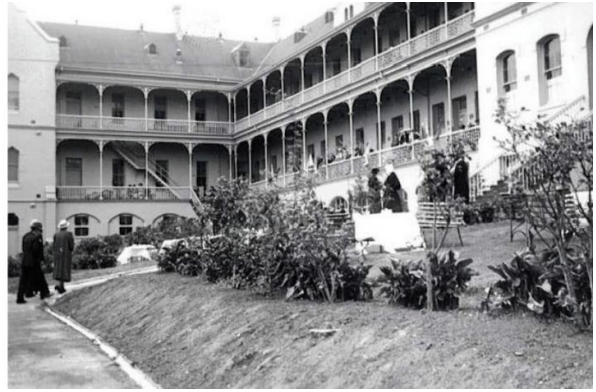
*Mid 20thc loggia closed in*

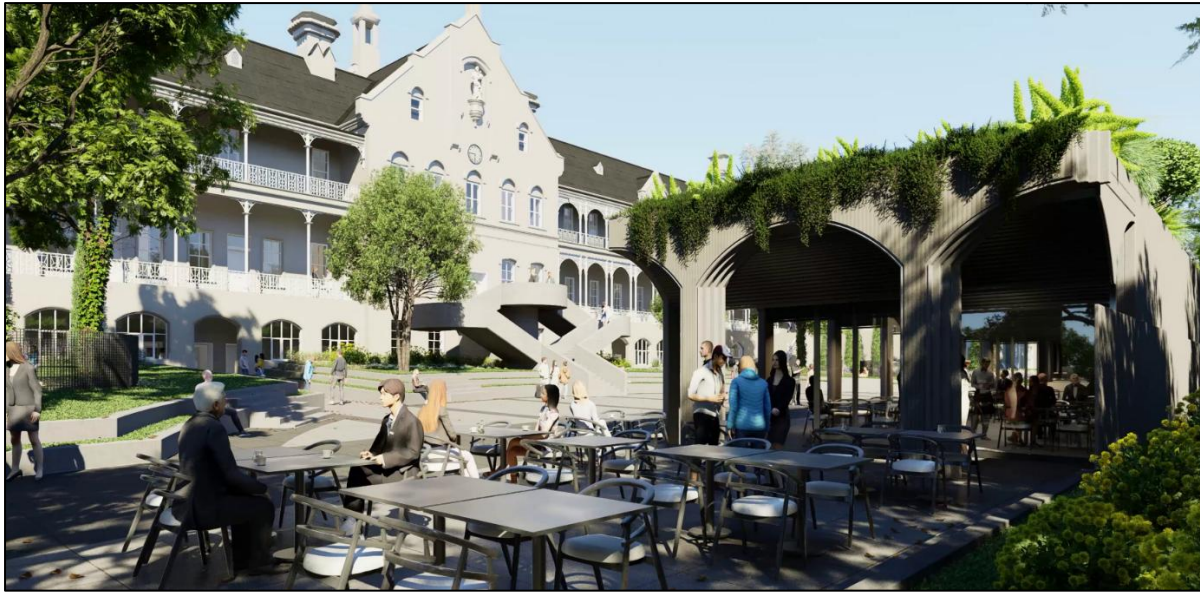
Figure 119 Proposed design of Platia viewed from the west end of the restaurant.

The restaurant and café have been relocated to the *Platia*, encouraging both formal and casual gatherings. Positioned opposite the berm, they form an active edge to the forecourt and help extend the sense of public space outward from between the wings.

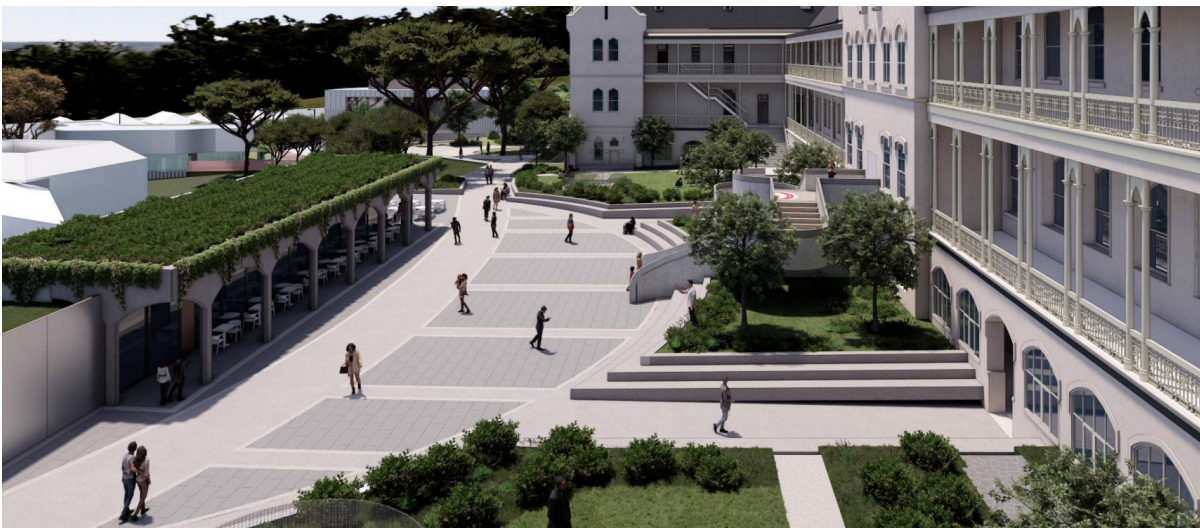
Figure 120 Proposed design of Platia viewed from the first-floor verandah of the south wing.

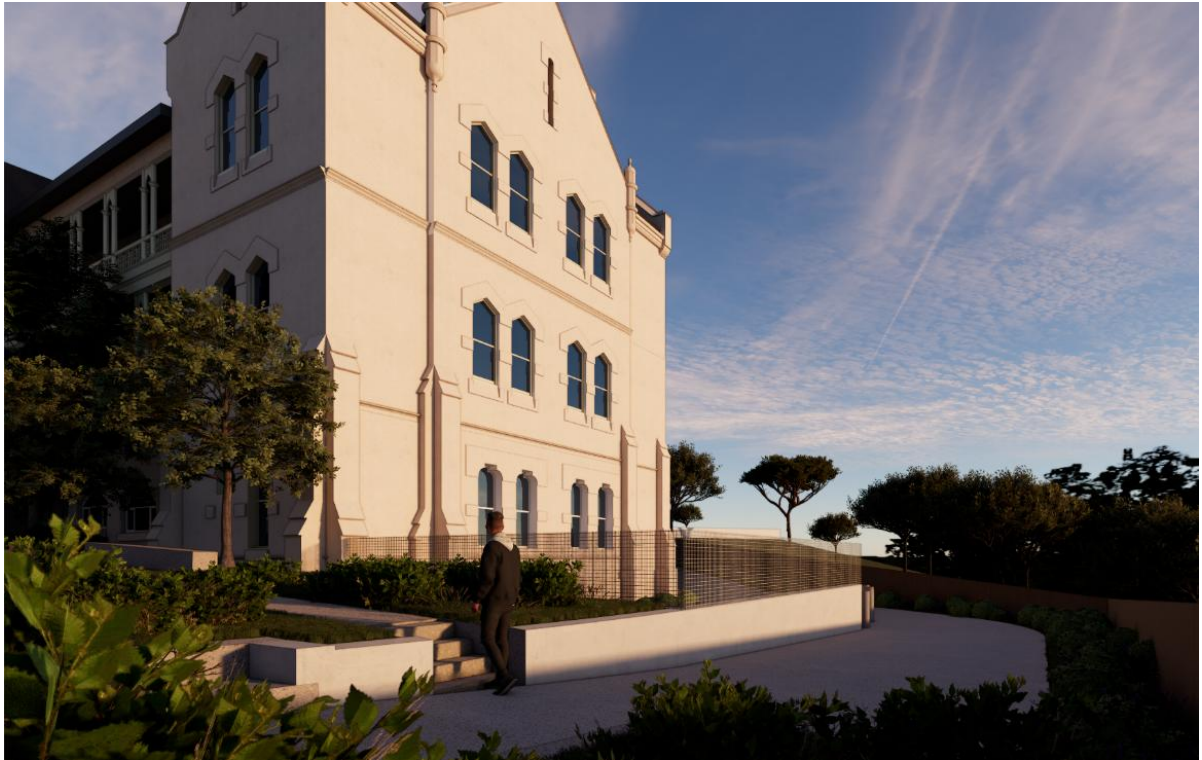
The mixed use and perpendicular alignment of this drive are difficult to resolve aesthetically and functionally. However, the carpark and bin store have been discreetly integrated into the base of the adjacent apartment building, and the entry to the *Platia* carpark, though more visible due to limited space, has been designed to minimise visual impact.

Figure 128 South wing pavilion and basement carpark entry viewed from the Platia.

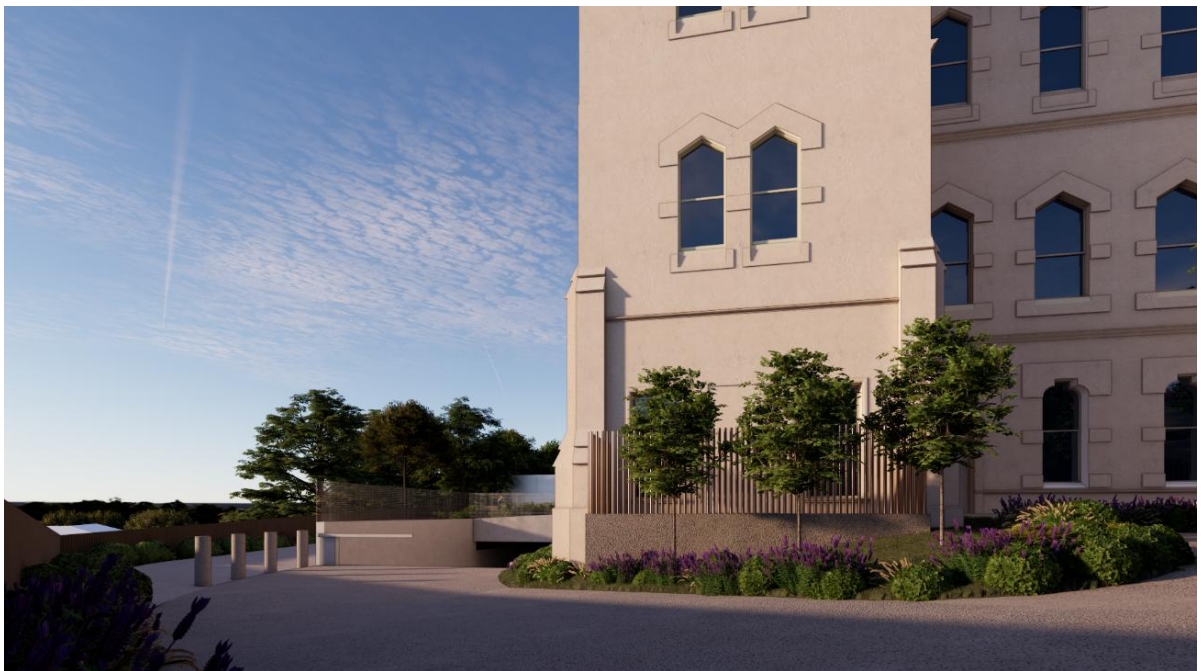
Figure 129 South wing pavilion viewed from the road descending from Hartington Street

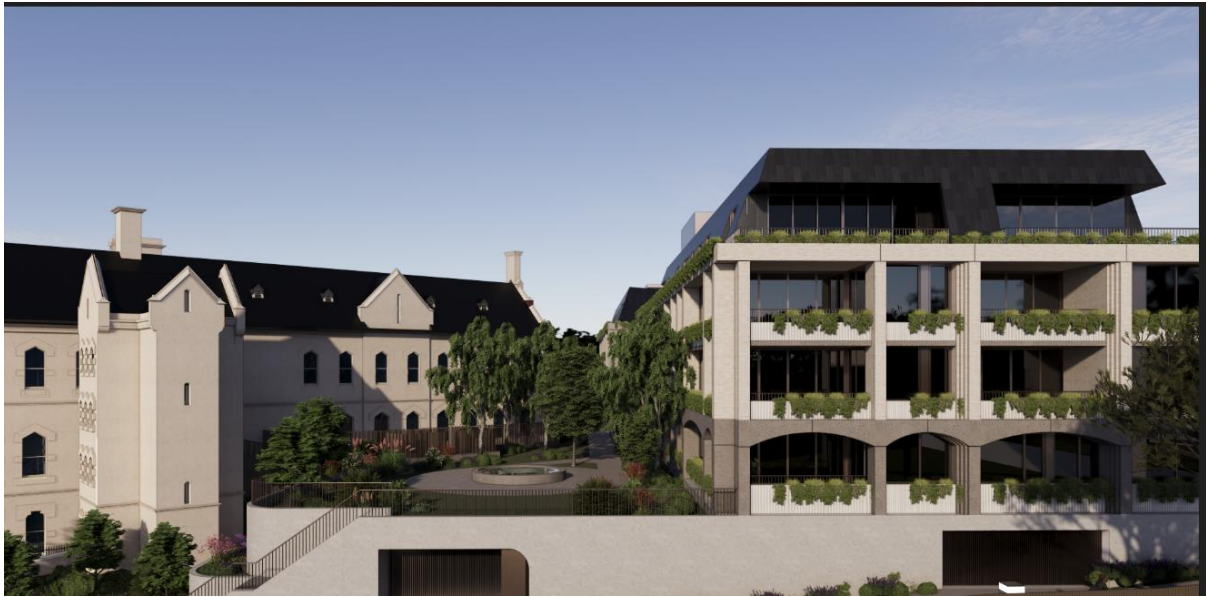
Figure 130 high view from the Hartington Street drive showing the relationship between the monastery and apartments

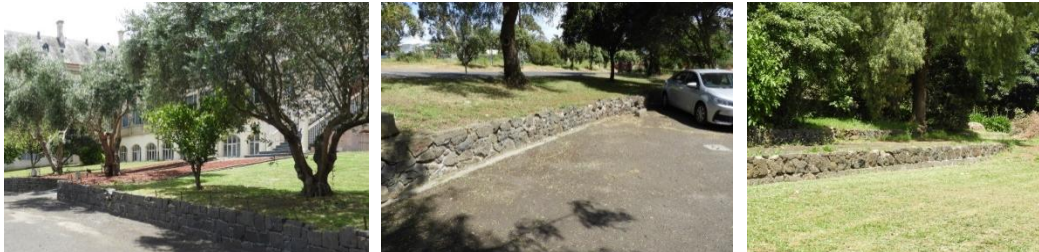
Figure 76 existing hard landscape features

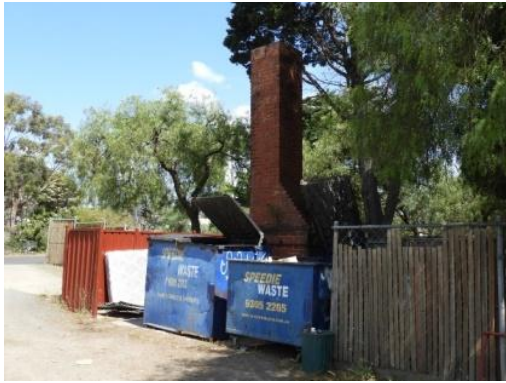
Incinerator in front of mortuary chapel (D)

Other landscape elements perform their functional roles but are otherwise unused. The incinerator is no longer operational. Overall, the walls and terraces remain structurally sound, although some areas of brickwork are in a state of decay.

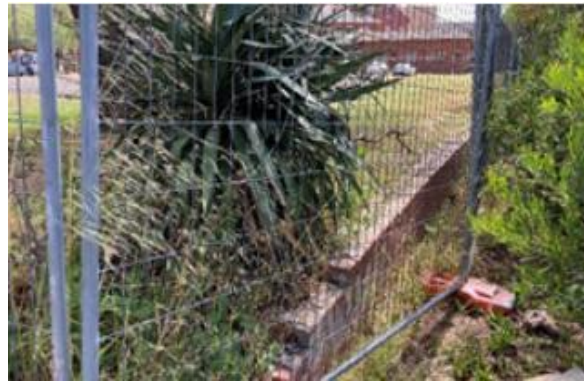
Remains of perimeter wall on Hawthorn St (S)

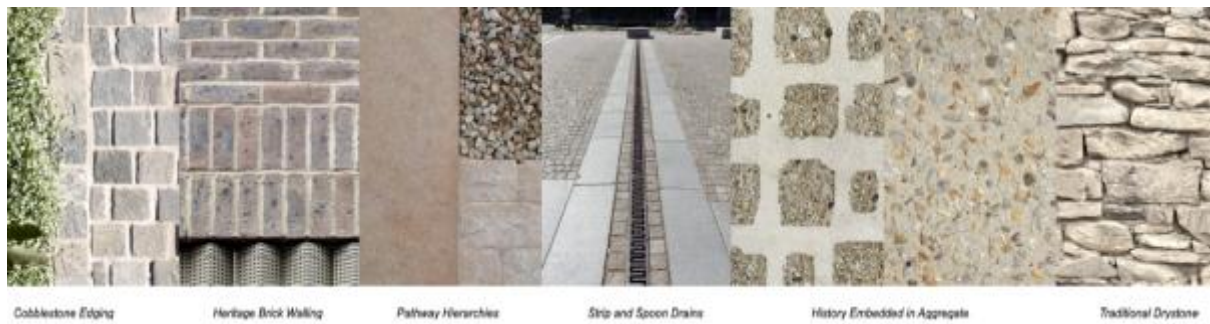
Figures 136 Proposed landscape palette

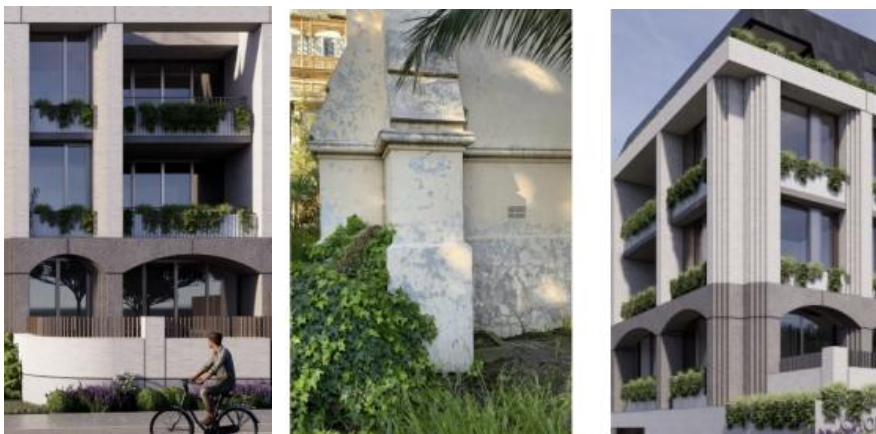
The upper level is expressed as a modern interpretation of a mansard roof. The walls are set back and raked, clad in black slate to reduce their visual prominence while referencing the pitched slate roofs of the monastery.

Figure 139 Render of mansard and monastery forms

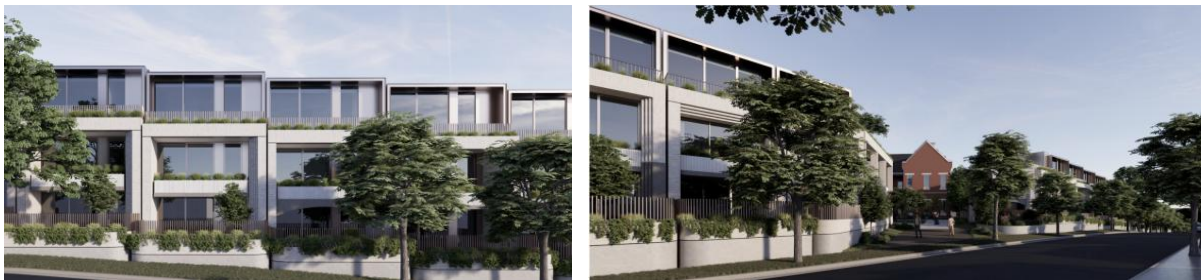
The architectural language of the townhouses aligns with that of the apartments. The upper level is lightweight in appearance and set back to minimise visual impact on the streetscape, while the ground and first floors are framed by a heavier smooth concrete portal structure that encloses both levels. The raised garden bed and low fence act as a visual plinth, anchoring the buildings to the street.

Figure 143 Renders of the townhouses showing individual units with front gardens and walls to the street

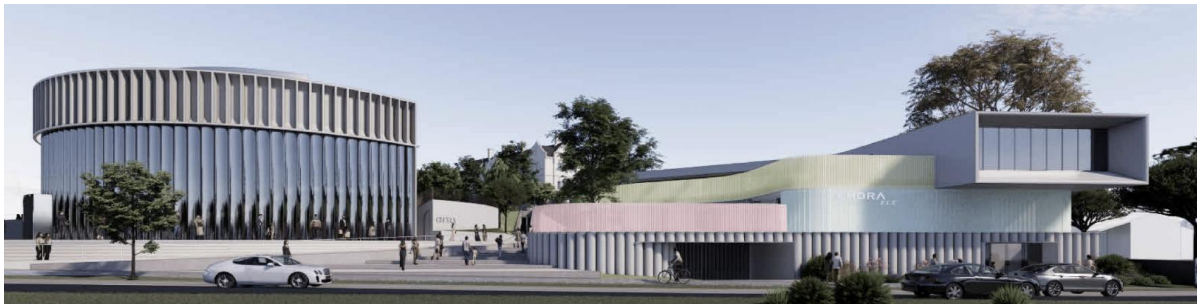
*Figure 146 View from St Georges Road. The decks of the Early Learning Centre are oriented up St Georges Road, while the cylindrical form of the theatre captures attention before directing views back toward the monastery.*

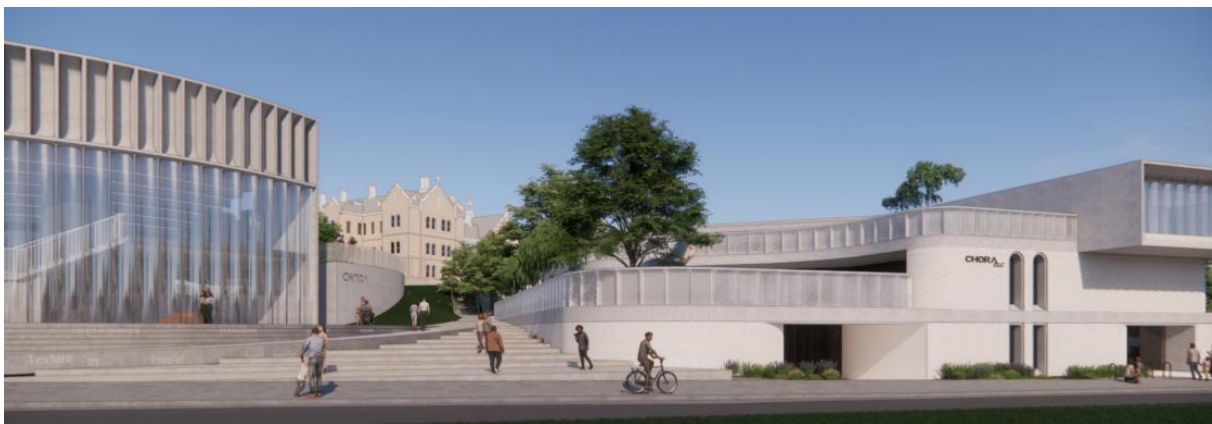
*Revised St Georges Rd Elevation – The ELC plan remains the same, but the St Georges Rd elevations of the building now share a language with the monastery building, while the balustrades and the curvilinear forms continue to share a language with the theatre. The colours have been removed and the solid cream masonry walls, horizontal banding and articulated arched window openings now clearly reference the monastery. The articulated window openings use a similar rationale to the restaurant cloister and the combination of cream brickwork and concrete replicates the use of materials in the apartment and townhouse fencing, helping to create a cohesive architectural language across the site.*

The Early Learning Centre (ELC) occupies the south-west corner of the site opposite the theatre and assists in directing views toward the monastery along the central pedestrian path. It forms part of the St Georges Road sub-precinct and, together with the theatre, defines the public edge of the development. Positioned within the irregular portion of land created by earlier subdivision, the ELC addresses both the street and the site interior, forming a visual and functional transition between the public domain and the quieter internal spaces.

The uppermost level is expressed as a rectilinear box projecting toward the street. This element provides balance to the cylindrical form of the theatre and reinforces the legibility of the ELC as a contemporary civic building.

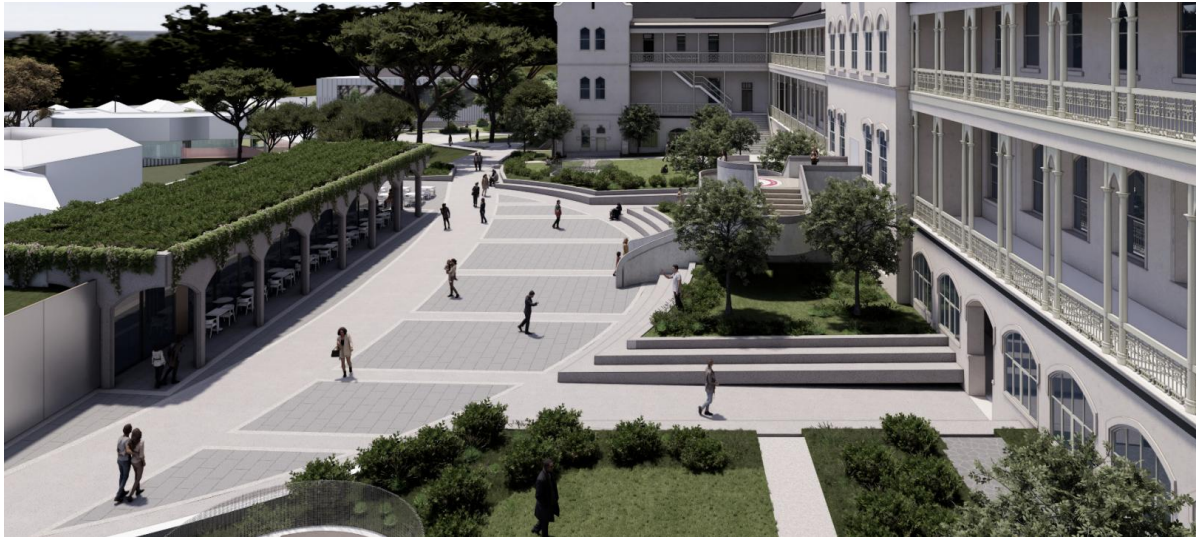
Figure 148 The aerial view illustrates the complementary bay structure at ground level and the strong open edge to the *Platia*

A low, single-storey restaurant and café is proposed along the western edge of the *Platia*. The design adopts the form of a cloister or *stoa*, functioning as an open arcade that echoes the rhythm and proportions of the monastery's loggia opposite. The layered façade allows the paved forecourt to flow seamlessly into the building, extending the public plaza while maintaining a light, transparent edge. Patrons will experience a strong sense of connection with the *Platia* whether seated inside behind the glass wall, within the covered verandah, or in the outdoor seating area. From above, the green roof will visually merge the building into the surrounding landscape of the berm and reinstate a green space in the location of the former garden in front of the chapel. The meadow species specified for the green roof will also evoke the original farm paddocks. From below, the repeating bays of the loggia and the restaurant will form a consistent architectural frontage that defines and activates the edge of the *Platia*.

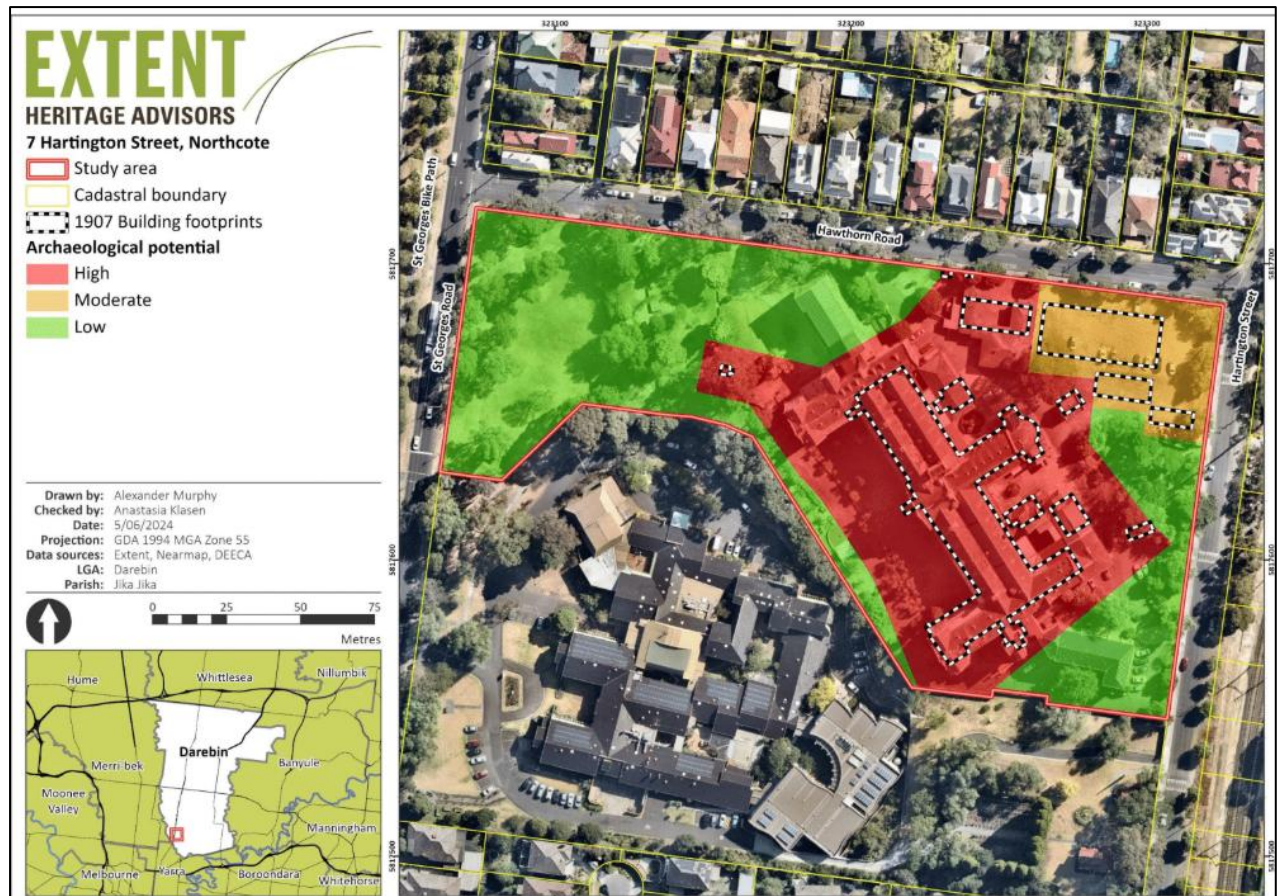
Figure 78 Extent mapping of zones of archaeological potential

No excavation works are proposed under the monastery building except potentially behind the east wall of the basement corridor to alleviate moisture problems. Where new buildings and basement carparking is proposed, excavation to a depth of several meters will be required. The removal of the multi-storey accommodation blocks will also result in substantial ground disturbance. Further archaeological will be commissioned to meet the requirements of the permit.

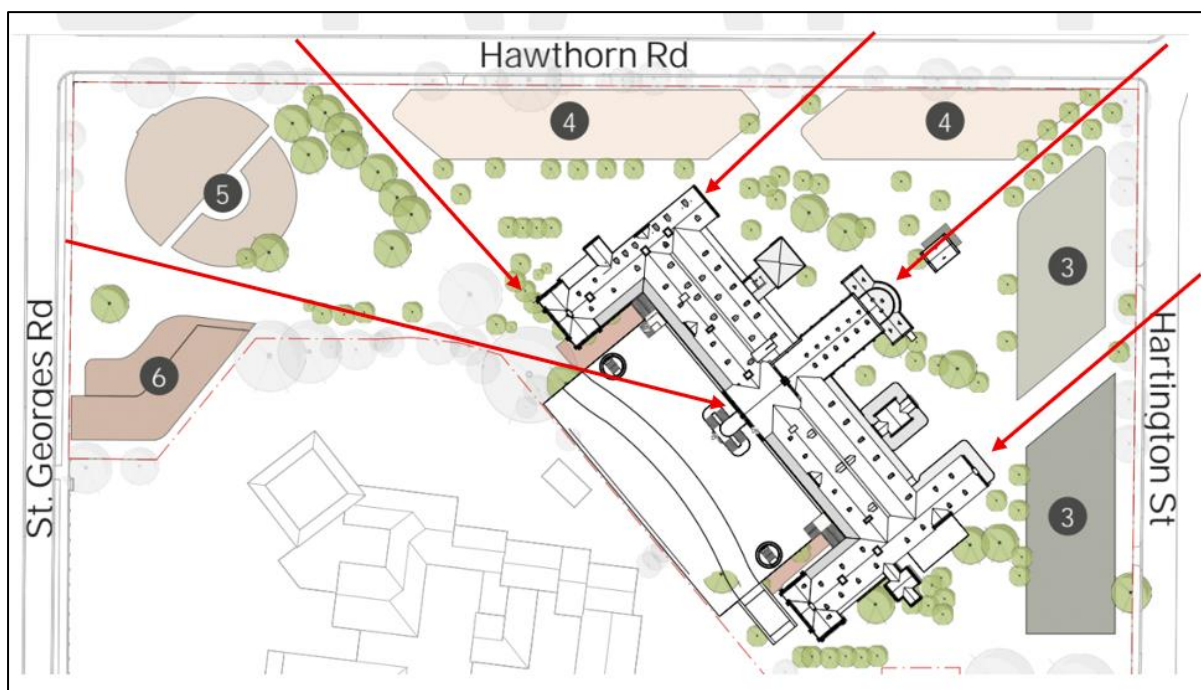
Figure 151 Diagram illustrating new sightlines into and through the site

The proposed masterplan re-establishes the building's visual primacy by framing new views and reintroducing processional approaches. The landscape and circulation design direct movement and sightlines toward the monastery, reinstating the sense of arrival once achieved by the grand drive from St Georges Road. Entry paths from Hawthorn and Hartington Streets are oriented along the building's diagonal geometry, which dictates the division of new building blocks and ensures the monastery remains the visual and compositional focus of the site.
