Arboricultural Impact Assessment

Tree/s Location: Carlton North Primary School 60 lee Street, Carlton North

Inspection date: 18 September 2024

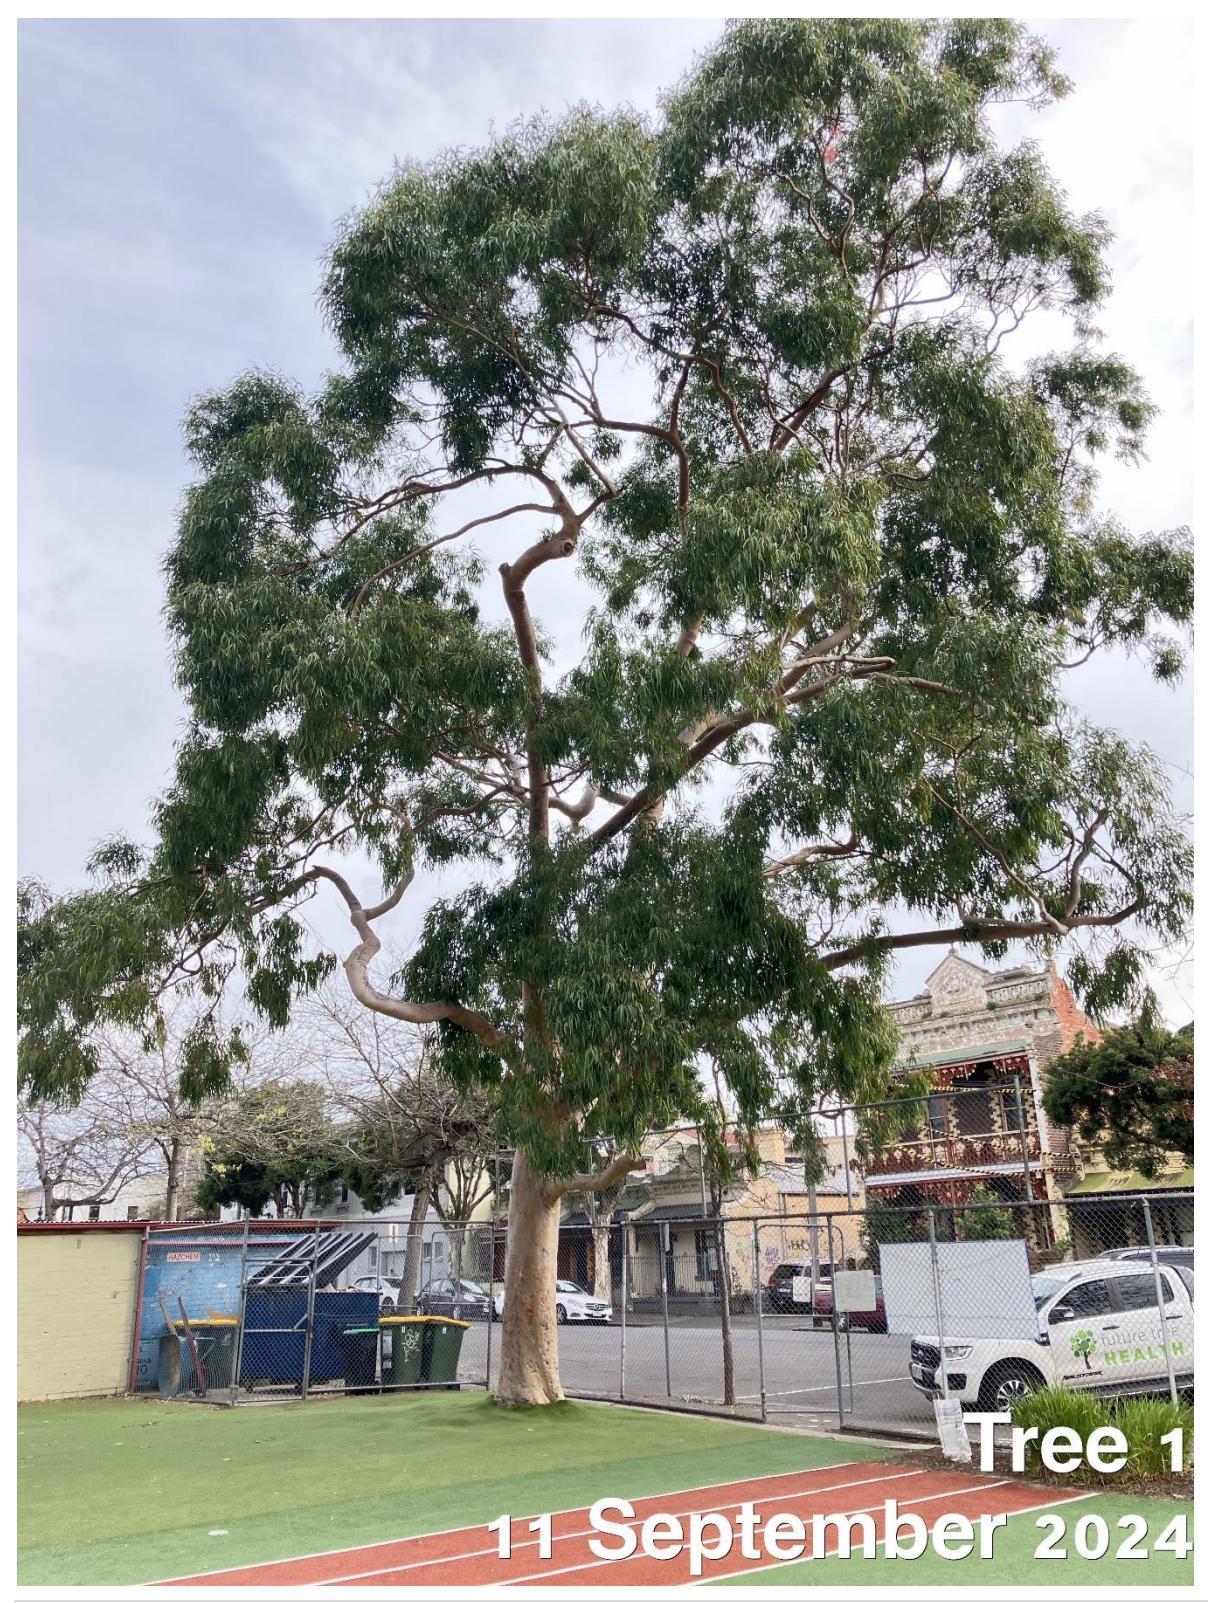
Tree # 1 Angophora costata Smooth-Barked Apple Gum

- Tree 1 is proposed for retention alongside the development plan.

- This tree will receive major encroachment greater than 10% of the TPZ resulting from the development plan. This has been mitigated to an acceptable level through lifting the floor level of the building above ground level and the use of screw piles. The screw piles will be approximately 180mm x 180mm and excavated to a depth of 500mm. we confirm that the tree will remain viable alongside and subsequent to the development however only excavation for the screw piles can occur within the TPZ.
