## **TRAM MAINTENANCE AND STABLING FACILITY**

### **RELOCATION OF MURAL**

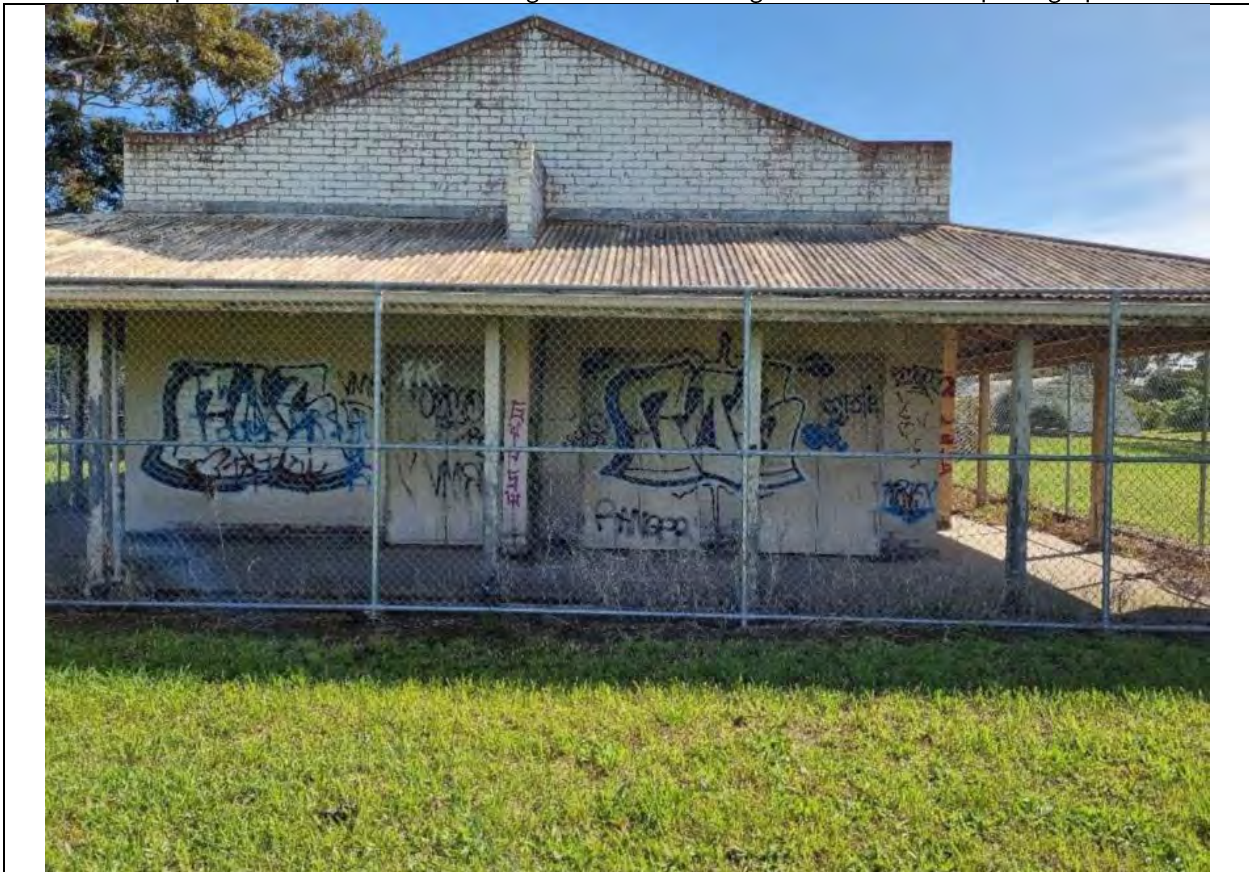
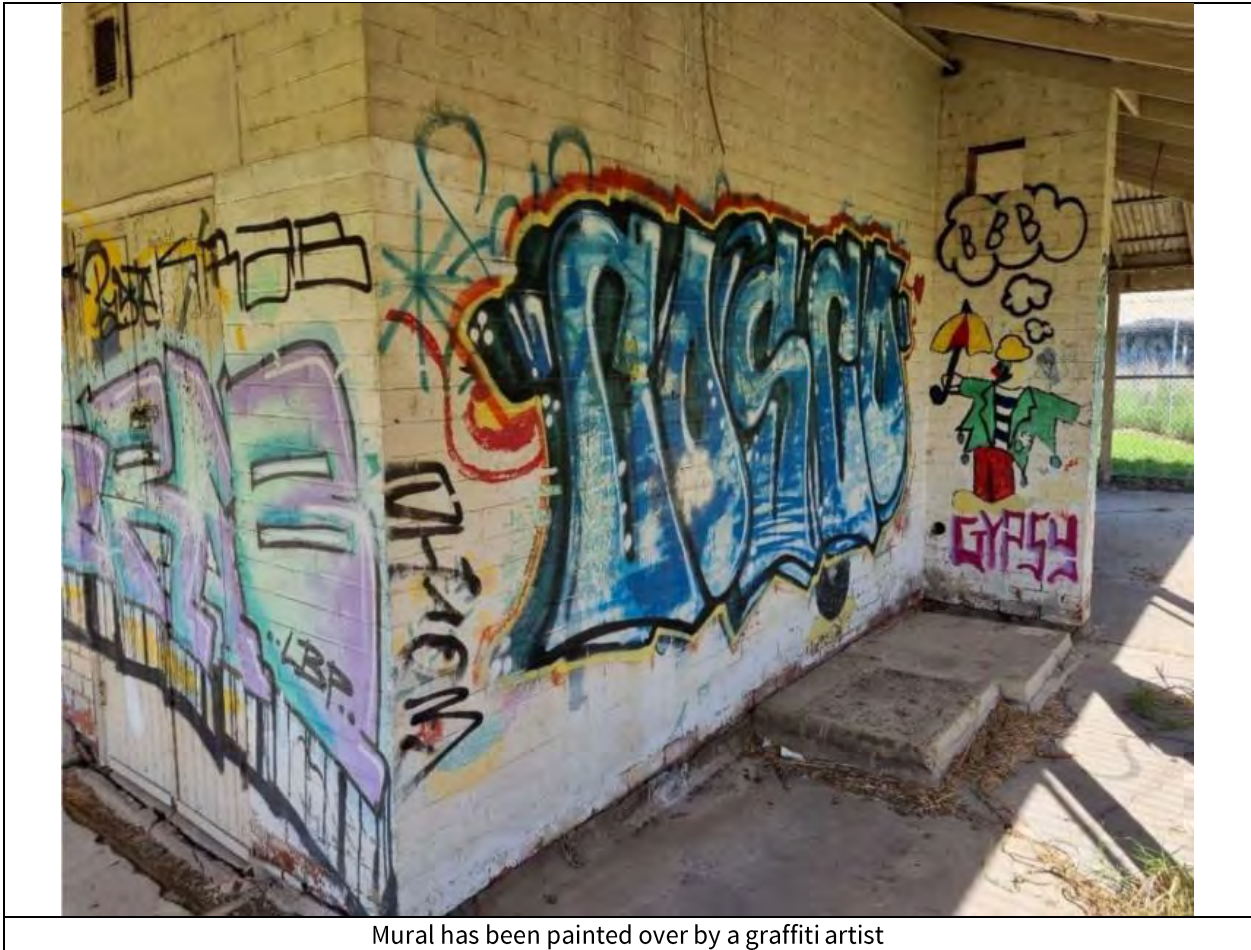
The murals are painted on double brick buildings. The brick building is illustrated in the photograph below.

From a structural point of view the walls are double brick founded on a concrete slab. A veranda surrounds the building on four sides. The side walls are approximately 8 m long by 3.2m high.

The wall housing the mural is in relatively good condition and we believe that it can be safely extracted from an existing building
