## **HERITAGE IMPACT STATEMENT** **for the**

### **Conservation Strategy to Dismantle, Restore and Relocate the Traill Fountain, Geelong Botanic Gardens**

**H2095 Eastern Park and Geelong Botanic Gardens  
[S2 Traill Fountain]**

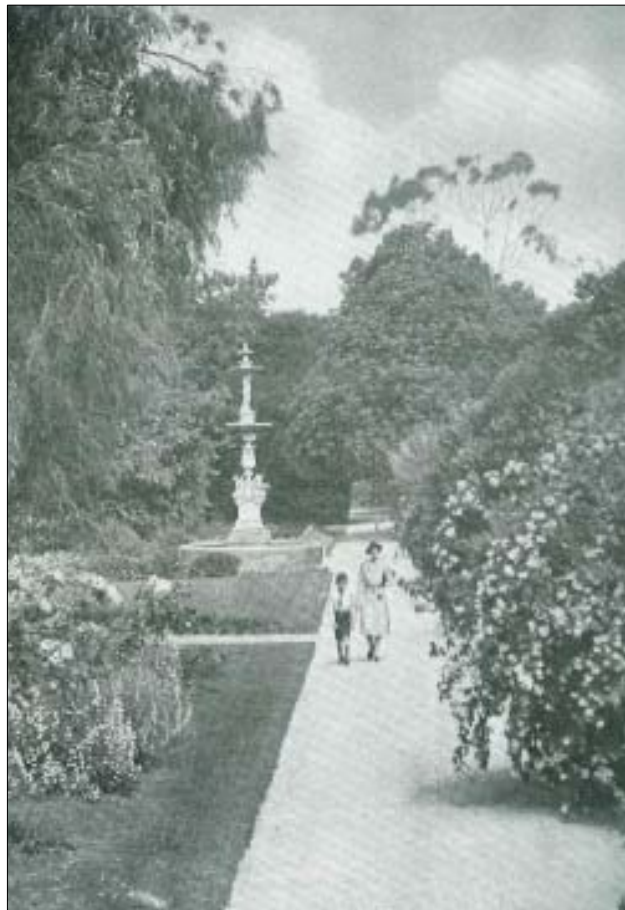
*Traill Fountain in the Geelong Botanic Gardens c1930  
(source : George Jones, Growing Together)*

*A tall and elegant concrete fountain of graceful proportions, comprising a square base surmounted by two-tiered pedestal and basin forms with decorative motifs of dolphins, swans, acanthus leaves, an urn and a semi-clad woman. The fountain is painted off-white/ cream and sits within a small round pond. It is awkwardly*

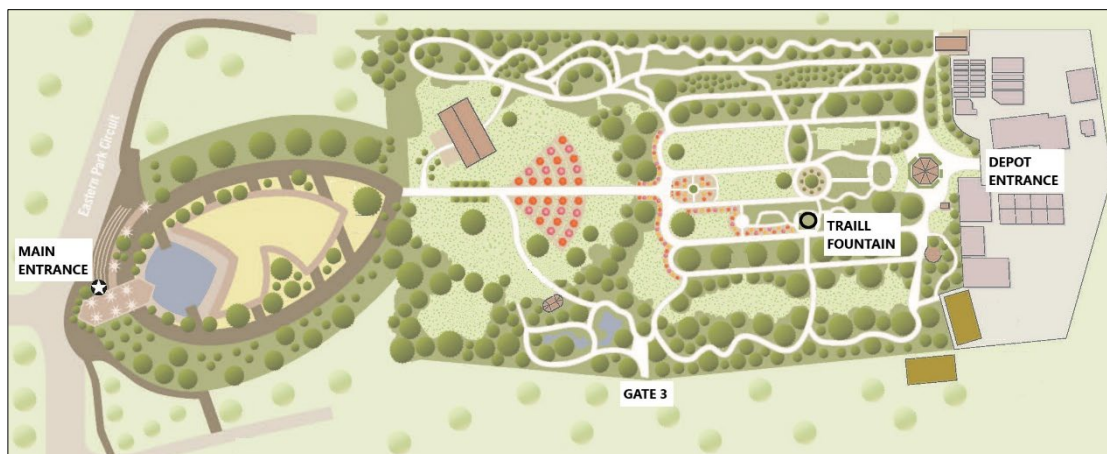
The Traill fountain is located in the Geelong Botanic Gardens (refer to *figure 1* below), in a densely planted section of the gardens. The fountain is between parallel paths that run north west to south east in the central section of the gardens and it is south east of the Hitchcock fountain which features on the central axis through the gardens.

*Figure 1 – Geelong Botanic Gardens map with entrances identified and location of Traill Fountain*
