ARCHITECTURAL NOTES:

EXISTING FENCE & GATE CONDITION CURRENTLY ONSITE

PROPOSED GATE CONDITION

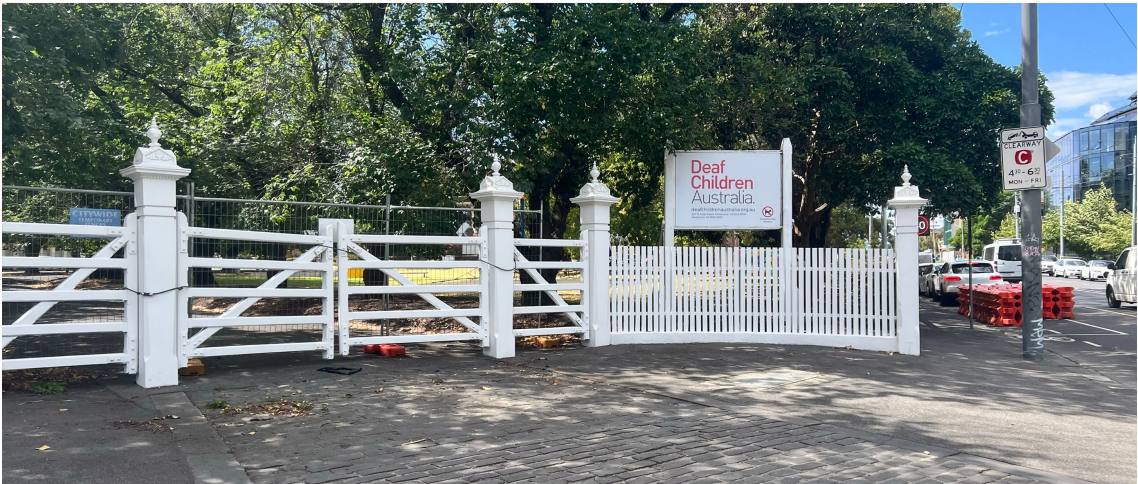
EXISTING FENCE & GATE CONDITION CURRENTLY ONSITE

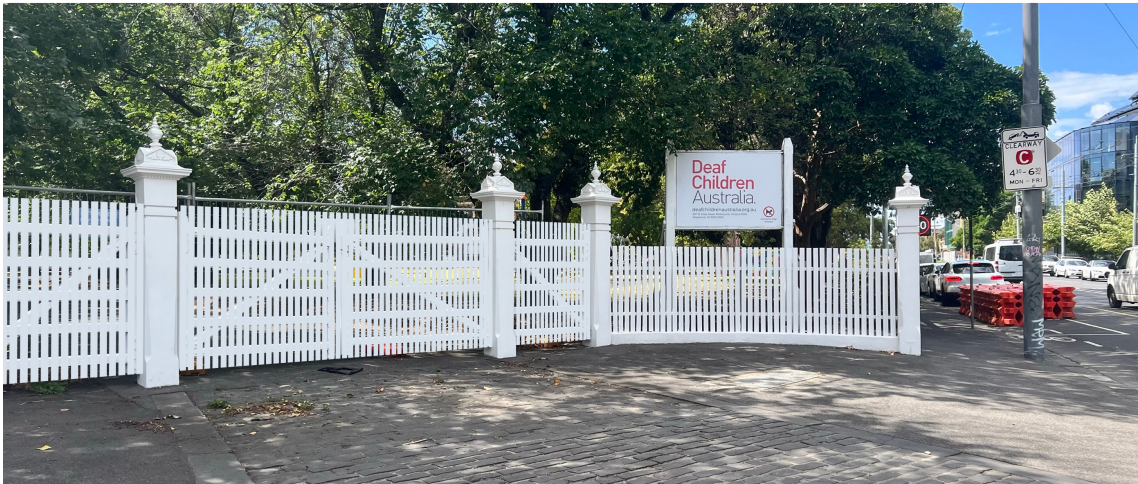
PROPOSED GATE CONDITION
