Michael Tuck Stand

Glenferrie Oval

### Michael Tuck Stand Landscape Legend

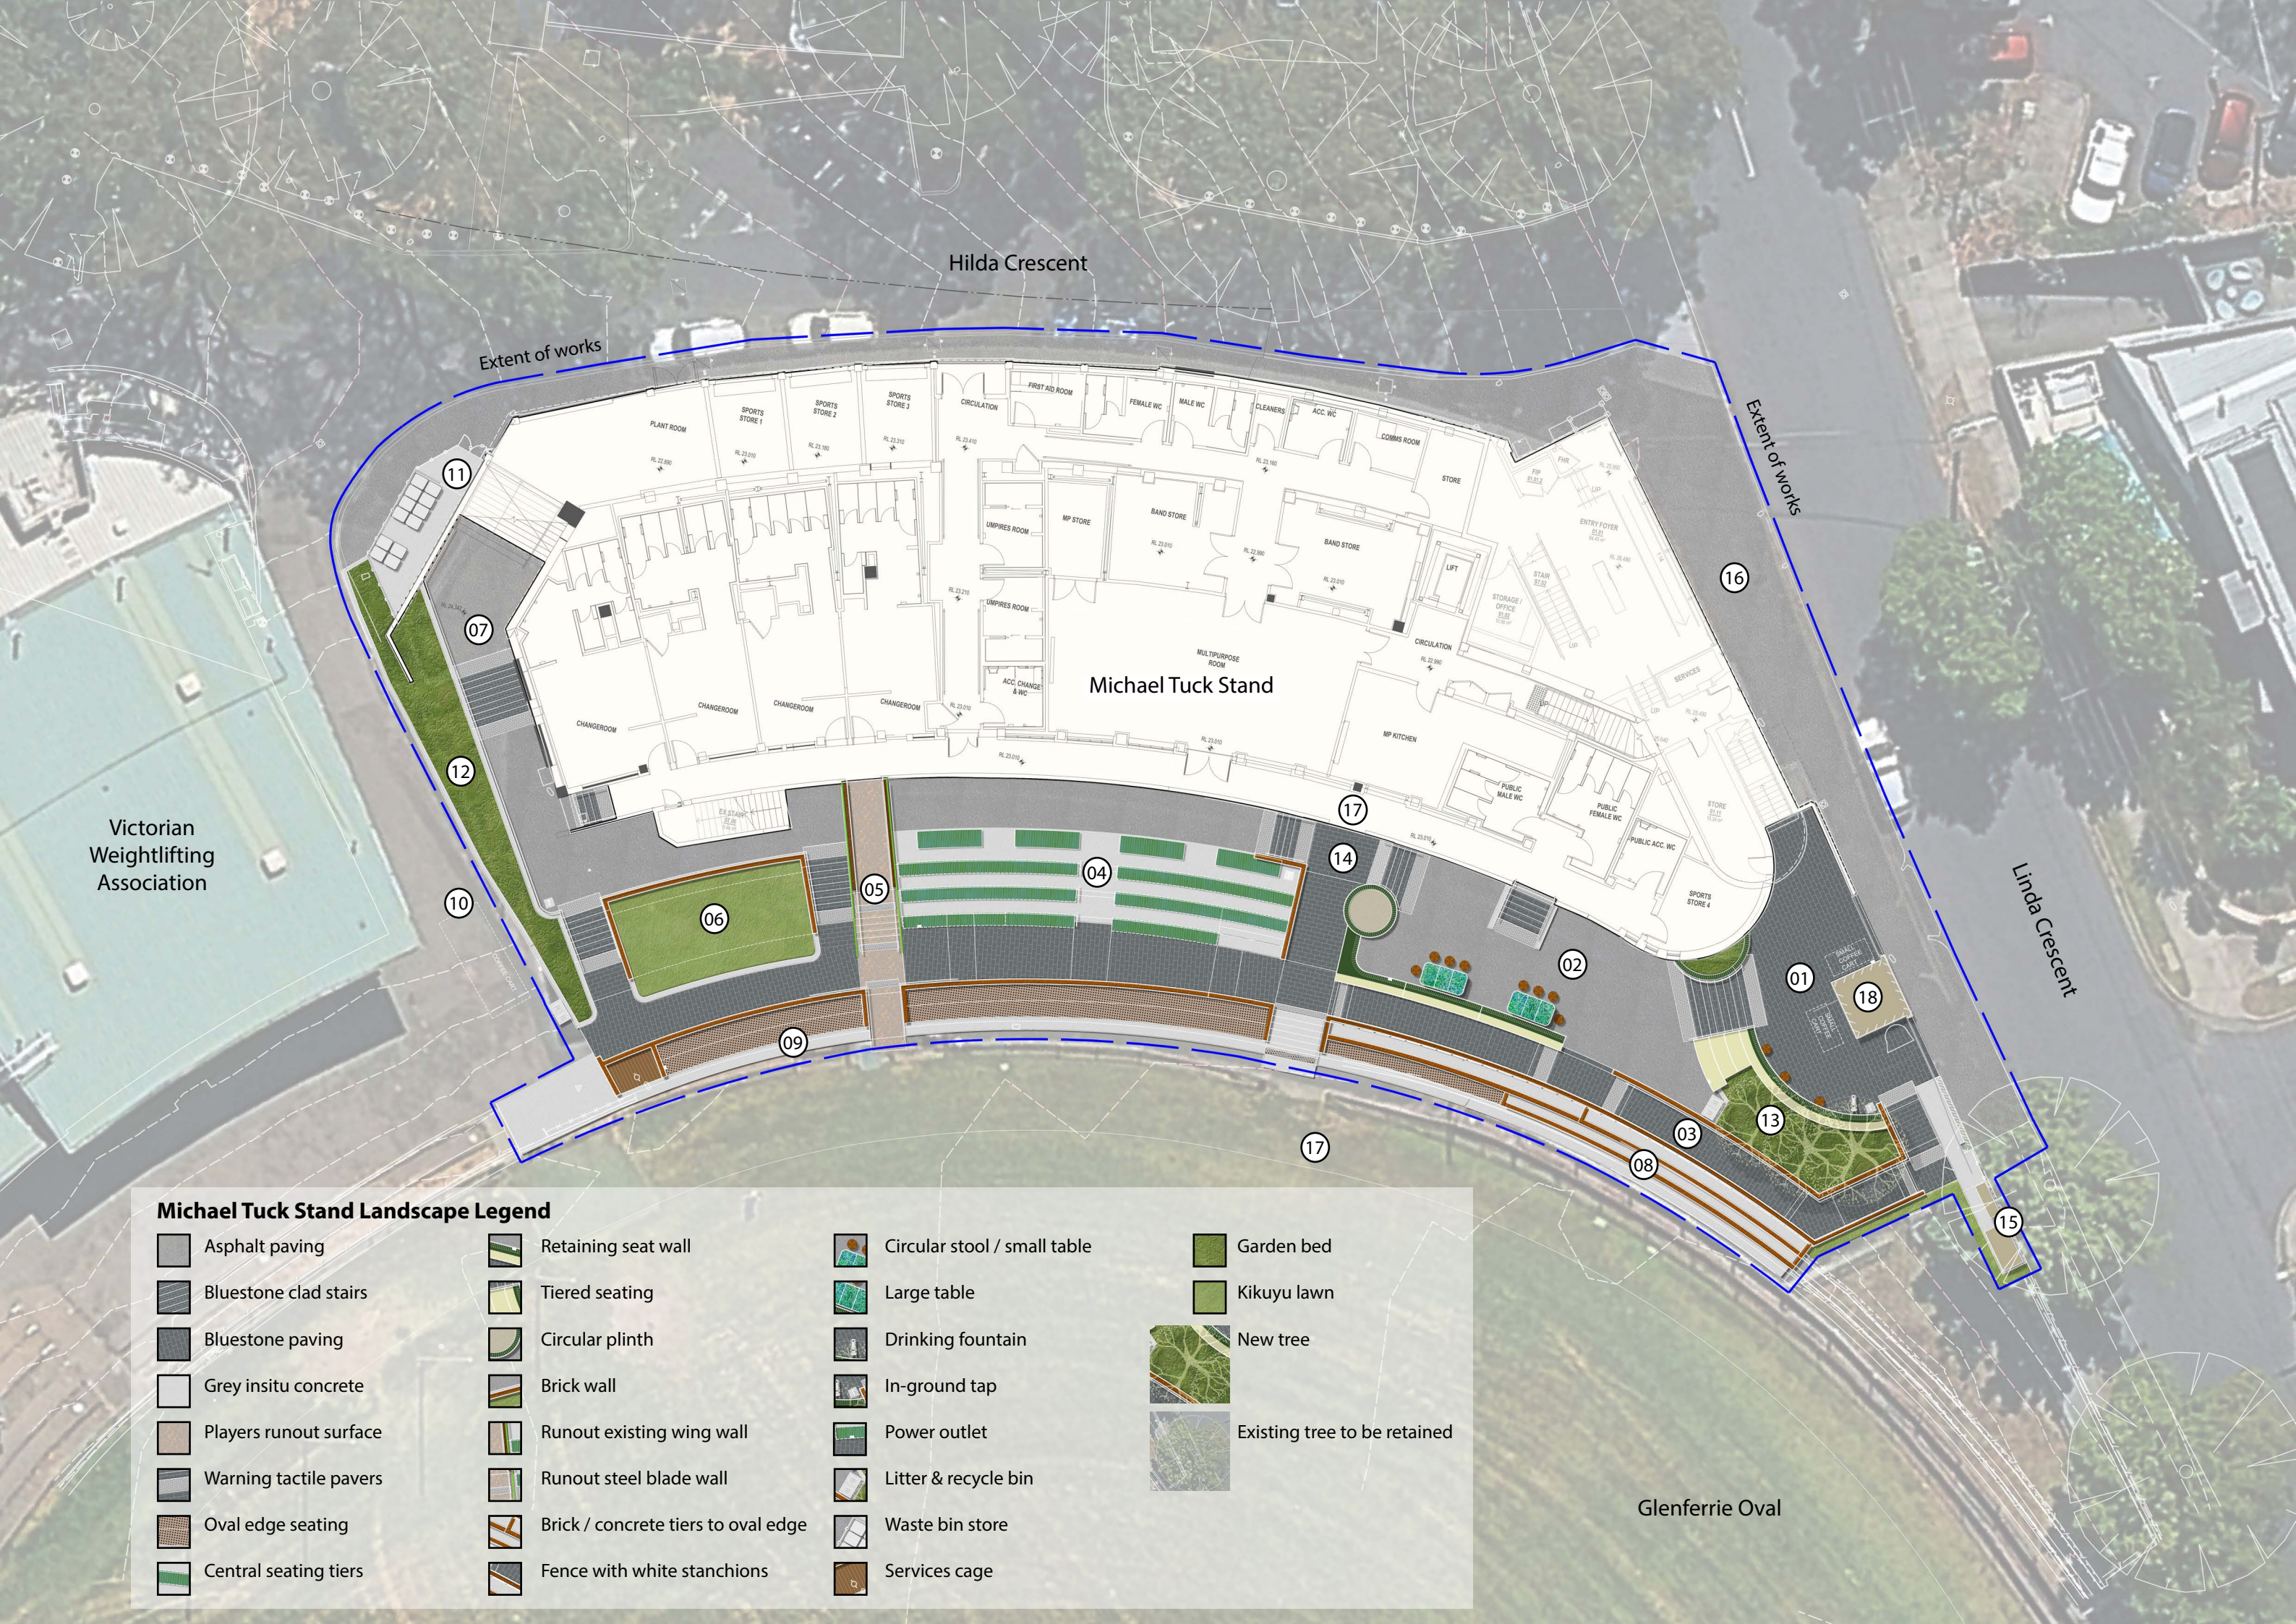
**Michael Tuck Stand Landscape Key Notes**

Linda Crescent entry with glazed brick seat wall, custom circular tables and drinking fountain.  
Space & power outlets have been allocated for events stall or coffee cart.
- 02**

Kiosk Terrace with seating and outdoor tables to cater for club, community and arts events, everyday recreation, fitness and social uses. Stair access is provided to Michael Tuck Stand public toilets.
- 03**

DDA ramped access from Linda Crescent entry to south east area
- 04**

Central tiered seating with painted timber seating
- 05**

Players runout path with slip resistant surface which protects players’ boot studs.  
Heritage brick runout wing walls are retained beside new retaining steel blade walls.  
DDA compliant grade access to oval with stairs, nosing and tactile indicators.
- 06**

New oval edge seating to match existing voal edge brick and concrete terracing. New handrails designed to reflect historic oval fencing (white posts, galvanised rails and chain link)
- 09**

Oval edge perforated steel sheet seat tiers over insitu concrete paving where located within floodzone
- 10**
