Re: P36571 - 97 Drummond Street, Carlton, Drummond Terrace (H0872)

I write with regard to the abovementioned permit application for 97 Drummond Street, Carlton, (which forms part of Drummond Terrace (H0872)) and a Request for Further Information (RFI) issued by Heritage Victoria on 2 September 2022. The RFI requested the following information:

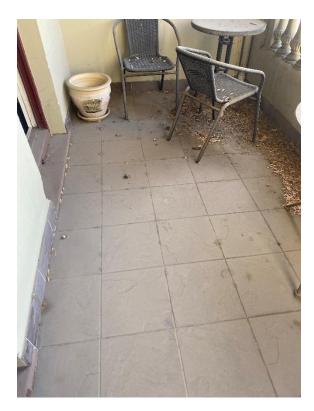
The first and second floor balconies currently have modern tiling (see Figure 1 and Figure 2) and while the date of this work is unclear, the fabric is evidently a later addition to the property. The balconies would have originally contained timber boards as is consistent with others in the terrace row, such as at no. 99 (Figure 3).

Figure 1 Modern tiling to the first floor balcony Source: Stoll Architecture

Due to the uncertainty of any extant fabric beneath the modern fabric, the tiling will be carefully removed during construction works, and should any extant timber boards be discovered, they will be retained and made good as opposed to replacement where possible. Any extant timber boards damaged beyond repair will be replaced with as close a match as possible. The aim of the proposal was to

Should modern fabric be discovered beneath the tiling with no evidence of the earlier timber boards, the tiling will be replaced with tongue and groove jarrah floorboards (as proposed) to reinstate a more appropriate floor finish that is sympathetic to the style and era of the building.

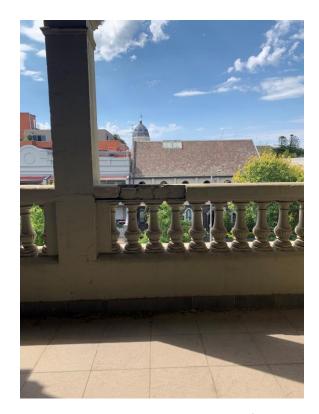
Correspondence from the Department of Education held in the Anglican Diocese of Melbourne Archives indicates that concrete was poured onto the top floor balcony in 1948. As such, it is unlikely that any original timber boards are extant below the modern tiling, which would be laid over the concrete slab. There was no record of concrete being poured over the first-floor balcony, however, it is possible that the detail was matched to the upper floor level when modern tiling was laid.

Figure 2 Modern tiling to the second floor balcony

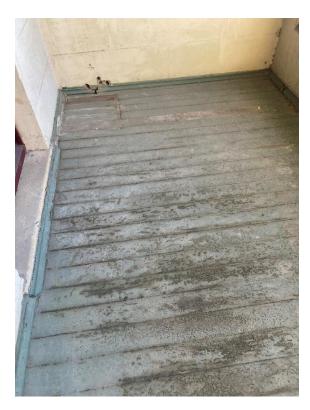
Figure 3 Original timber floorboards to the balcony of 99 Drummond Street Source: Stoll Architecture
