# Barwon Aqueduct

## Structural Engineering and Risk Assessment Report

Reference: BAR-HVP-REP-001

Issue for Permit | 28 August 2025

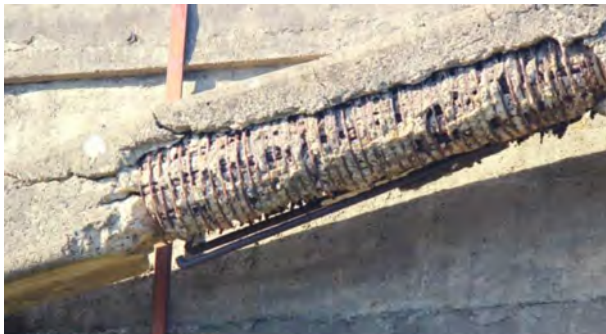
- In approximately 13x locations throughout the truss top and bottom chord of the bridge, main bar ends are visible and, in some cases, have detached from the core concrete. The bars appear to be splice points in the original structure. Bar ends that are visible are not anchored in the concrete matrix, and thus will not develop tension in the bar at the as-designed location. The exact effect of the development loss is difficult to quantify based upon visual review only, but is expected to have a significant effect on the load carrying capacity of these members and is thus a likely point of future failure. Refer Figure 4 for example.

**Figure 4 Example of reinforcement splice degradation (member ref 598)**

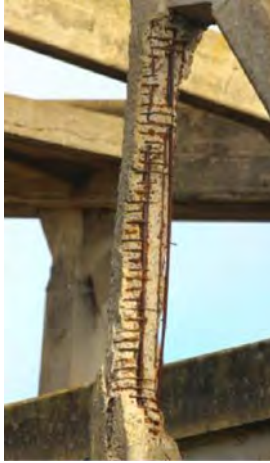
- Buckled main reinforcement - mainly in the thin vertical webs. This is evident where the reinforcing bars are no longer straight and have pulled away from the concrete core (typically coupled with loss of ligatures). Again, this effect has a significant effect on the load carrying capacity of these members. Refer Figure 5 for example.

**Figure 5 Example of main bar buckling (Member Ref 1032) – daylight visible between bar and core concrete**

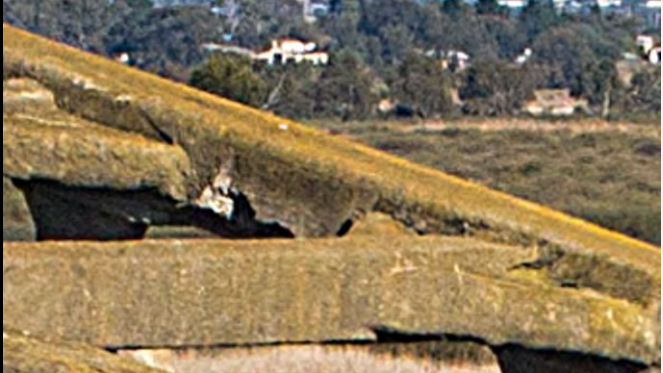
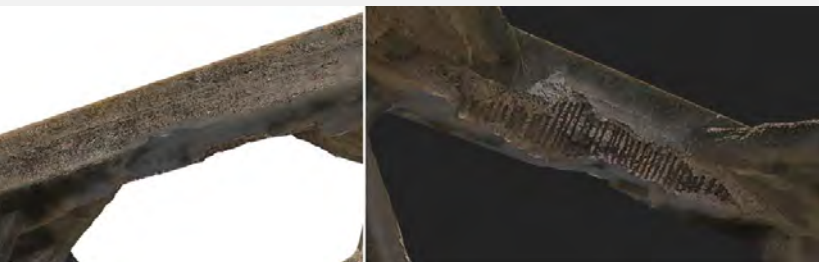
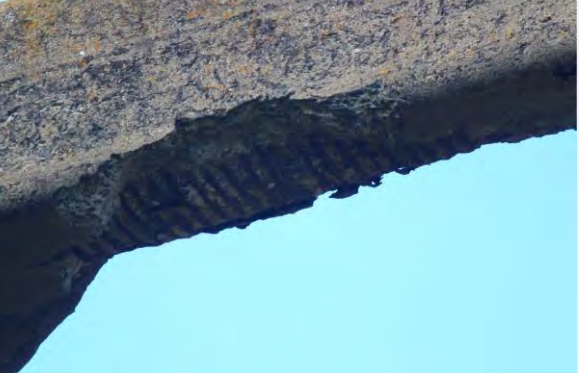
Member/Face Unique ID	Span/Pier Reference	Side	Component	Member Type	Original or previously repaired?	Condition Type - Glasshouse 03/2022	Images - Glasshouse 03/2022	Condition Type - Pointerra Point Cloud 12/2023	Images - Pointerra Point Cloud 12/2023	Condition Type - Matterport 07/2024	Images - Matterport 07/2024	Grade Change - Glasshouse 03/2022 to Pointerra Point Cloud 12/2023	Comments - Glasshouse 03/2022 to Pointerra Point Cloud 12/2023	Grade Change - Pointerra Point Cloud 12/2023 to Matterport 07/2024	Comments - Pointerra Point Cloud 12/2023 to Matterport 07/2024
20	Span 1 Nth	West	Truss	Top Chord 2		5

na		na	No signs of further degradation
29	Span 1 Nth	West	Truss	Btm Chord 3		5

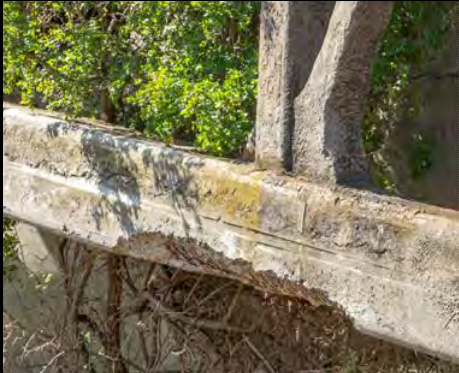
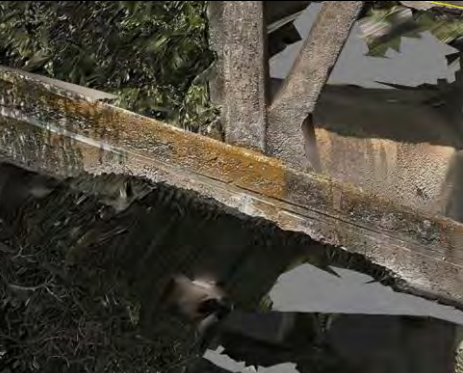
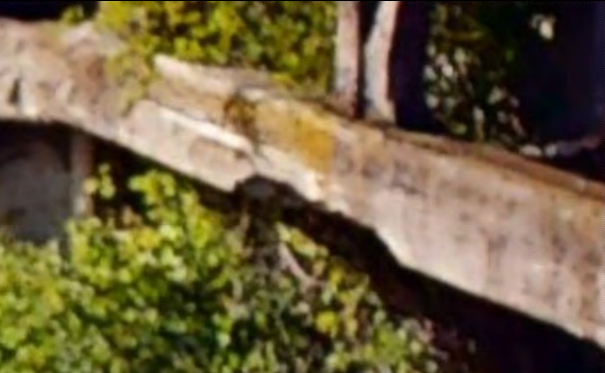
na		na	
30	Span 1 Nth	West	Truss	Btm Chord 4		5

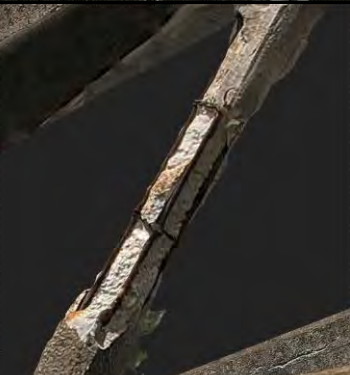
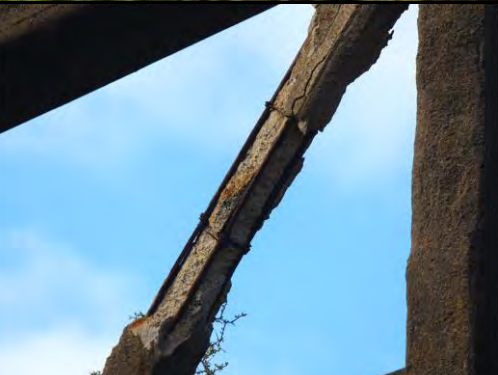
na		na	
41	Span 1 Nth	West	Truss	Diag Web 4	Shotcrete	5

na		na	No signs of further degradation

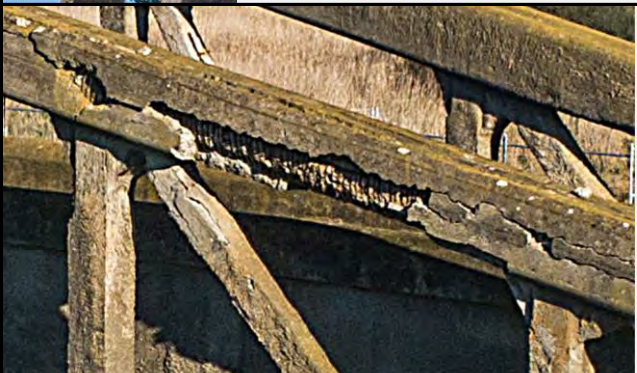
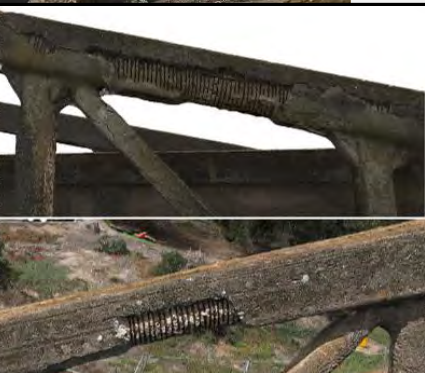
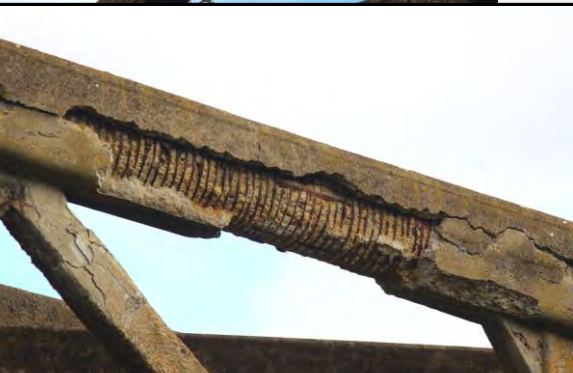
60	Span 1 Nth	East	Truss	Top Chord 5		5

na		na	No signs of further degradation
80	Span 1 Nth	East	Truss	Diag Web 5	Shotcrete	5

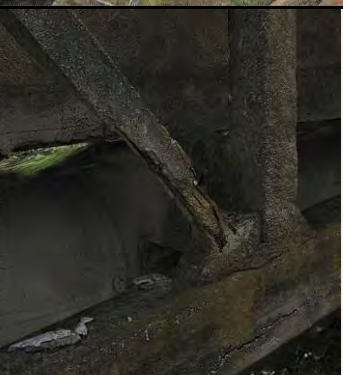
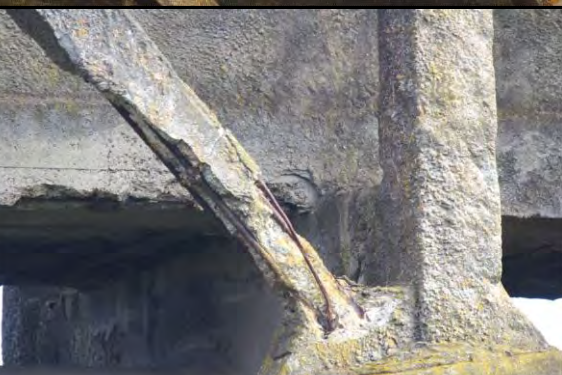
na		na	No signs of further degradation
127	Span 1 Sth	West	Truss	Btm Chord 2		5

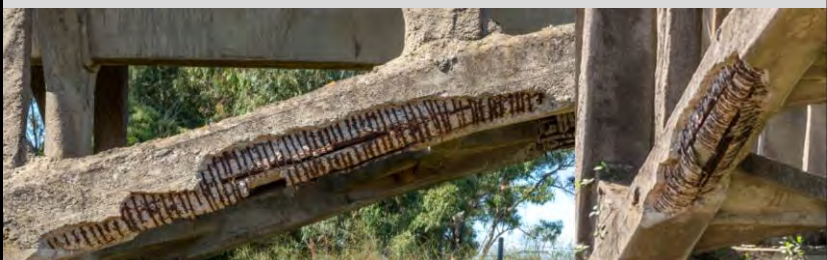
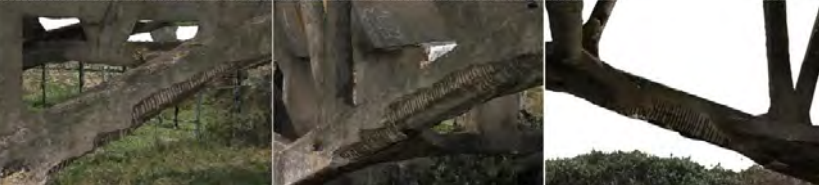
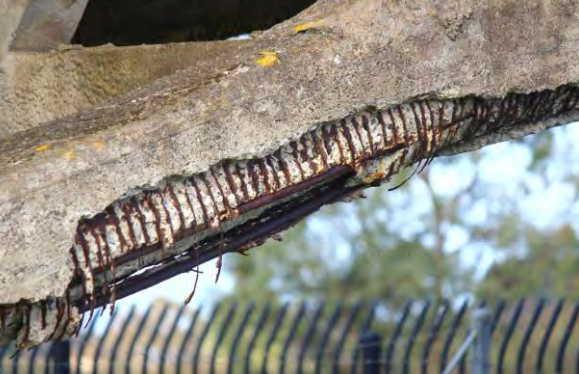
na	Loss of ligatures	na	No signs of further degradation
128	Span 1 Sth	West	Truss	Btm Chord 3		2

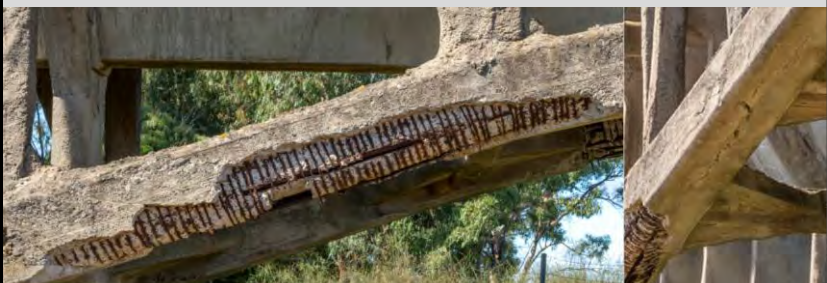
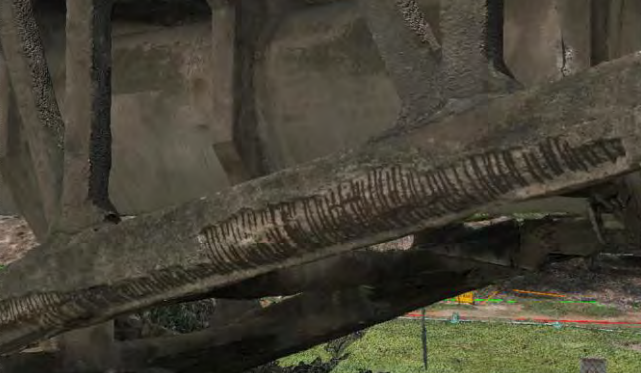
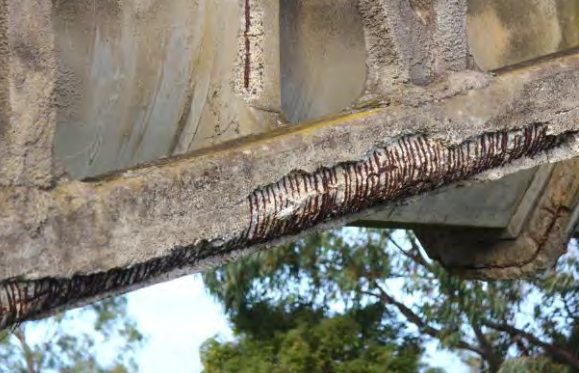
2 to 5	Loss of concrete cover	na	No signs of further degradation
155	Span 1 Sth	East	Truss	Top Chord 1		5

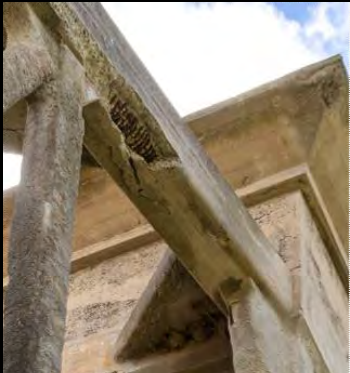
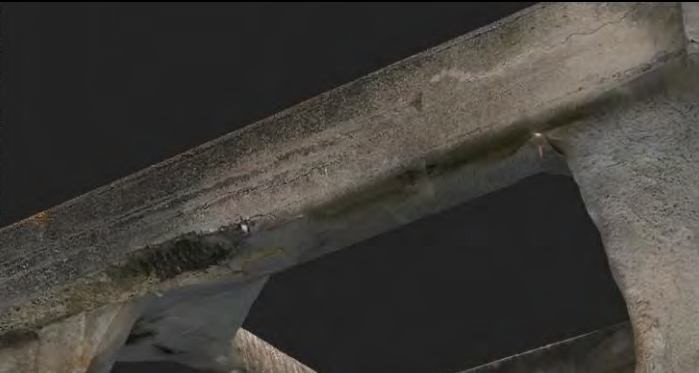
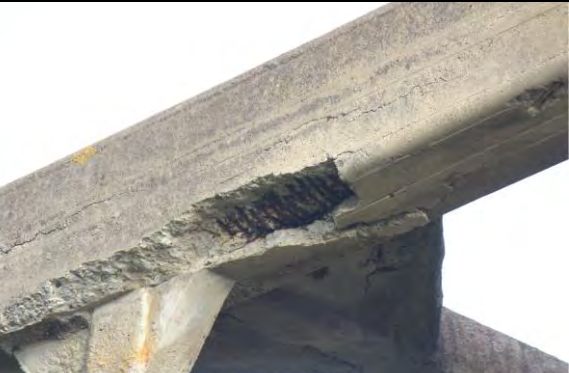
na		na	No signs of further degradation
165	Span 1 Sth	East	Truss	Btm Chord 3		5

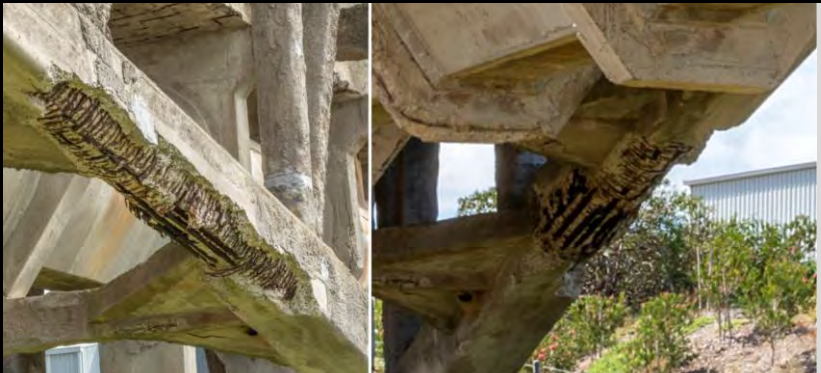
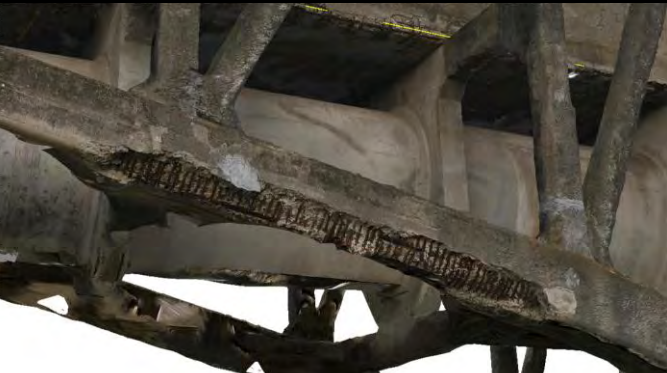
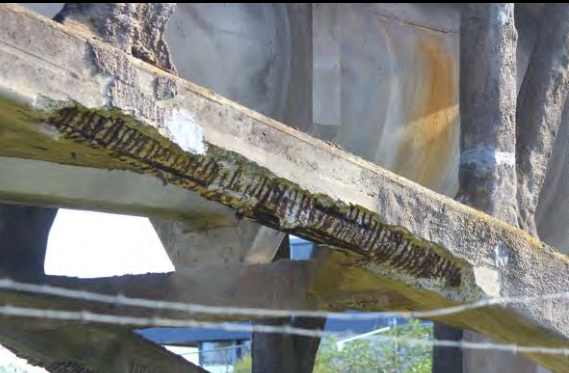
na		na	No signs of further degradation

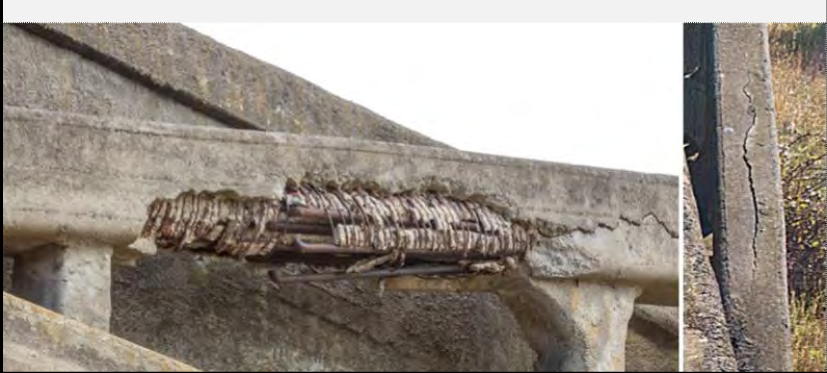
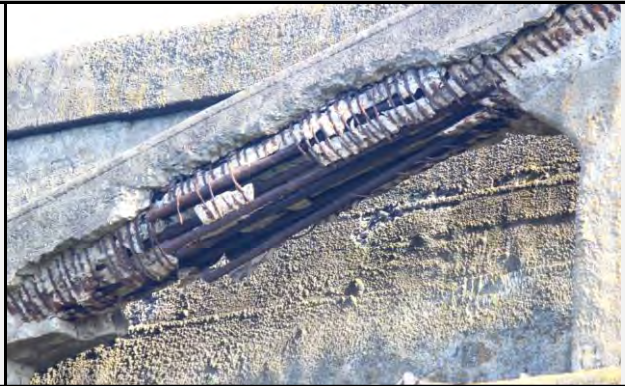
352	Span 2 Sth	East	Truss	Top Chord 7	5

na	Loss of concrete cover	na	No signs of further degradation
356	Span 2 Sth	East	Truss	Btm Chord 3	5	 	5	 	5	 	na		na	No signs of further degradation
358	Span 2 Sth	East	Truss	Btm Chord 5	5

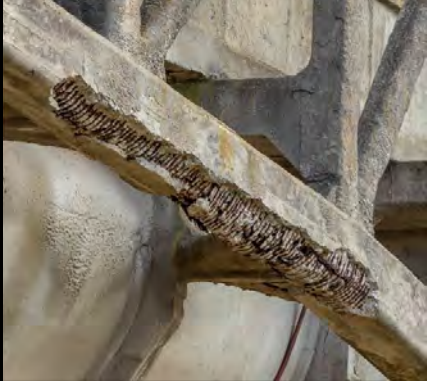
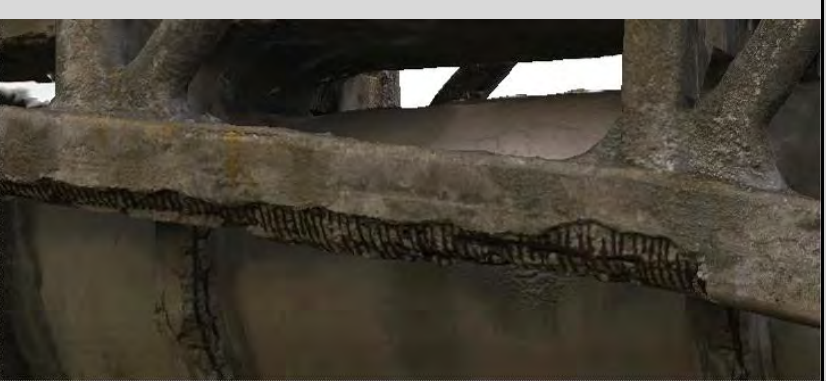
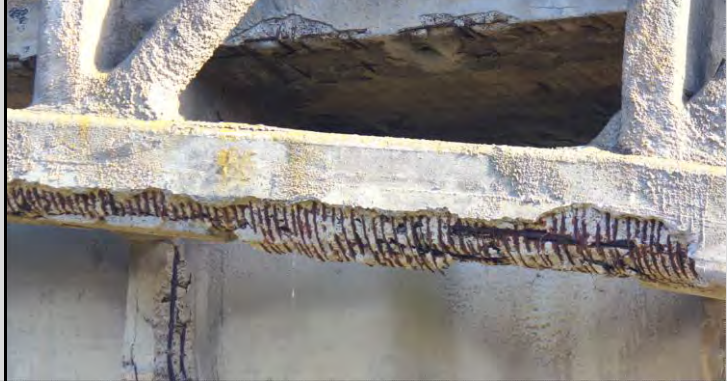
na		na	No signs of further degradation
395	Girder 2-3	East	Girder	Walkway beam South-central	5	 	5	 	5	 	na		na	
399	Girder 2-3	East	Girder	Pipe hanger South-central	5	 	5	 	5	 	na		na	
402	Span 3 Nth	West	Truss	Top Chord 2	5

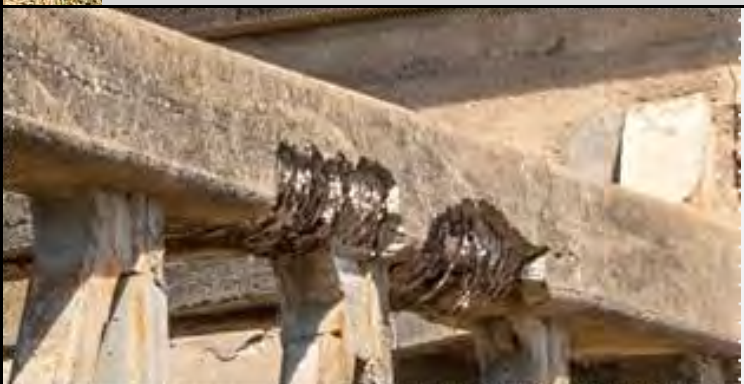
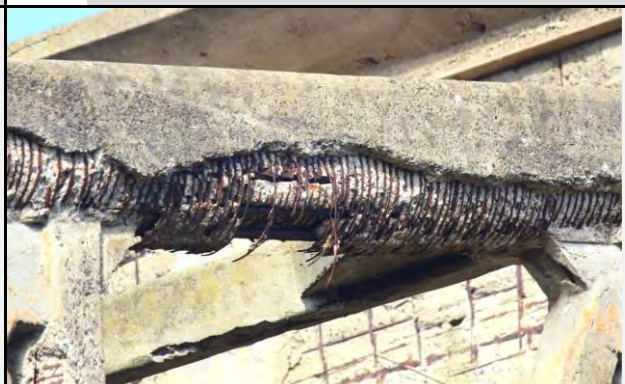
na	Loss of concrete cover	na	Loss of concrete cover
403	Span 3 Nth	West	Truss	Top Chord 3	5

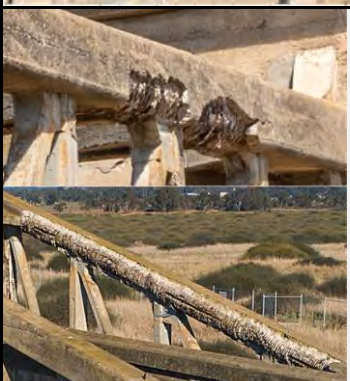
5	 	5	 	na		na	Loss of concrete cover
404	Span 3 Nth	West	Truss	Top Chord 4	5

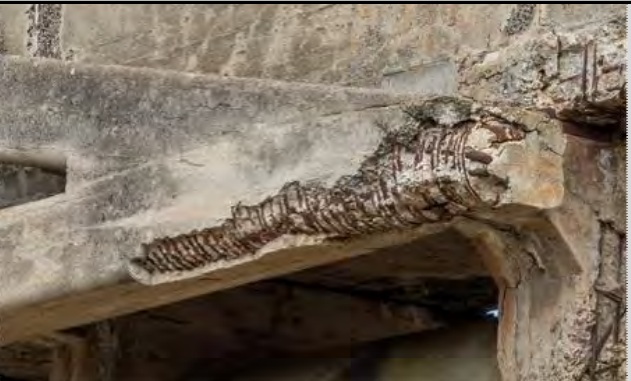
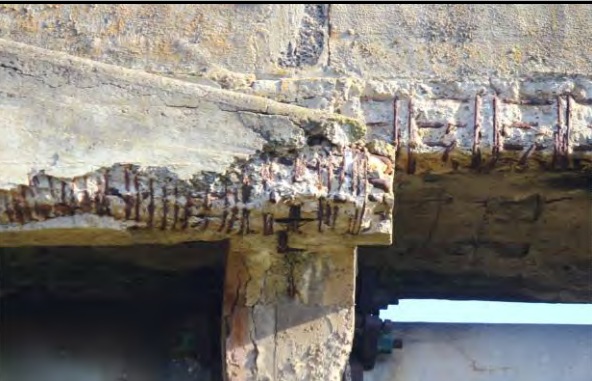
453	Span 3 Nth	East	Truss	Btm Chord 8		5

na	Loss of concrete cover	na	No signs of further degradation
455	Span 3 Nth	East	Truss	Vert Web 1	Cast patch repair	5

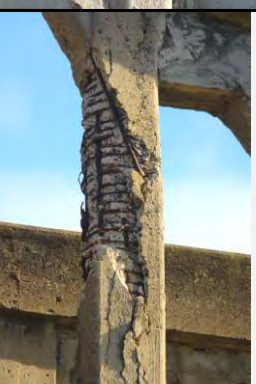
na		na	No signs of further degradation
461	Span 3 Nth	East	Truss	Vert Web 4	Cast patch repair	5

na	Loss of concrete cover	na	No signs of further degradation
476	Pier 3	West	Pier	Pier Leg Sth		5

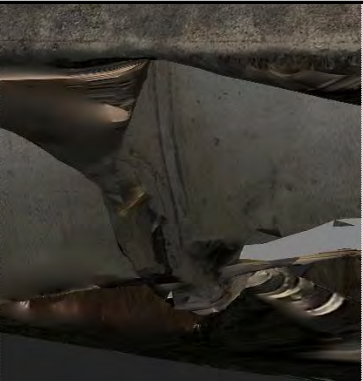
5	 	na		na	
2283	Girder 12-13	West	Girder	Pipe hanger South	Tie	4

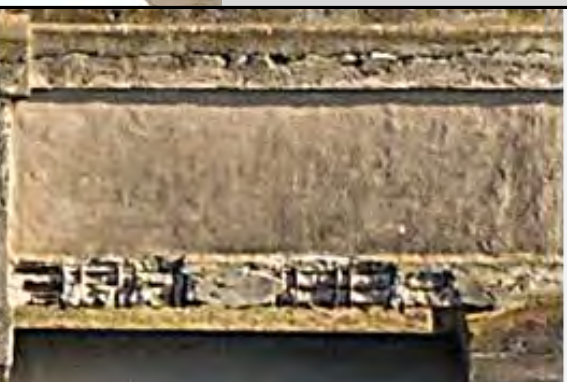
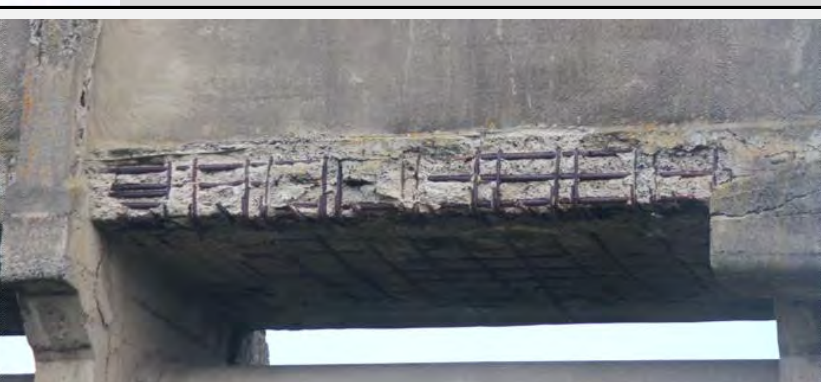
5	 		5	 	4 to 5	Point Cloud defect area not captured	na	
2284	Girder 12-13	East	Girder	Walkway beam North		5

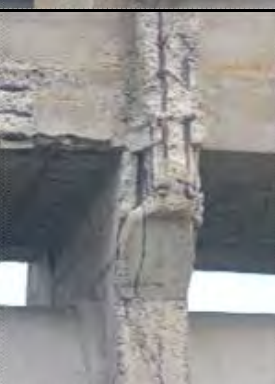
na	Loss of concrete cover	na	No signs of further degradation
2291	Girder 12-13	East	Girder	Pipe hanger South-central	Tie	5	 		5	 		5

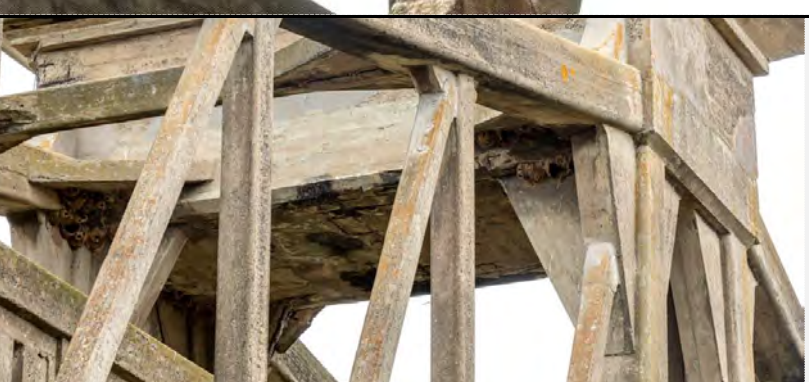
na		na	
2361	Span 13 Nth	East	Truss	Pipe Hanger 3	Cast patch repair	5	 		5	 		5	 	na		na	
2379	Pier 13	na	Pier	Pier head soffit		5

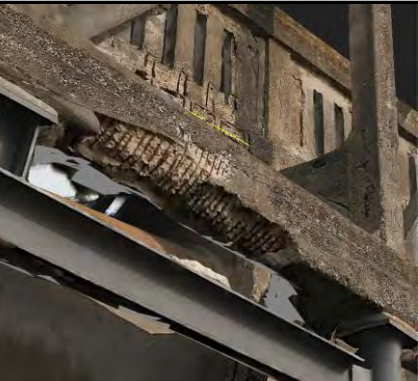
2496	Span 14 Nth	West	Truss	Btm Chord 5	Metal support	5	 		5

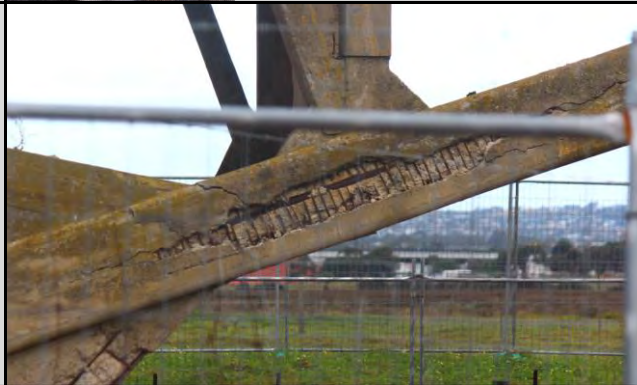
na		na	
2529	Span 14 Nth	East	Truss	Btm Chord 1		5	 		5	 		5

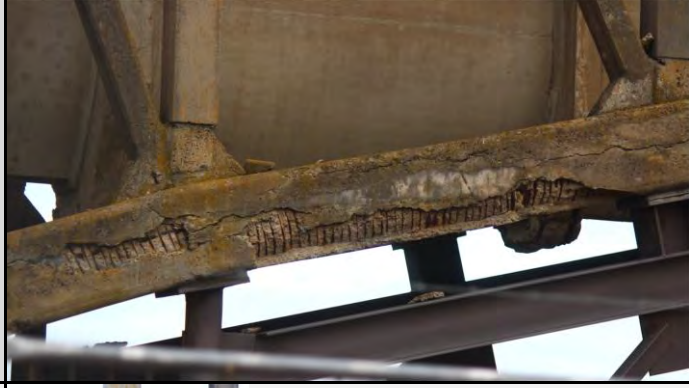
na	Loss of concrete cover	na	No signs of further degradation
2530	Span 14 Nth	East	Truss	Btm Chord 2		5	 		5	 		5	 	na		na	No signs of further degradation
2531	Span 14 Nth	East	Truss	Btm Chord 3		5	 		5	 		5

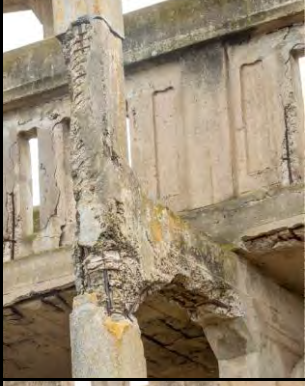
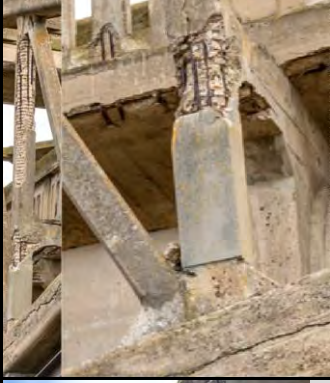
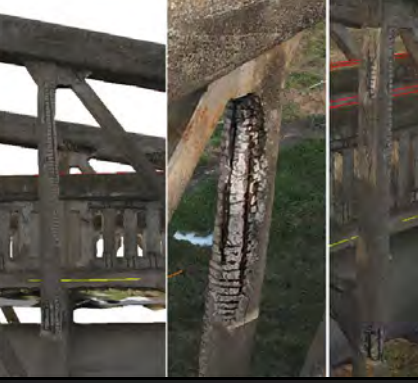
na		na	No signs of further degradation
2540	Span 14 Nth	East	Truss	Vert Web 2	Cast patch repair	5

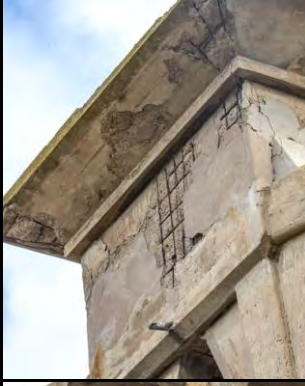
5	 	na		na	No signs of further degradation
2565	Pier 14	East	Pier	Pier head Face east	Cast patch repair	5

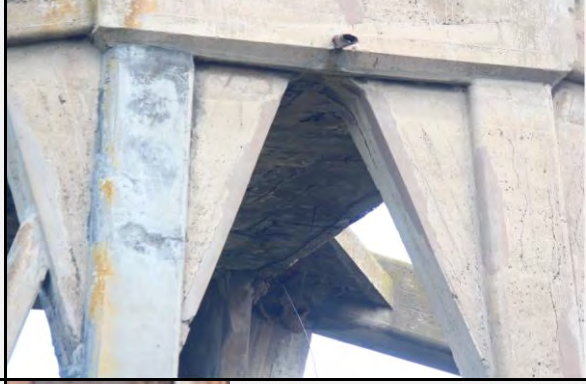
5	 		5	 	na		na	
2570	Pier 14	na	Pier	Pier head soffit		5	 		0	na		5

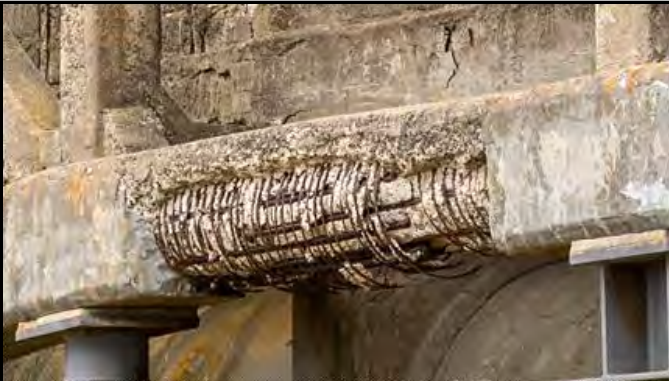
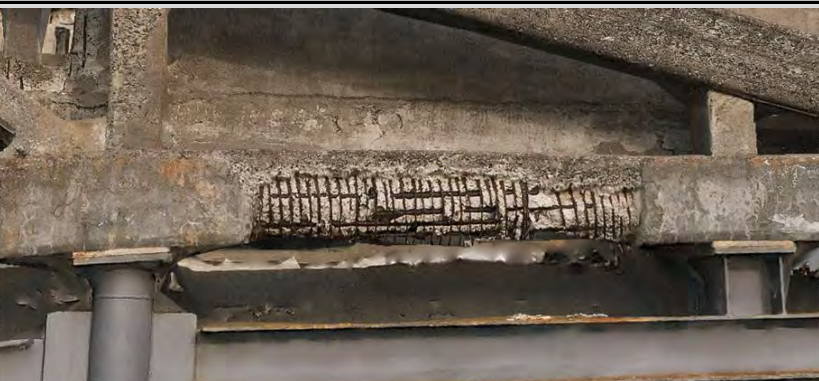
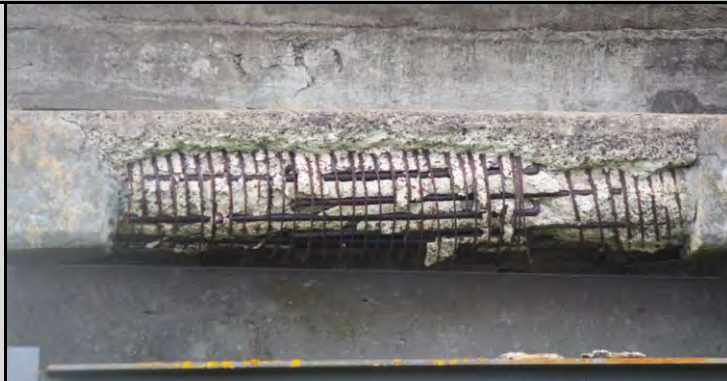
2597	Span 14 Sth	West	Truss	Btm Chord 7	Cast patch repair	5

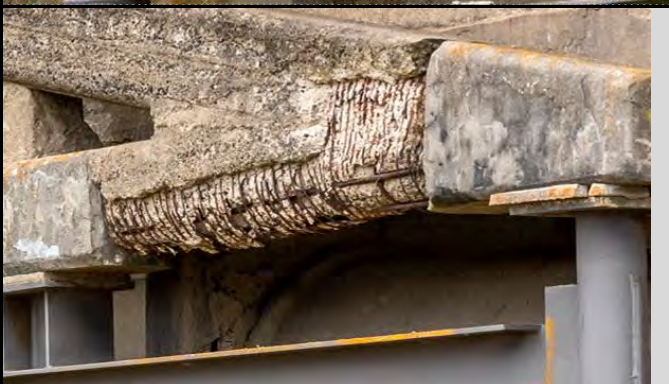
na		na	No signs of further degradation
2598	Span 14 Sth	West	Truss	Btm Chord 8	Cast patch repair	5

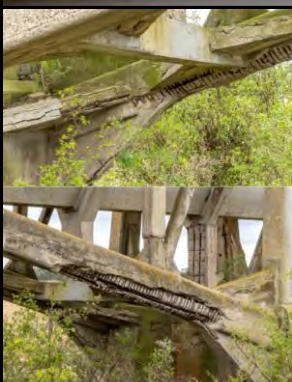
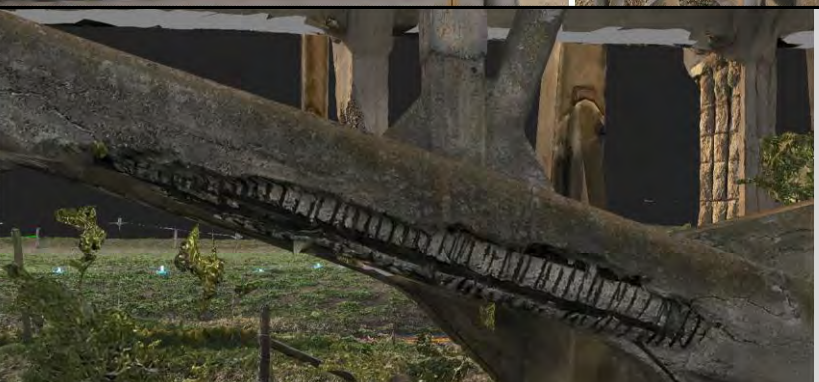
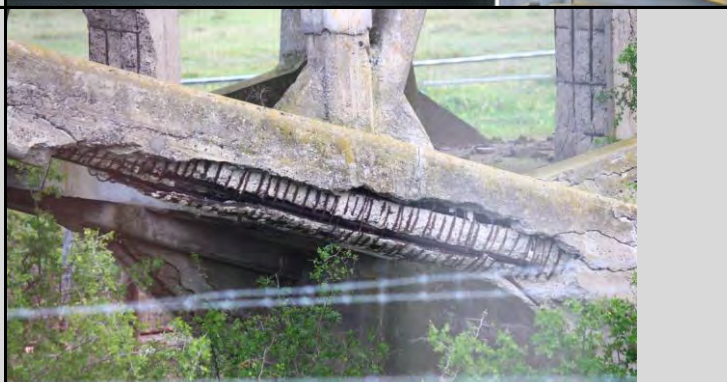
na		na	No signs of further degradation
2628	Span 14 Sth	East	Truss	Btm Chord 1		5

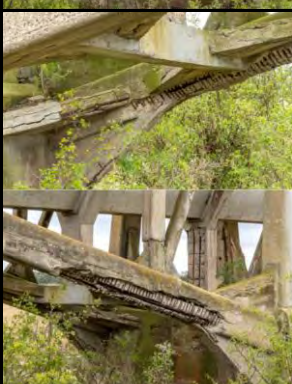
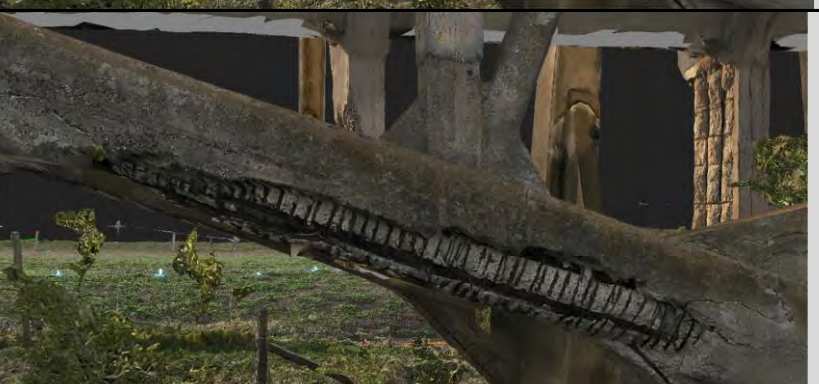
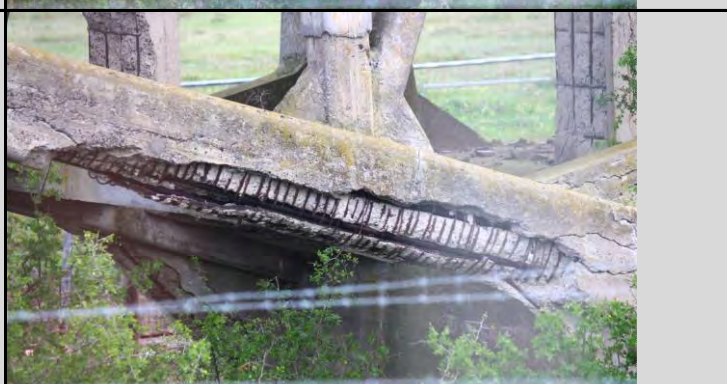
na		na	No signs of further degradation
2629	Span 14 Sth	East	Truss	Btm Chord 2		5

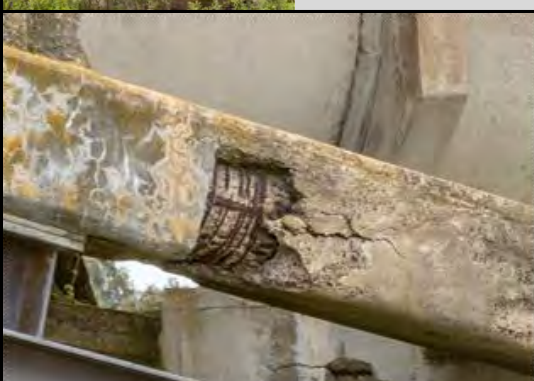
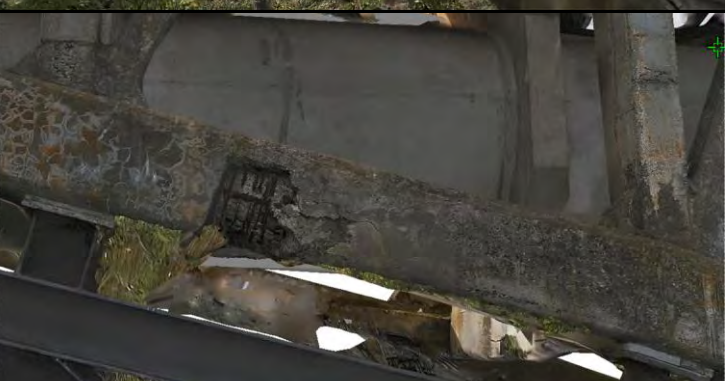
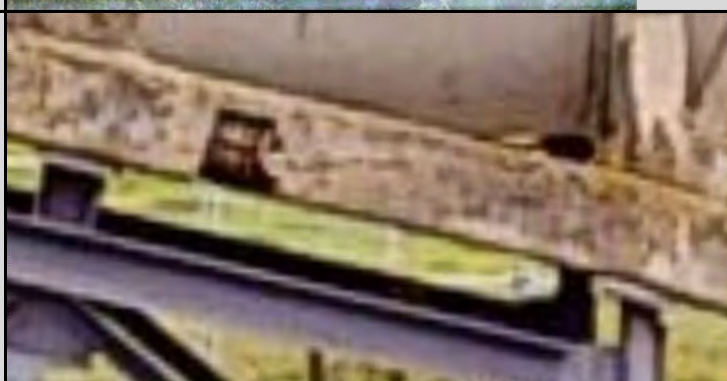
na		na	No signs of further degradation
2630	Span 14 Sth	East	Truss	Btm Chord 3		5

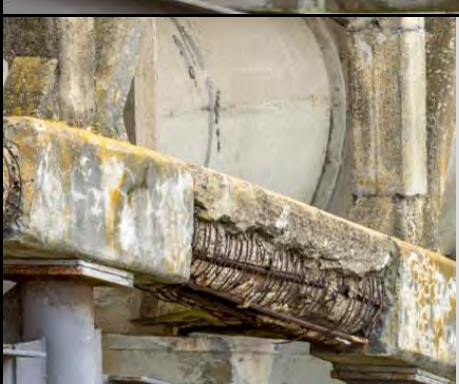
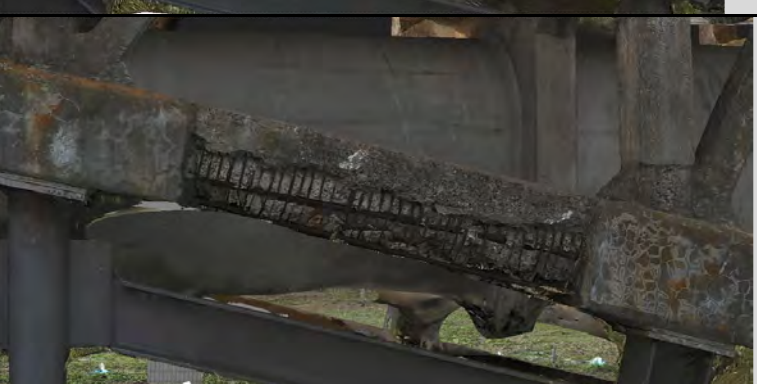
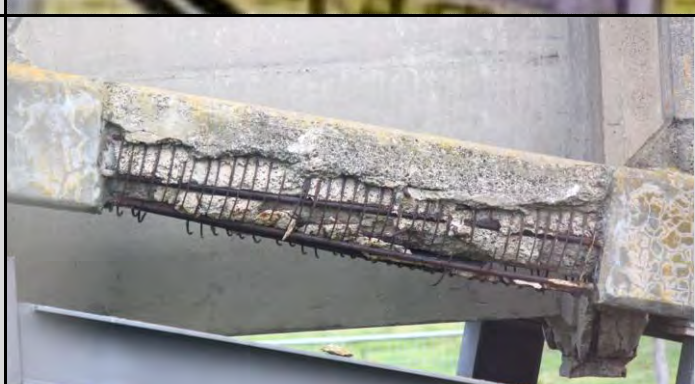
na		na	No signs of further degradation
2631	Span 14 Sth	East	Truss	Btm Chord 4		5

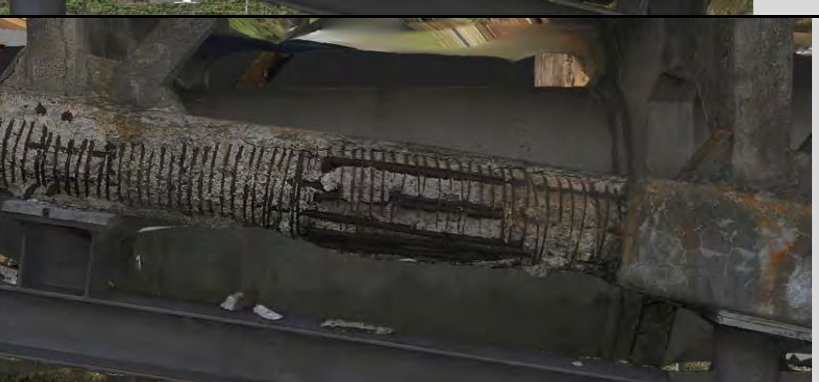
na		na	No signs of further degradation
2632	Span 14 Sth	East	Truss	Btm Chord 5		5

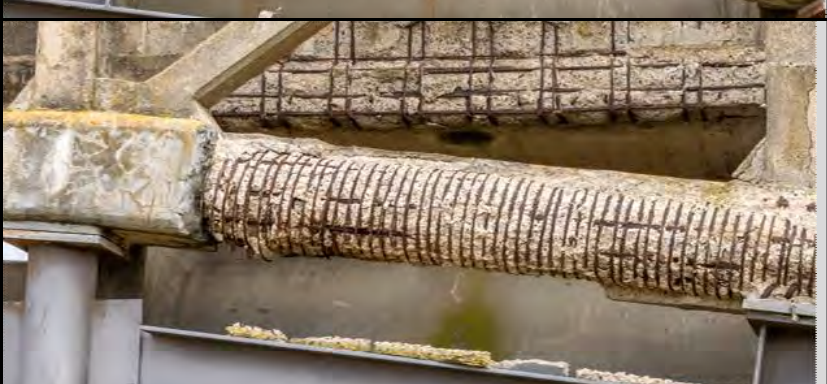
na		na	No signs of further degradation
2633	Span 14 Sth	East	Truss	Btm Chord 6		5

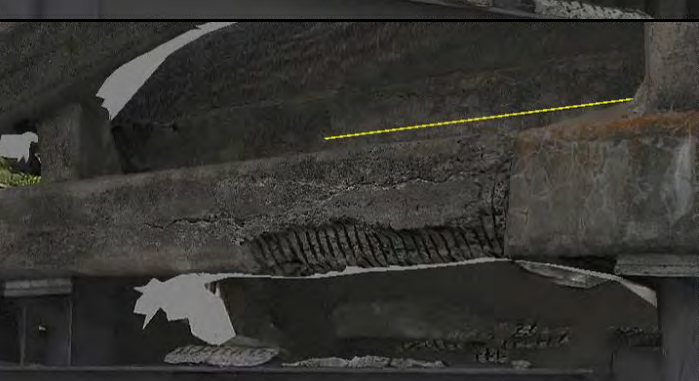
na		na	No signs of further degradation
2634	Span 14 Sth	East	Truss	Btm Chord 7		5

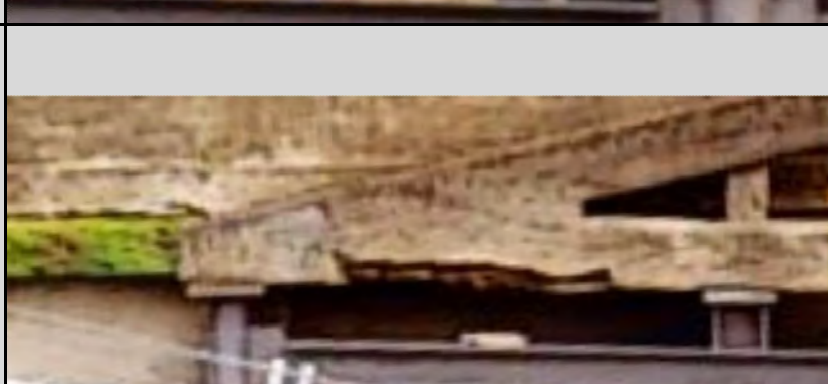
2635	Span 14 Sth	East	Truss	Btm Chord 8		5

na		na	No signs of further degradation

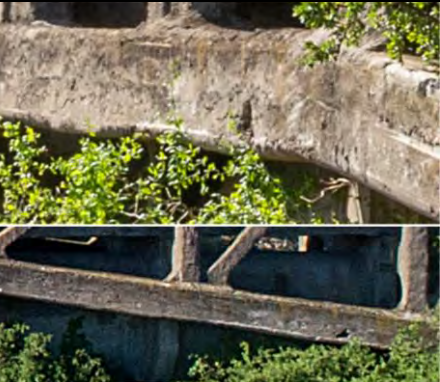
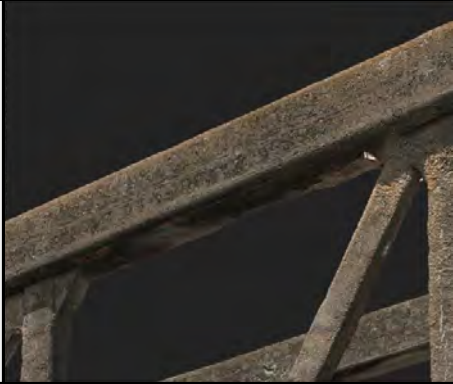
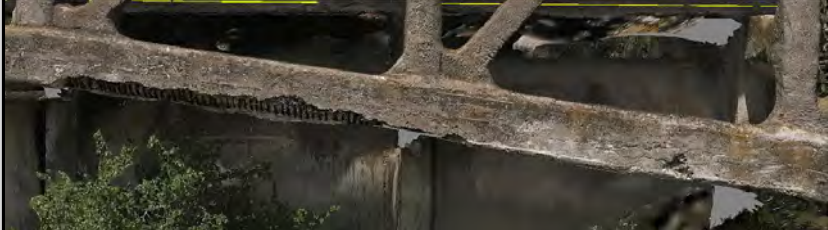
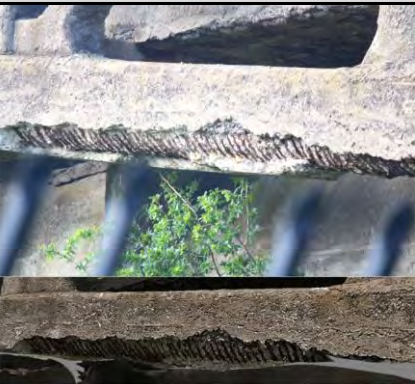
3 to 4	Loss of concrete cover	na	
32	Span 1 Nth	West	Truss	Btm Chord 6	1

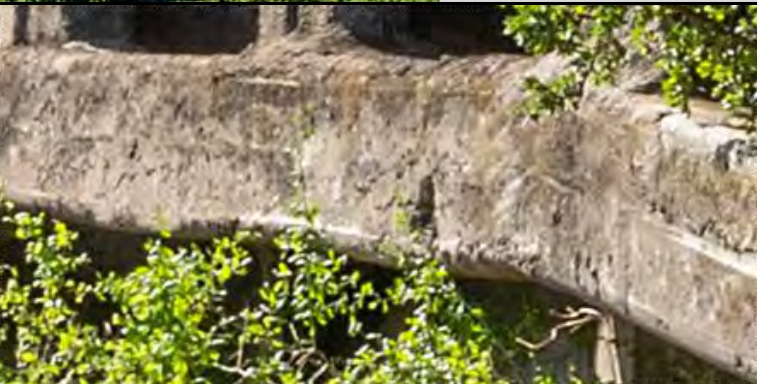
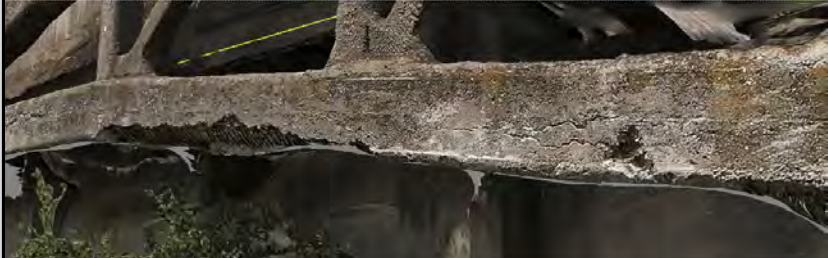
1 to 4	Loss of concrete cover	na	No signs of further degradation
67	Span 1 Nth	East	Truss	Btm Chord 4	3

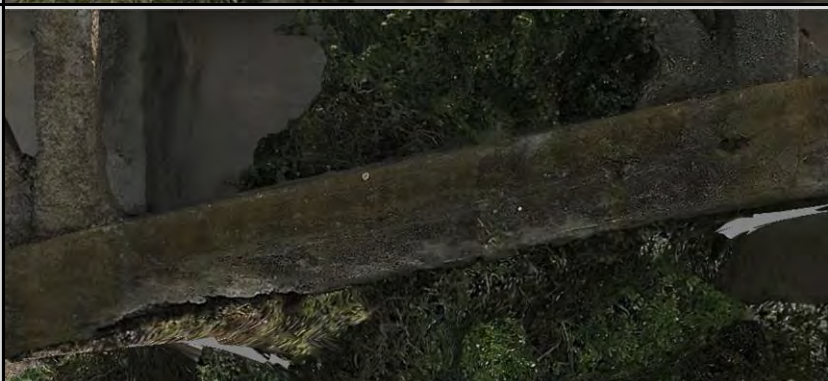
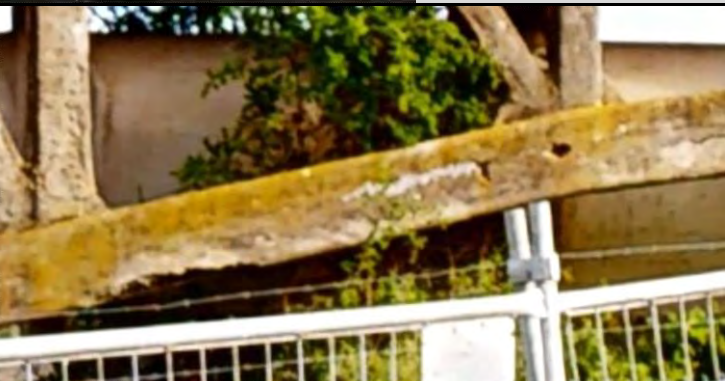
na		3 to 4	New loss of concrete cover

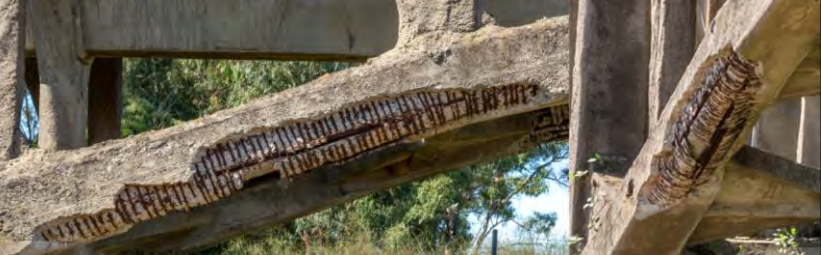
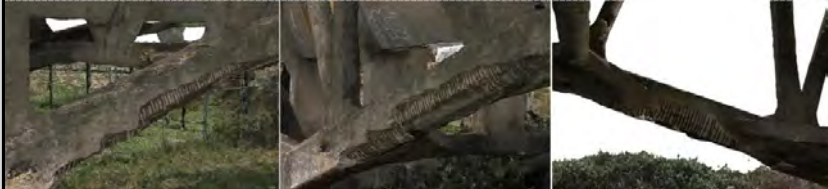
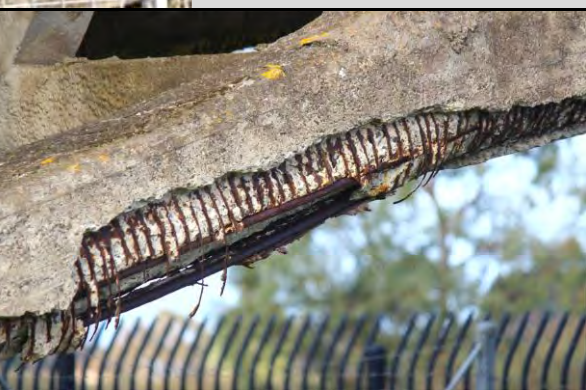
na	Loss of ligatures	na	No signs of further degradation
128	Span 1 Sth	West	Truss	Btm Chord 3	2

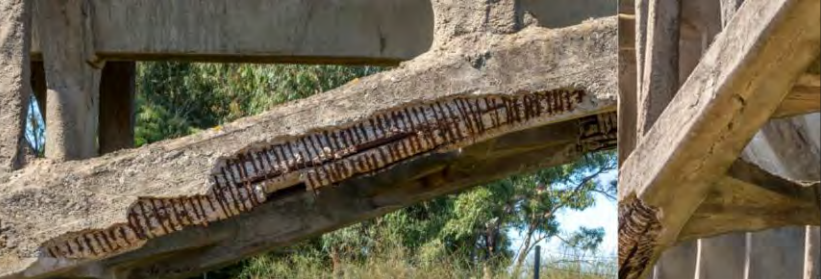
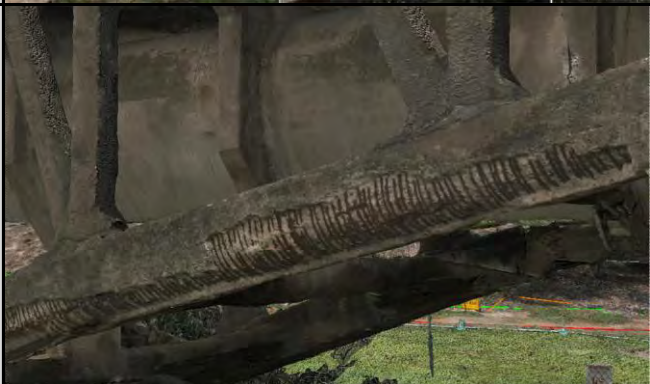
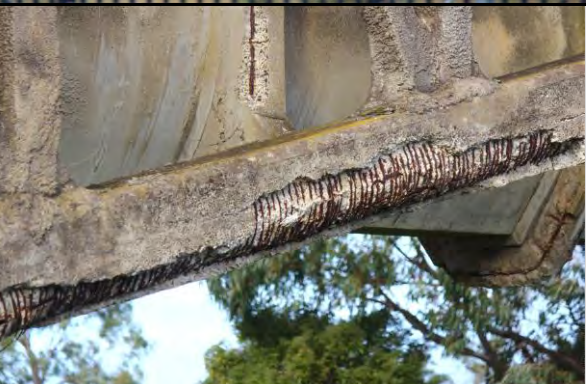
2 to 5	Loss of concrete cover	na	No signs of further degradation
129	Span 1 Sth	West	Truss	Btm Chord 4	2

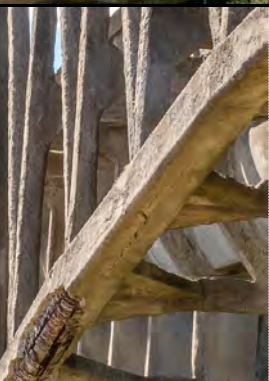
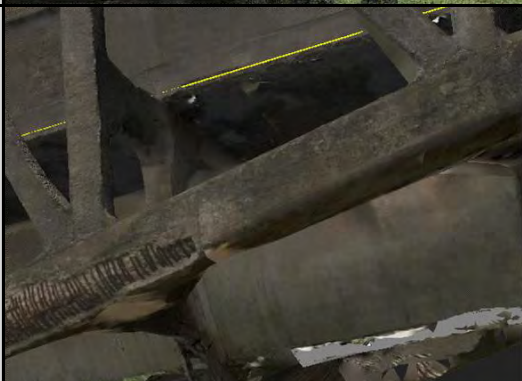
2 to 4	Loss of concrete cover	na	
167	Span 1 Sth	East	Truss	Btm Chord 5	5

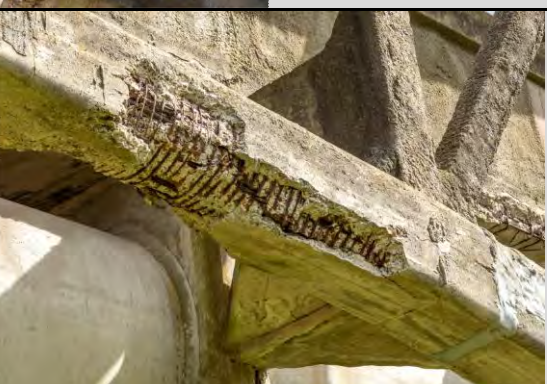
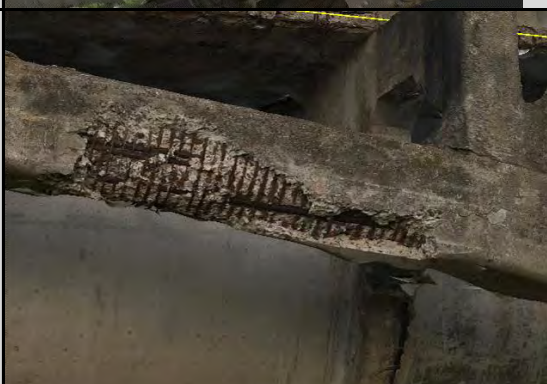
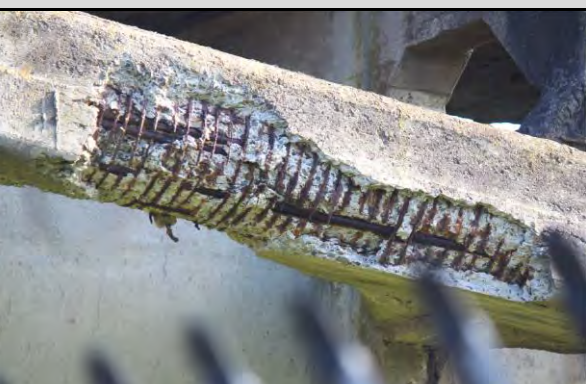
na	Loss of concrete cover	na	No signs of further degradation
169	Span 1 Sth	East	Truss	Btm Chord 7	2

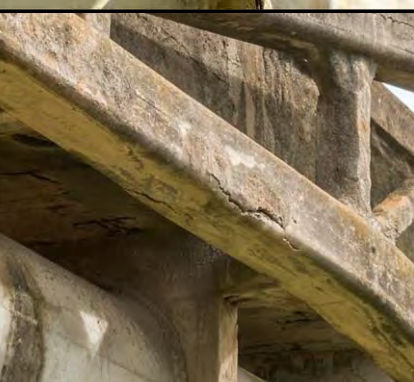
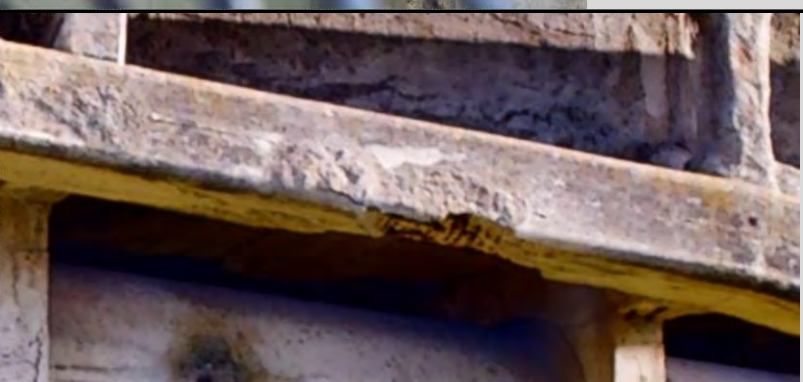
2 to 5	Loss of concrete cover	na

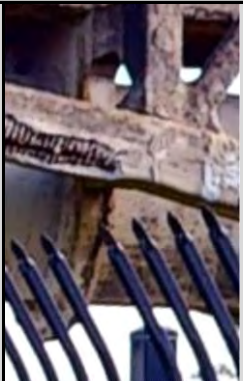
187	Span 1 Sth	East	Truss	Pipe Hanger 4	3

na		na	New loss of concrete cover
194	Girder 1-2	West	Girder	Walkway beam Central	4

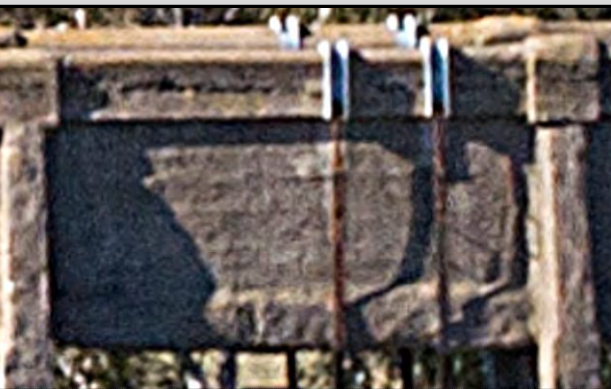
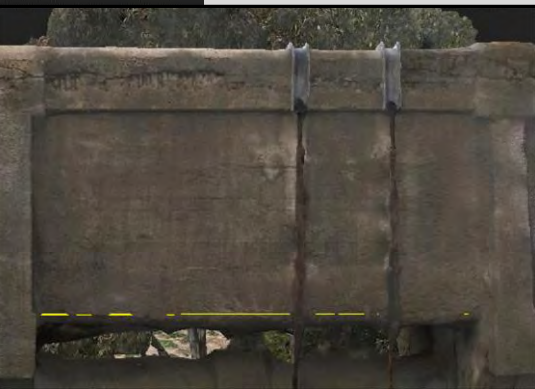
na	Loss of concrete cover	na	
197	Girder 1-2	West	Girder	Pipe hanger North	2

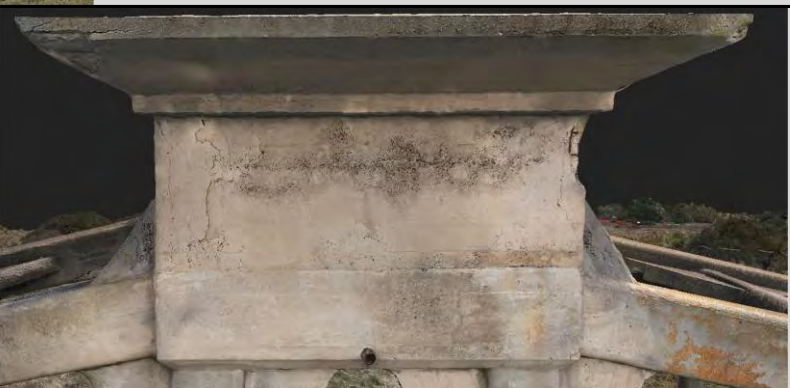
2 to 3	Loss of concrete cover	na	
351	Span 2 Sth	East	Truss	Top Chord 6	2

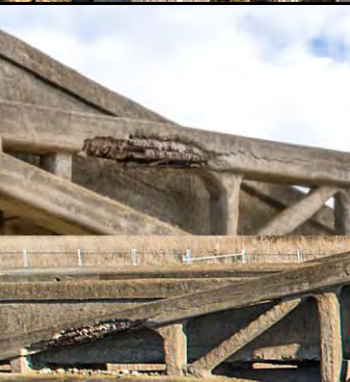
2 to 4	Loss of concrete cover	na	
352	Span 2 Sth	East	Truss	Top Chord 7	5
