# Barwon Aqueduct

## Structural Engineering and Risk Assessment Report

Reference: BAR-HVP-REP-001

Issue for Permit | 28 August 2025

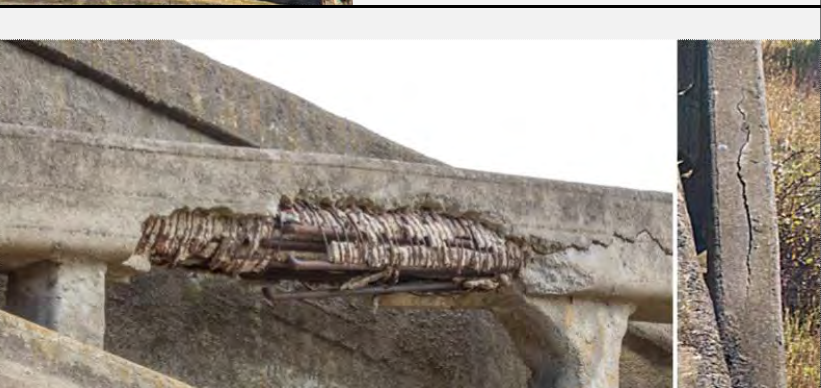
na	Loss of concrete cover	na	No signs of further degradation
357	Span 2 Sth	East	Truss	Btm Chord 4	4

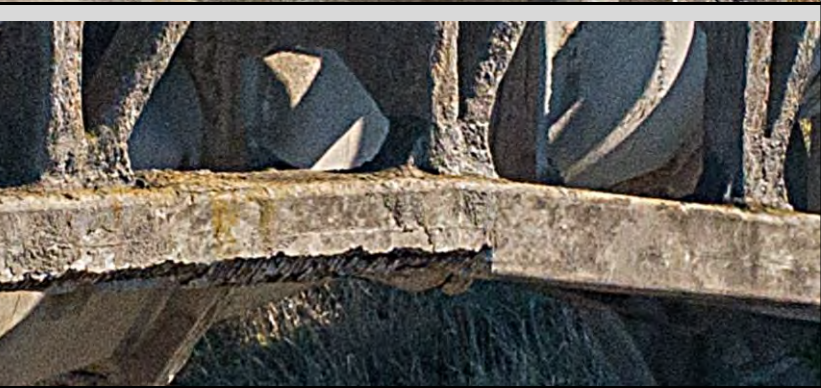
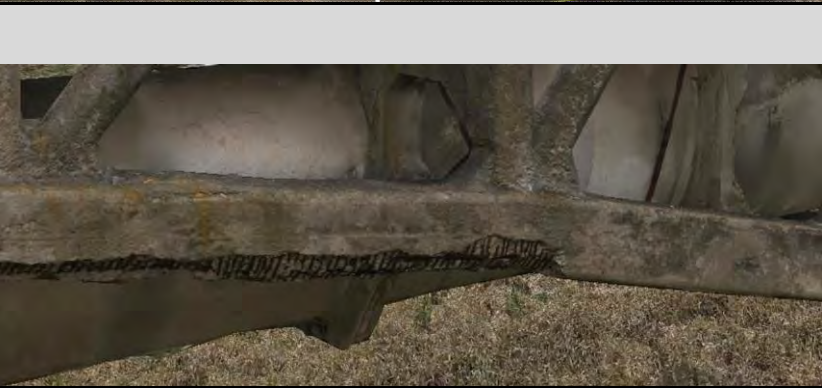
na	Loss of concrete cover	na	
391	Girder 2-3	West	Girder	Pipe hanger South	1

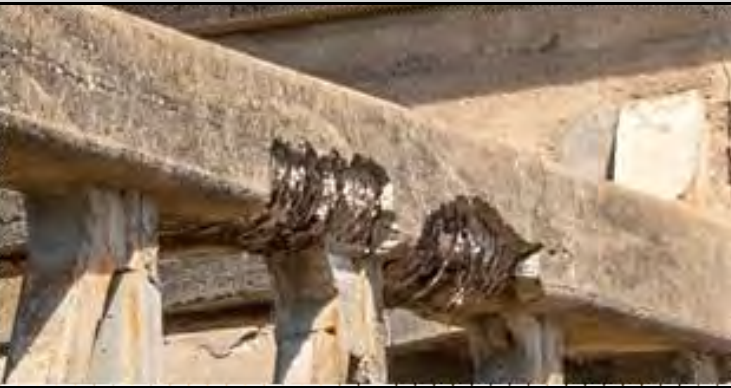
na	Loss of concrete cover	na	Loss of concrete cover
403	Span 3 Nth	West	Truss	Top Chord 3	5

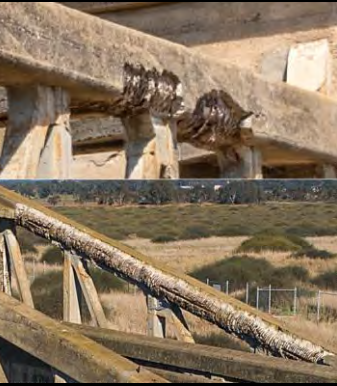
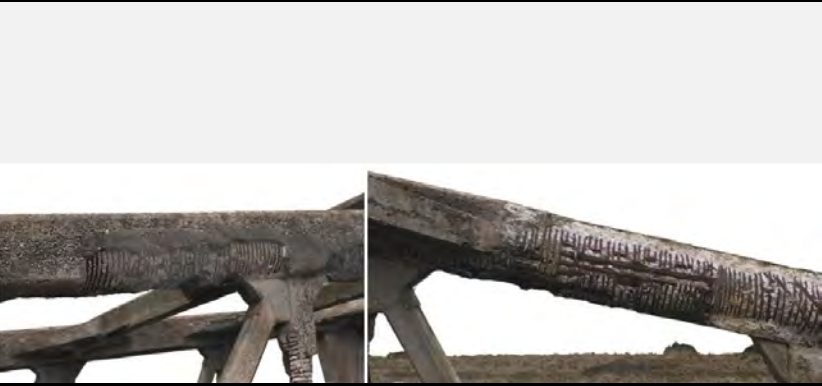
na		na	Loss of concrete cover

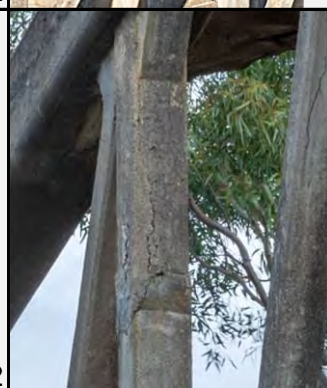
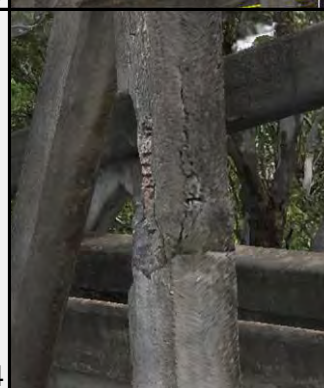
2 to 5	Loss of concrete cover	na	
1702	Span 9 Sth	East	Truss	Vert Web 2	2

4		2 to 4	Loss of concrete cover	na	
1967	Span 11 Nth	East	Truss	Vert Web 2	2

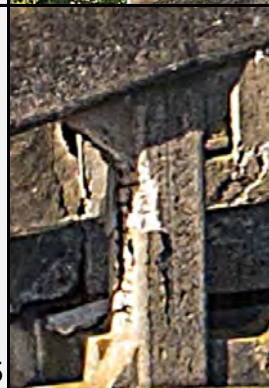
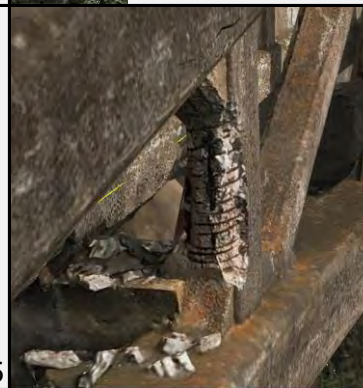
0		2 to 4	Loss of concrete cover	Insufficient Data	
2129	Span 12 Nth	West	Truss	Vert Web 6	5

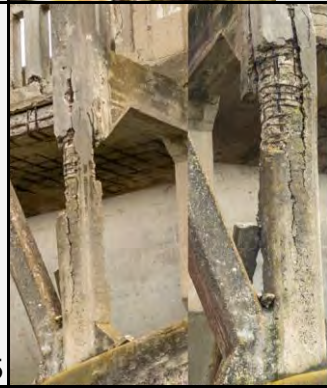
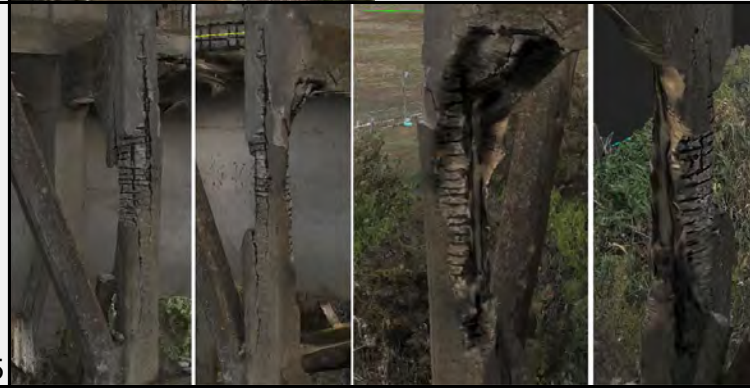
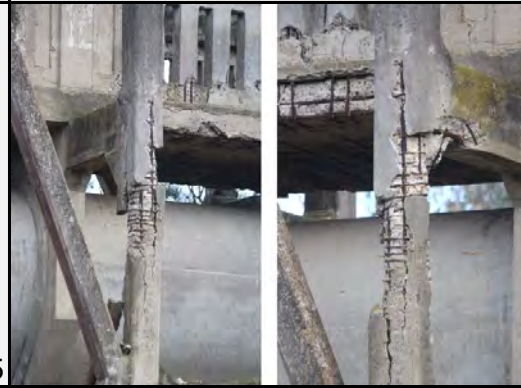
0	na	na	Loss of concrete cover	Insufficient Data	
2158	Span 12 Nth	East	Truss	Vert Web 2	5

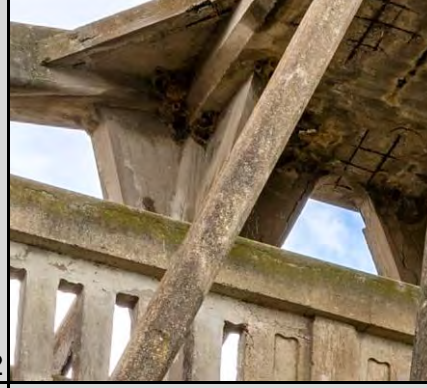
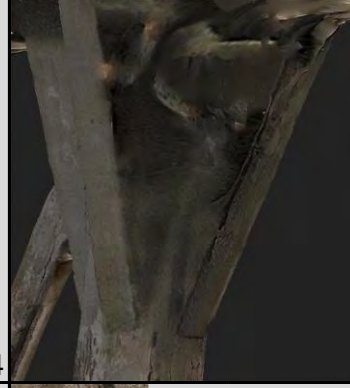
0		2 to 3	Loss of concrete cover	Insufficient Data	
2190	Pier 12	West	Pier	Gussets Sth	2

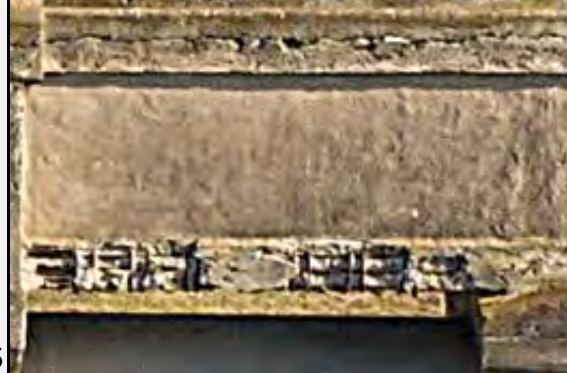
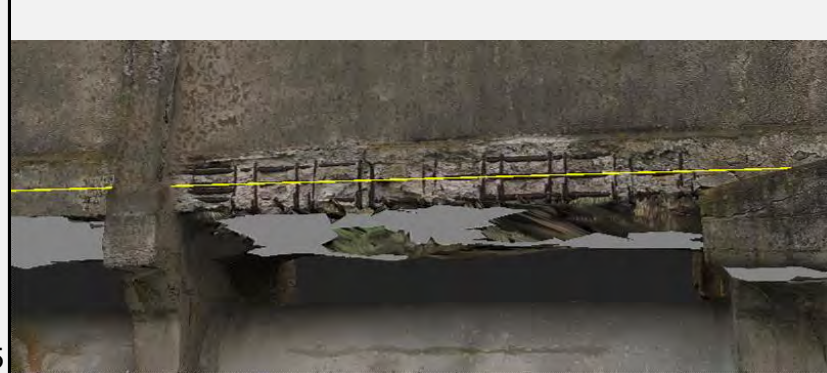
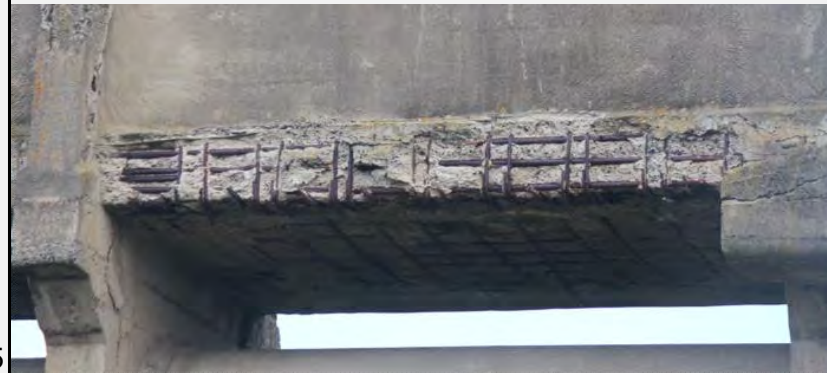
2284	Girder 12-13	East	Girder	Walkway beam North	5

na	Loss of concrete cover	na	No signs of further degradation

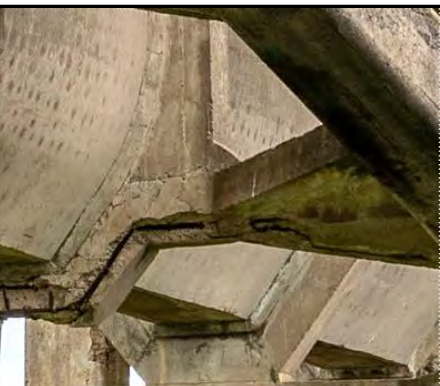
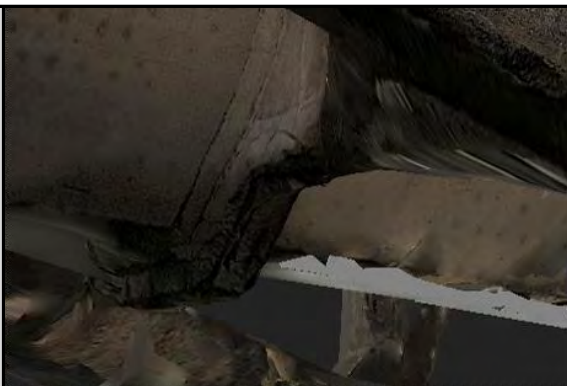
2324	Span 13 Nth	West	Truss	Pipe Hanger 3	4

na	Loss of concrete cover	na	
2494	Span 14 Nth	West	Truss	Btm Chord 3	2

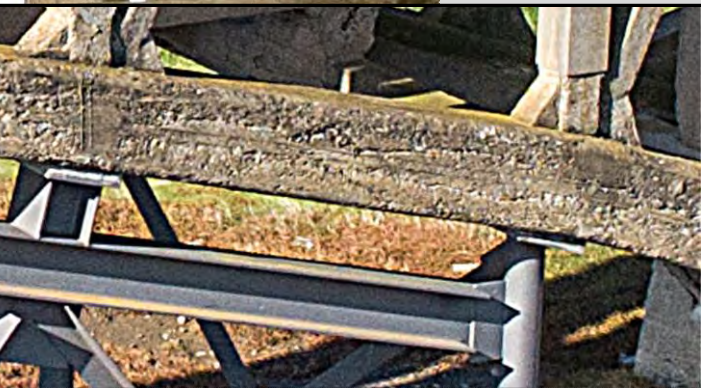
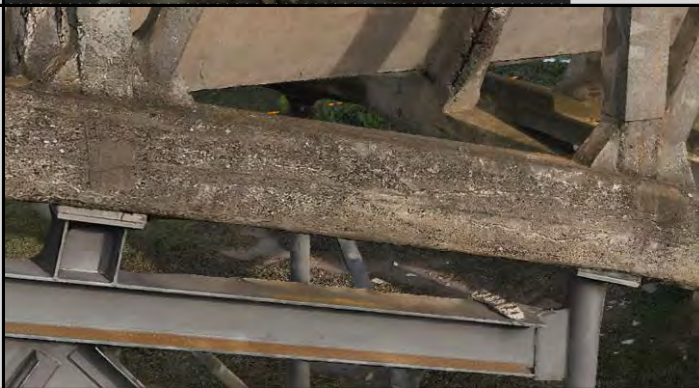
2 to 3	Loss of concrete cover (loose concrete on truss)	na	
2502	Span 14 Nth	West	Truss	Diag Web 2	2

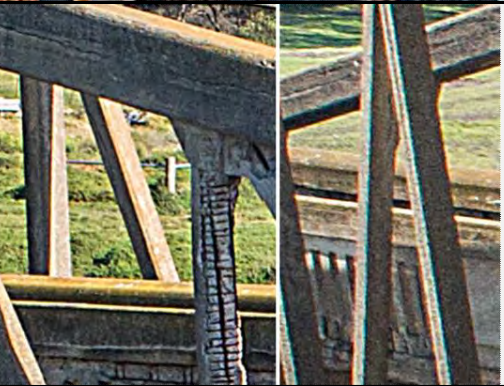
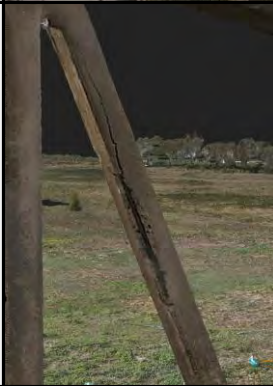
2 to 3	Loss of concrete cover	na	
2529	Span 14 Nth	East	Truss	Btm Chord 1	5

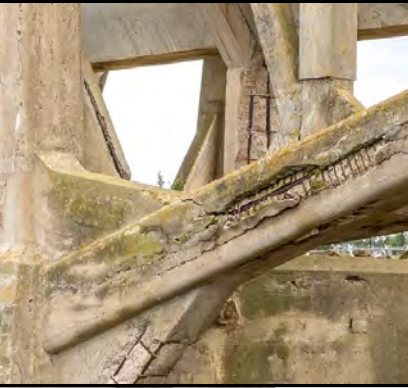
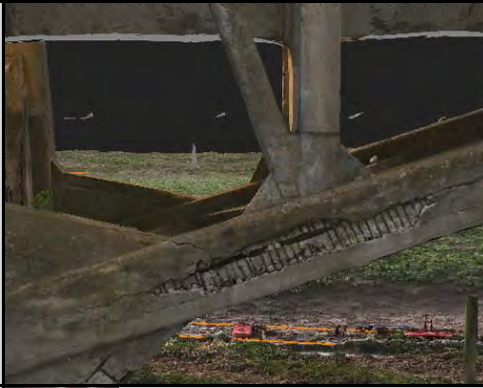
na	Loss of concrete cover	na	No signs of further degradation
2671	Girder 14-15	East	Girder	Pipe hanger North	3
